# PROPERTY CONDITION ASSESSMENT REPORT

FOR THE PROPERTY AT:  
123 Commercial Rd  
Springfield, IL 11223

INSPECTION DATE:  
Wednesday, April 4, 2018

Report No. 1011, v.5

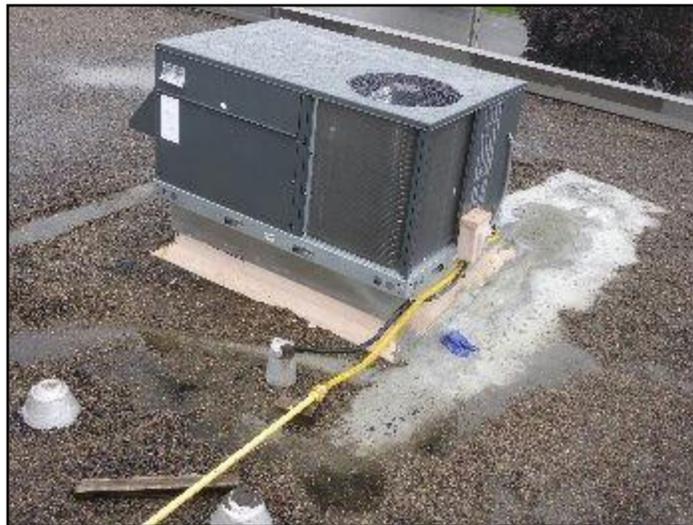
2. Office rooftop unit

Dedicated rooftop unit serving the offices. Note the roof flashing repair made with portland cement. The unit has a heat output of approximately 110,000 BTU/hr.

**43. Condition:** • Damaged membrane on the curb mount

Repair made with cement along the north perimeter of the office rooftop unit is temporary and should be improved.

**Task:** Repair

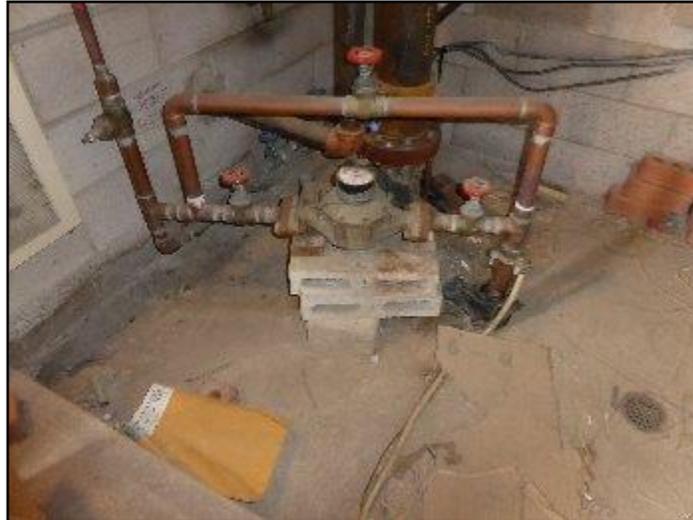
4. Main domestic water supply

**Condition:** • Backflow prevention device missing at the main domestic water service entrance

Implication: Possible contamination of municipal water supply.

**30. Condition:** • Backflow prevention device missing at the main domestic water service entrance

**Task:** Provide

**Time:** One year

**Cost:** \$3,000 to \$4,000

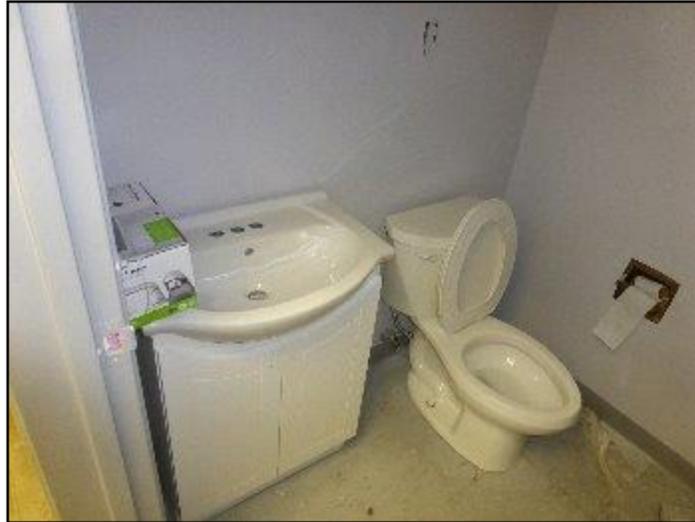
5. Washroom under renovation

**34. Condition:** • Leak

As stated above, there was a leak at the supply pipe servicing one of the newly installed warehouse washroom toilets.

**General:** • The washrooms were in the process of being renovated at the time of the inspection. As such, none of the wash basins had been equipped with faucets yet. Therefore, these fixtures could not be tested.

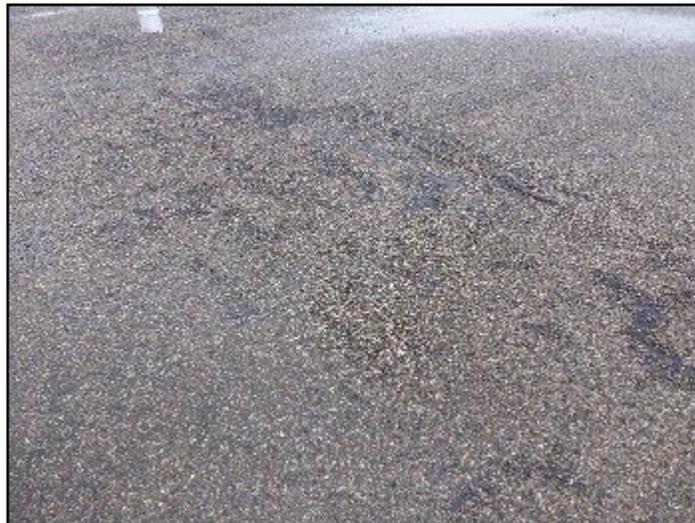
**39. Condition:** • Exposed membrane

**6.** *Example of exposed membrane*

**Time:** Immediate

**Cost:** Part of \$10,000 repair number

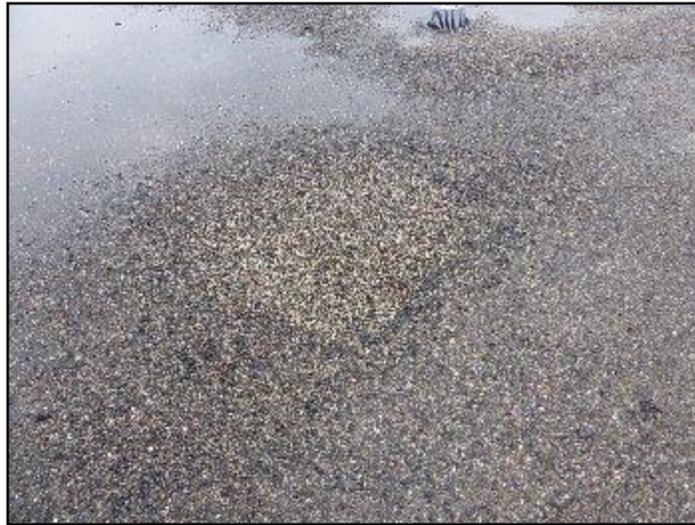
**40. Condition:** • Previous repairs noted

7. Example of a previous repair

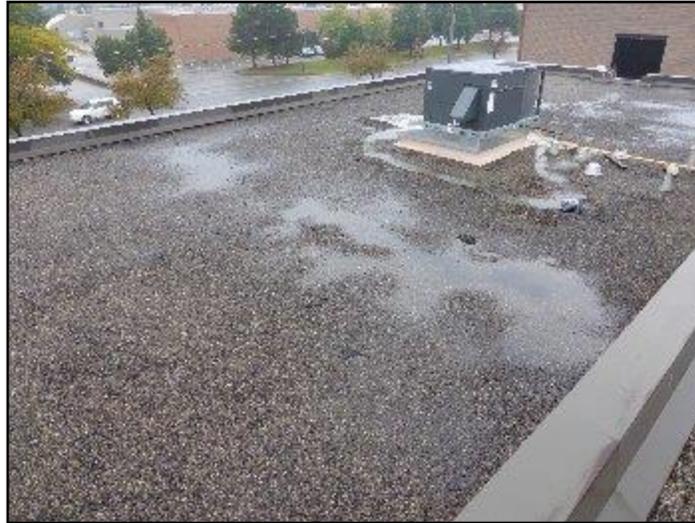
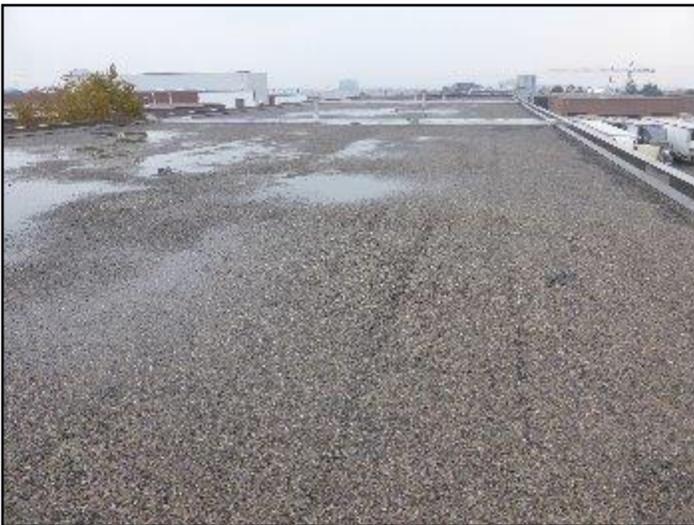
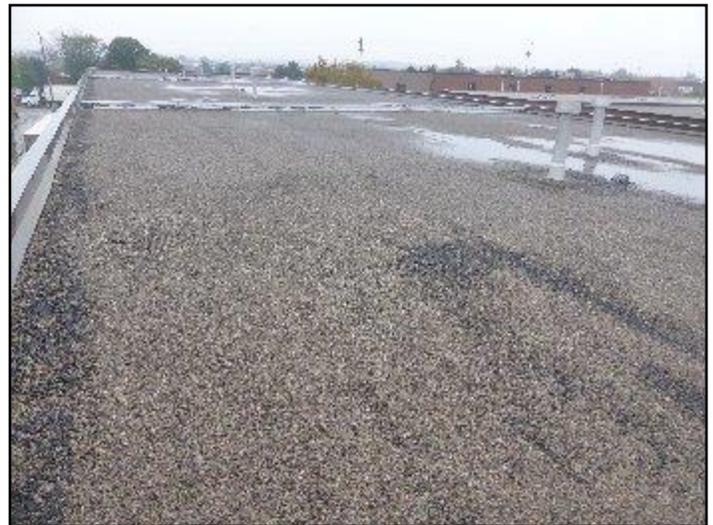
**38. Condition:** • Beyond typical life expectancy

Although the roof is beyond its typical lifespan, replacement can be deferred if immediate repairs are undertaken. Complete replacement will be required in approximately 3 years.

**Task:** Repair now and replace in 3 years

**Cost:** Repairs costs are \$10,000 now: Replacement cost is \$170,000 in 3 years

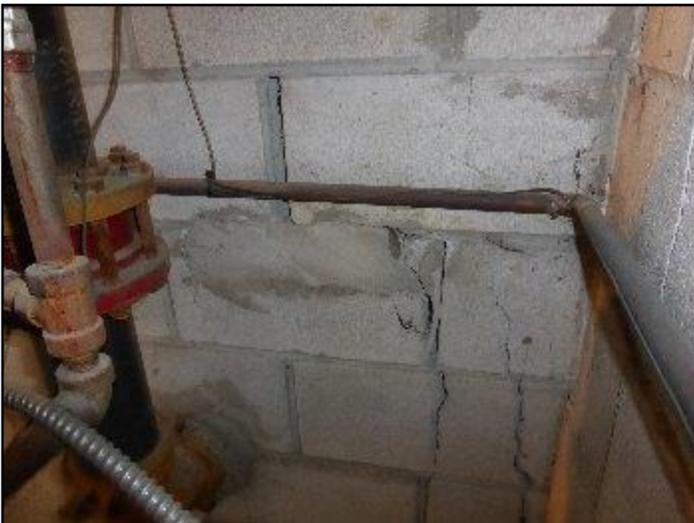
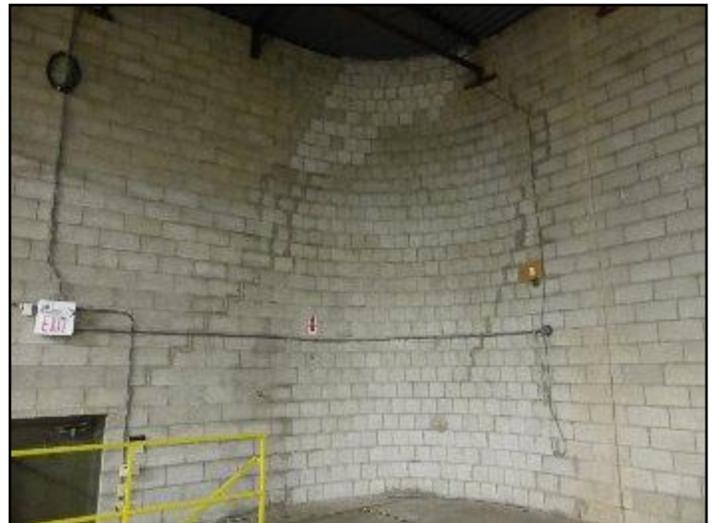
**53. Condition:** • Minor settlement was noted

Settlement evident in minor cracking of the block walls from within the warehouse. Most of the cracks have been re-mortared in past. In some locations, further cracking is noted, indicating continued settlement. These cracks are not a major structural concern and no structural remedial action is warranted. The cracks should be re-repaired with mortar and monitored for further movement.

11. Minor settlement crack in main electrical room

12. Minor settlement crack at southeast warehouse

**Time:** One year

**Cost:** Minor

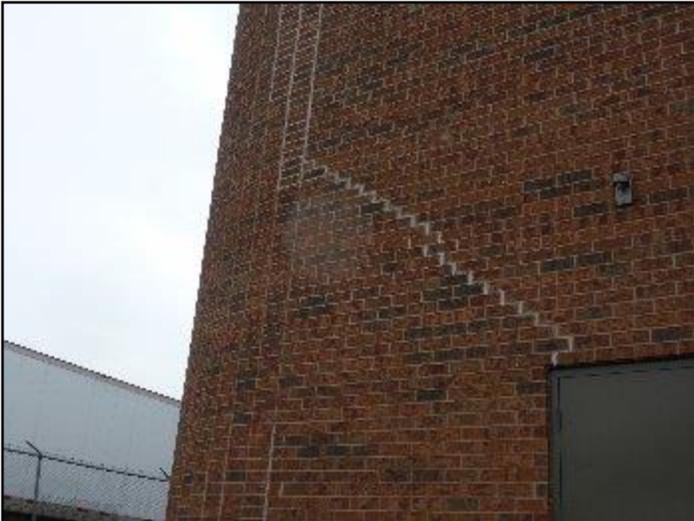
Settlement cracks in the east wall and spalled cement parging on the north wall

Implications: Water may enter wall systems and cause damage to the interior, or damage to the wall assemblies. especially during freeze/thaw cycles.

14. Settlement cracks

**Task:** Repair

**Time:** Within 1 year

**Cost:** \$4,000 - \$6,000

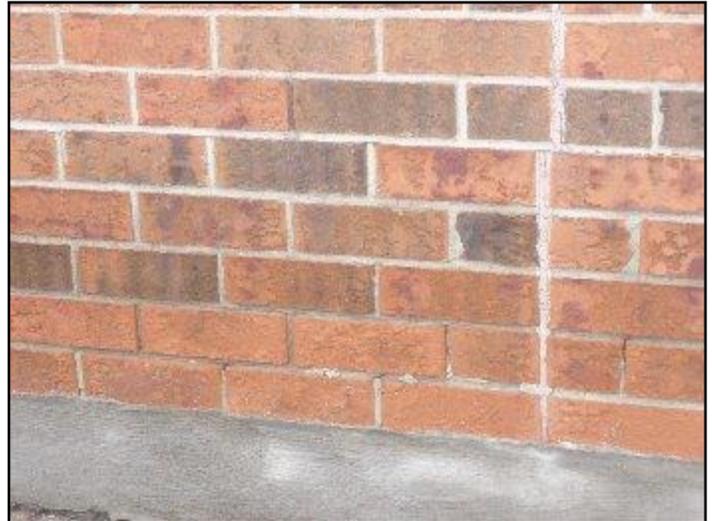
Deteriorated mortar joints in the bottom 5 rows of brick on the south wall

15. Example of mortar deterioration

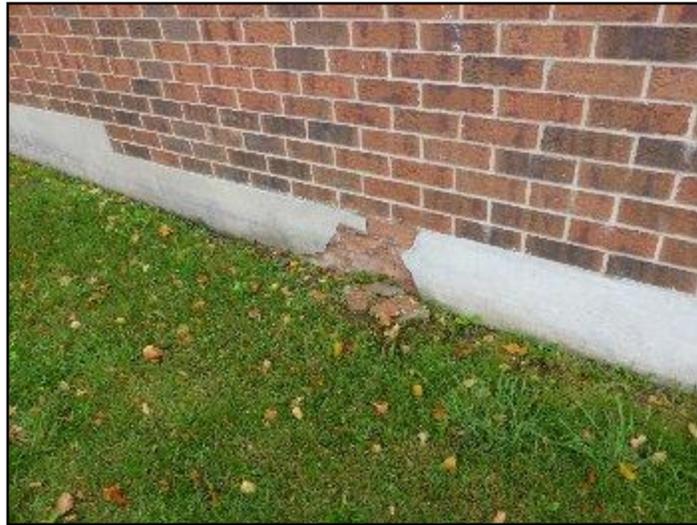
16. Spalled cement parging

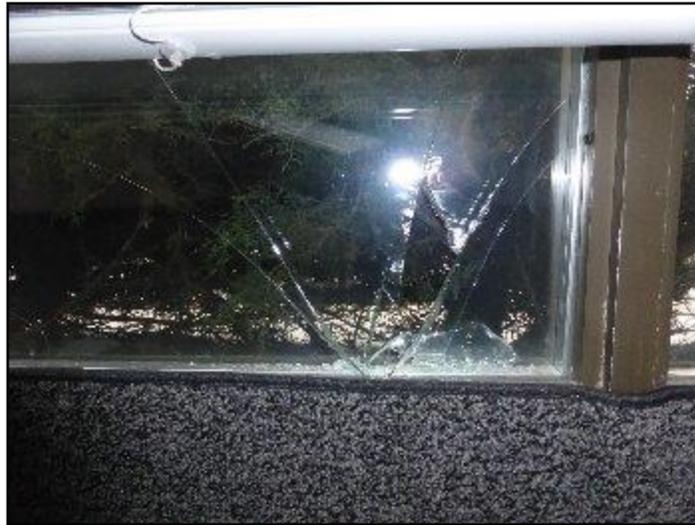
62. **Condition:** • Minor deficiencies noted

There are some cracked and broken window panes, and some double-glazed panes have lost their seal.

17. Broken pane

**Task:** Replace
