INSPECTION REPORT

Friday, July 26, 2019

2499 Worthington Drive

Horizon Professional Inspection Services Ltd.

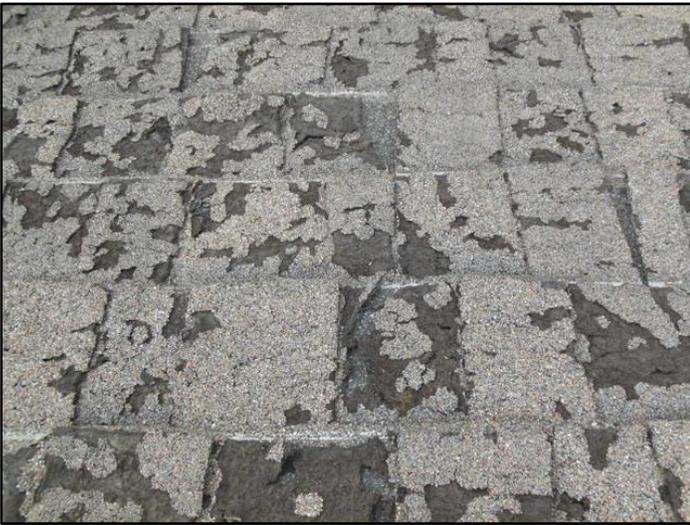
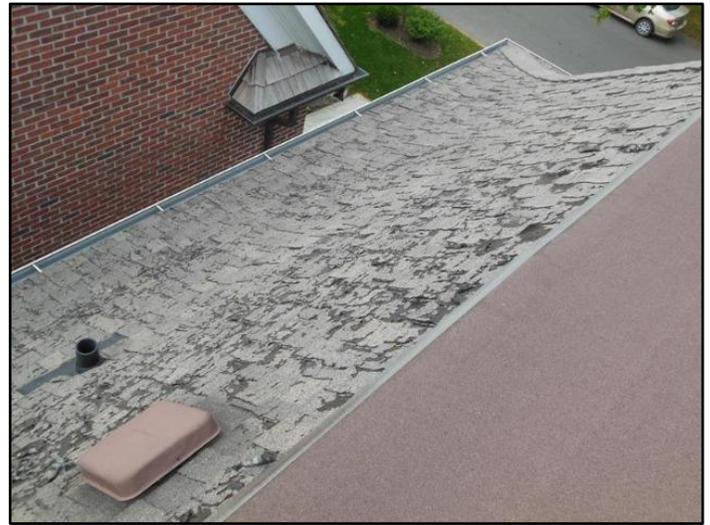
Old, worn out

Location: West Second Floor

5. Old, worn out

6. Old, worn out

Task: Replace

Time: Immediate

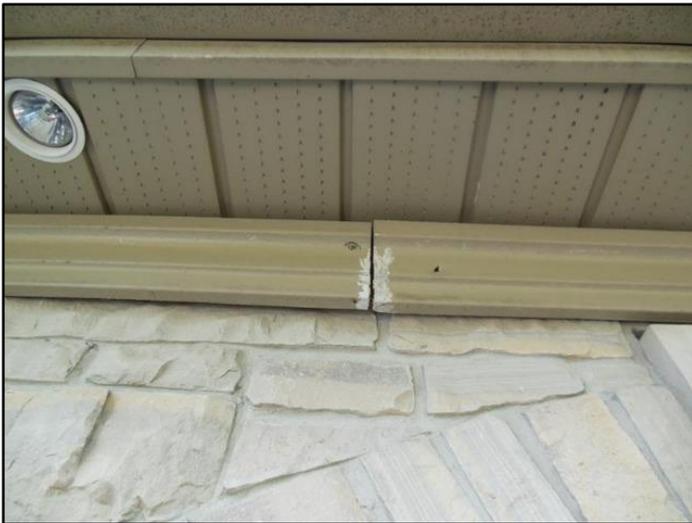
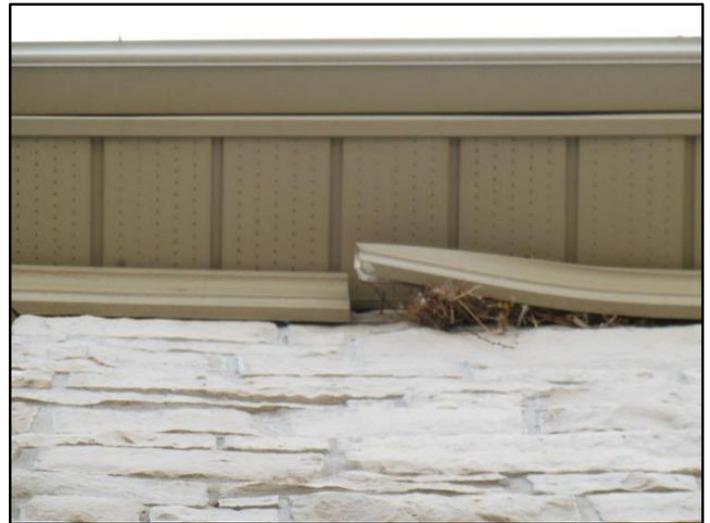
Damage

Implications: Chance of water damage to contents, finishes and/or structure

7. Damage

8. Damage

Task: Repair or replace

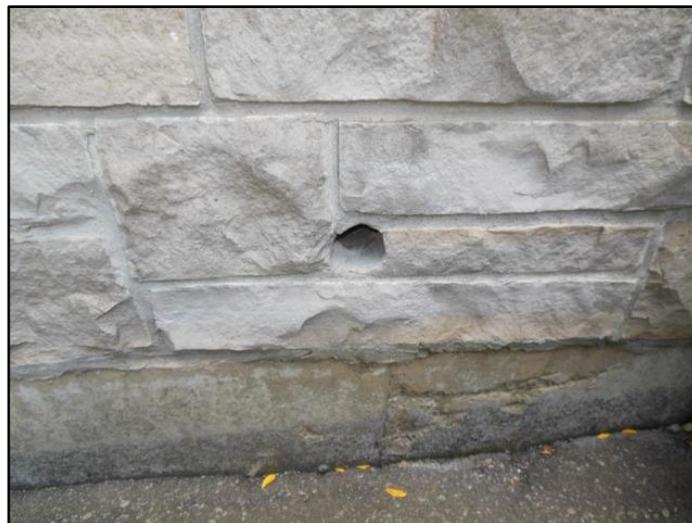
Mechanical damage

Implications: Weakened structure | Chance of water entering building

9. Mechanical damage

Task: Repair

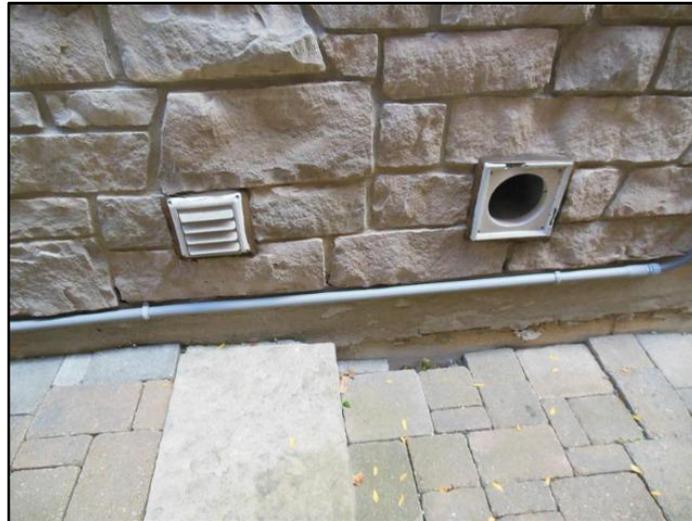
Cover missing

Implications: Increased heating and cooling costs | Chance of pests entering building

10. Cover missing

Task: Provide

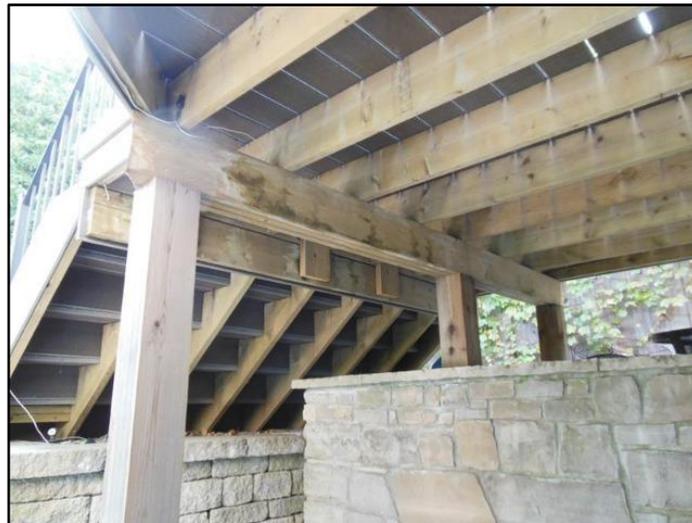
Connections weak

Implications: Chance of structural movement | Weakened structure

11. Connections weak

Notes: Have specialist check all connections and remedy as needed.

Task: Recommend further review by a qualified professional to determine the next best course of action

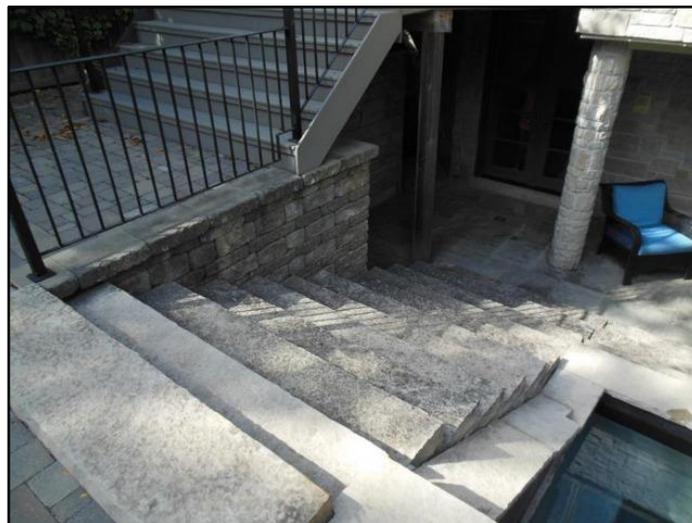
Missing

Implications: Fall hazard

12. Missing

Task: Provide

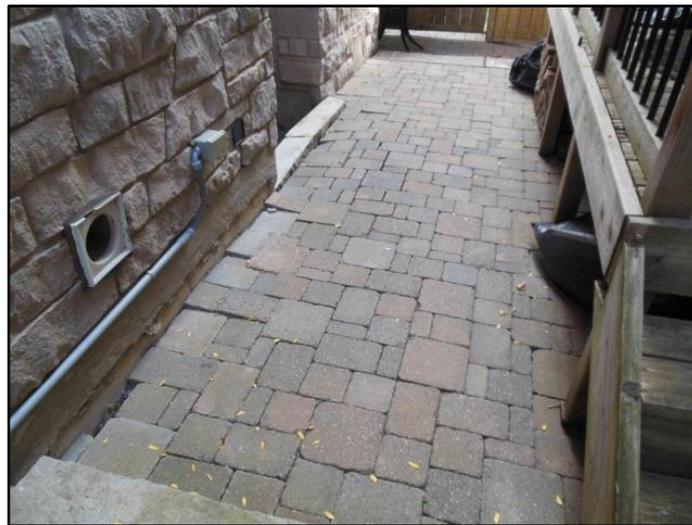
Improper slope or drainage

Implications: Chance of water damage to contents, finishes and/or structure

13. Improper slope or drainage

Notes: Watch for moisture problems in basement, and re-slope walkway if needed.

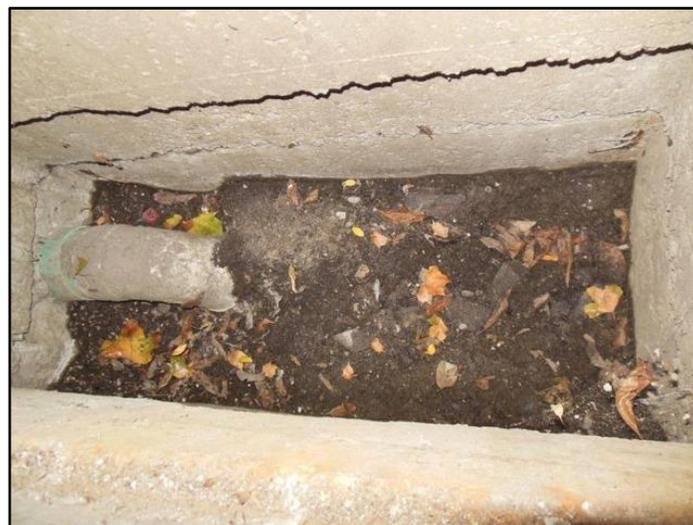
Clogged catch basin

Implications: Chance of water damage to contents, finishes and/or structure

14. Clogged catch basin

Task: Clean

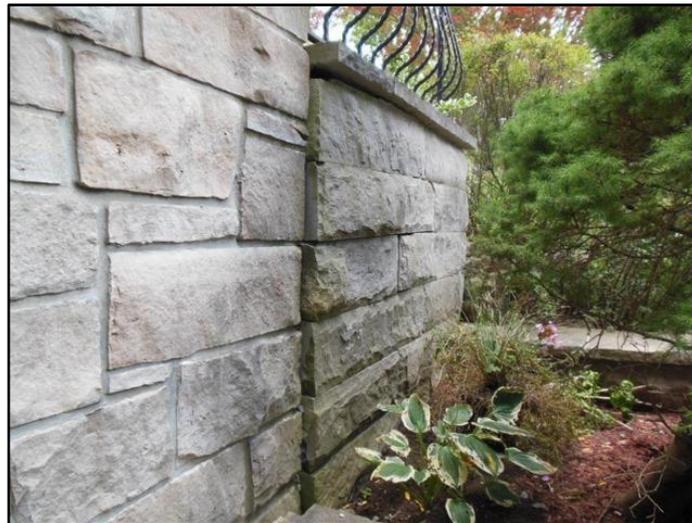
Leaning

Implications: Chance of movement | Weakened structure

15. Leaning

Notes: No repairs needed right now. Watch for further movement.

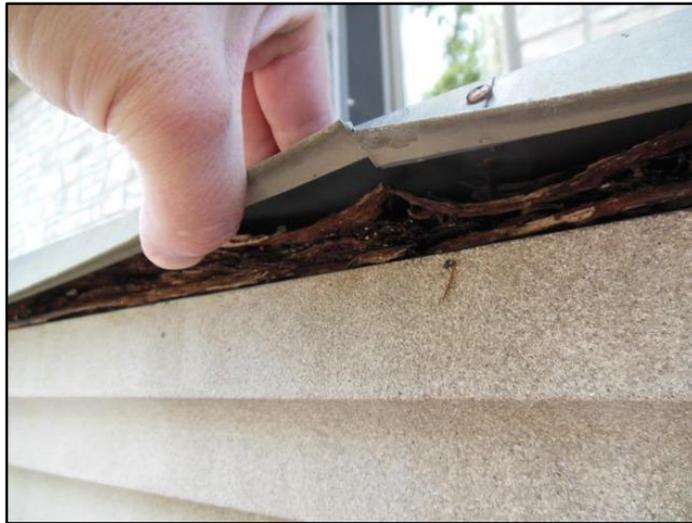
Damage

Implications: Weakened structure | Chance of water damage to contents, finishes and/or structure

18. Damage

Notes: Extent of damage not determined. Check all sheathing when re-roofing.

Task: Repair or replace

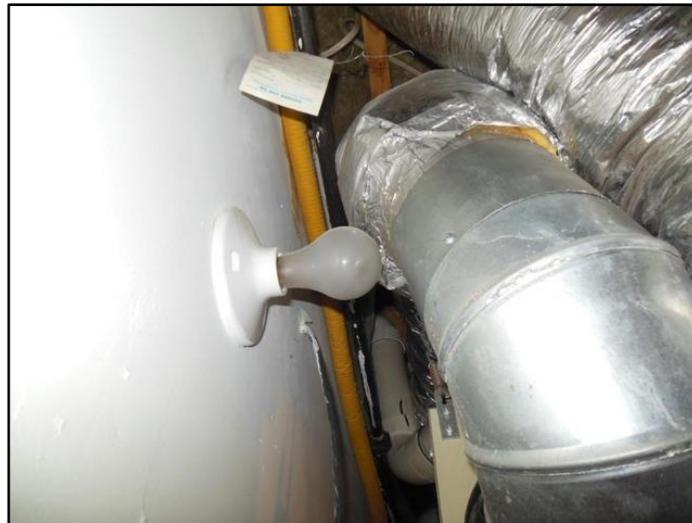
Exposed to mechanical damage (No cage or protective lens)

Implications: Physical injury | Glass breaking

21. Exposed to mechanical damage (No cage or...

Notes: Add a cage or lens to protect light bulb.

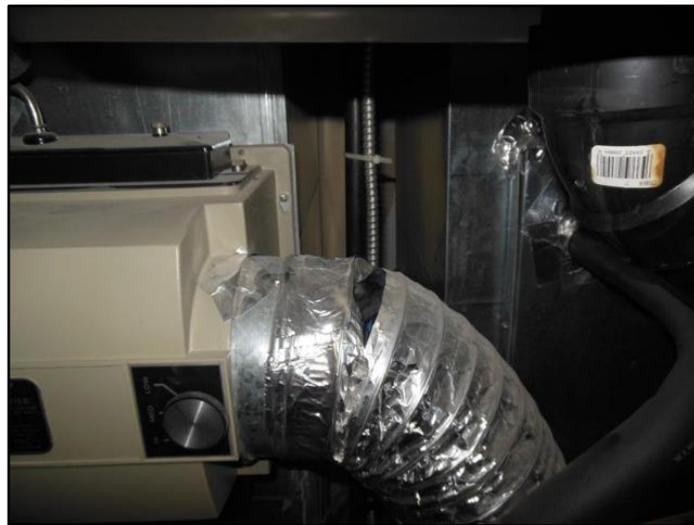
Ductwork damage

Implications: Reduced comfort

24. Ductwork damage

Task: Repair or replace

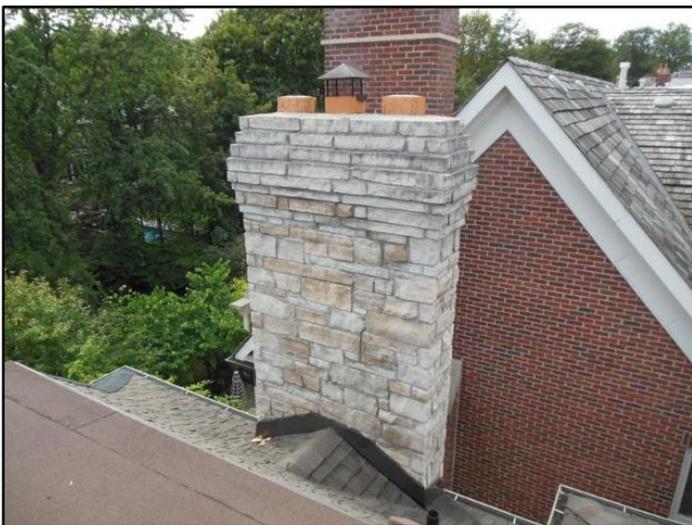
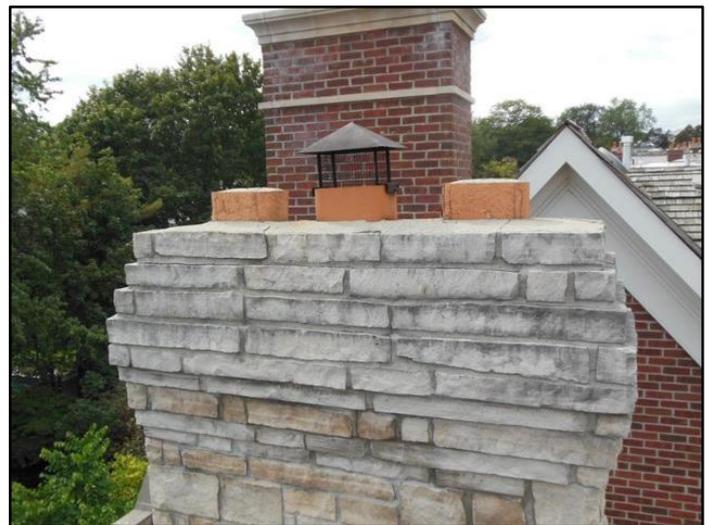
Missing

Implications: Chance of water damage to contents, finishes and/or structure | Shortened life expectancy of material

25. Missing

26. Missing

Notes: This is an improvement rather than a repair.

Task: Provide

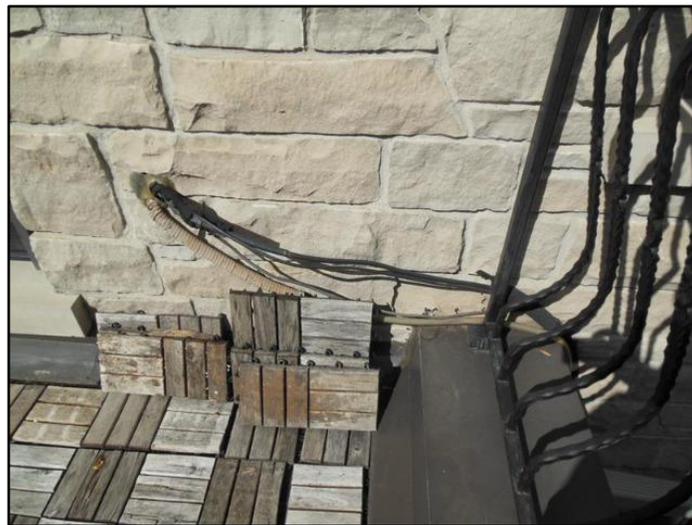
Insulation - missing

Implications: Reduced system life expectancy | Increased cooling costs | Reduced comfort

27. Insulation - missing

Task: Replace

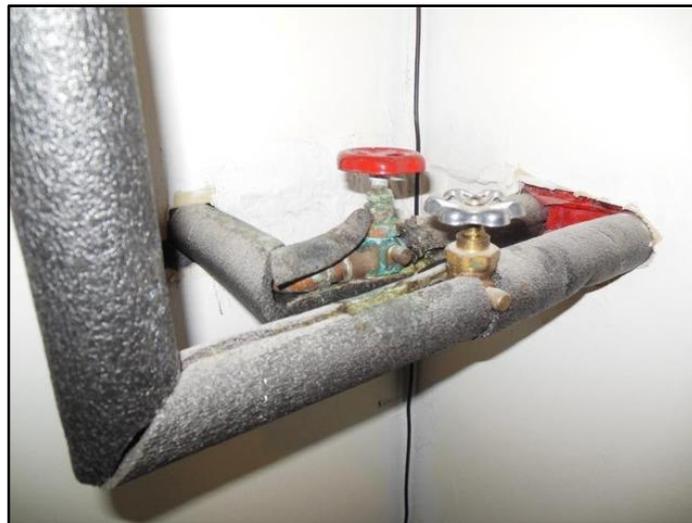
Leak

Implications: No water | Chance of water damage to contents, finishes and/or structure

28. Leak

Task: Repair

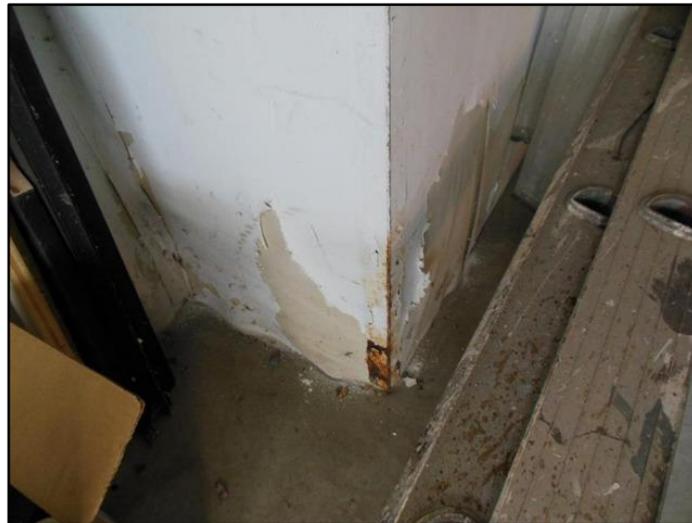
Water damage

29. Water damage

Task: Repair or replace

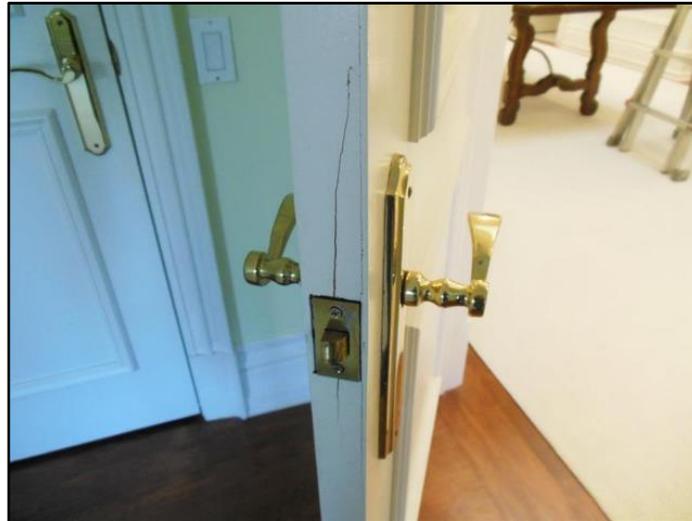
Damage

Implications: Increased heating and cooling costs | Reduced comfort | Shortened life expectancy of material

30. Damage

Task: Repair or replace
