Inspection Report

For the Property At:
2499 Worthington Drive
Chicago, IL

Inspection Date:
2019/07/26

Horizon Professional Inspection Services Ltd.
932 Lee Street, 101
Chicago, IL 60016
800 268 7070
arielesguerra@carsondunlop.com

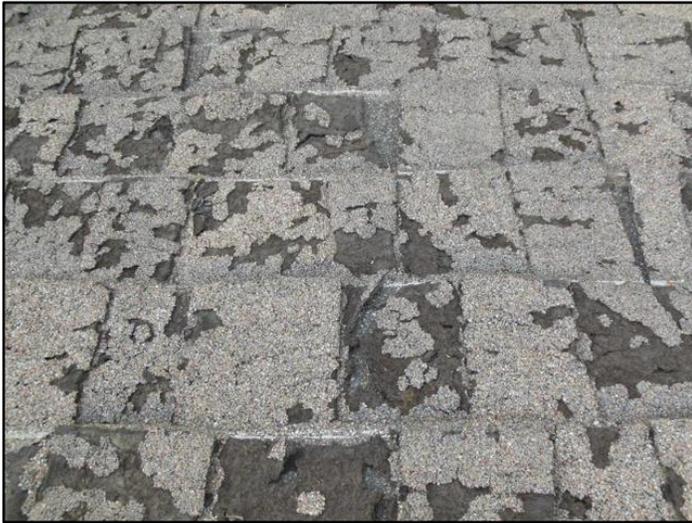
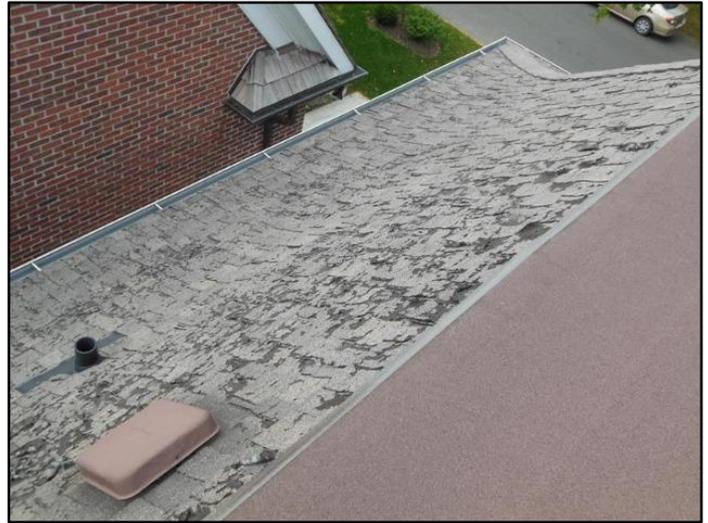
Old, worn out

Implications: Chance of water damage to contents, finishes and/or structure

5. Old, worn out

6. Old, worn out

Task: Replace

Time: Immediate

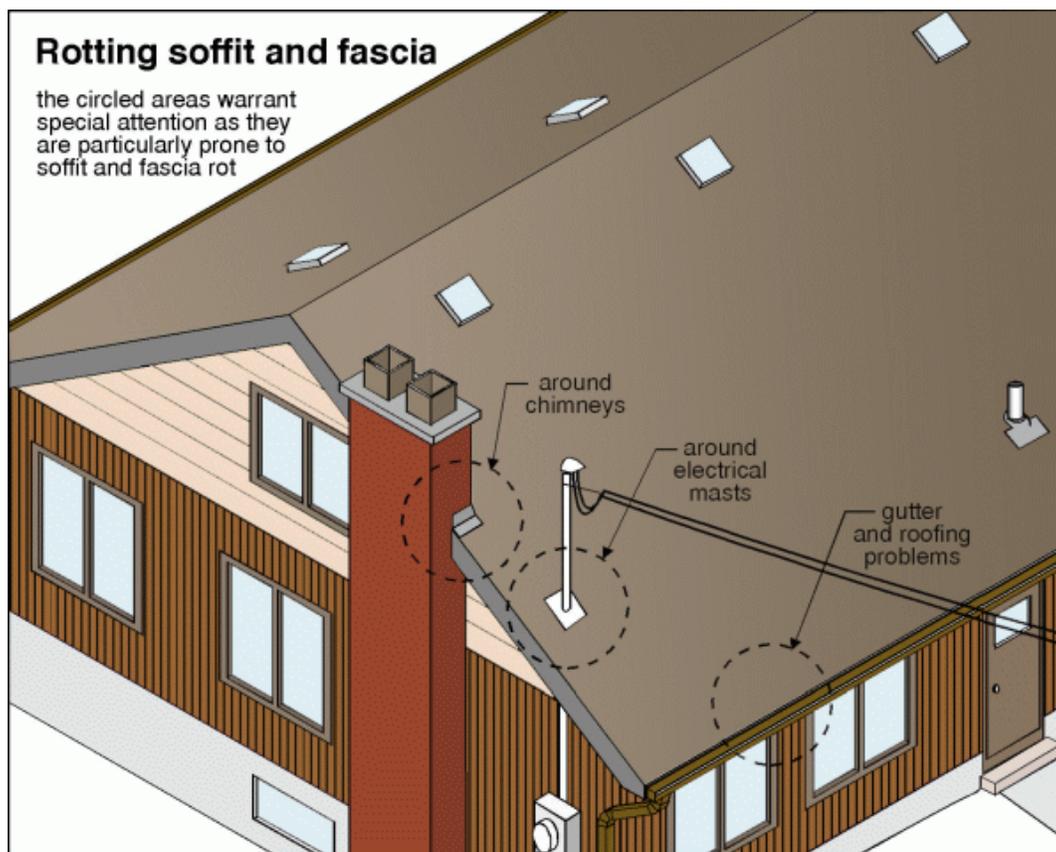
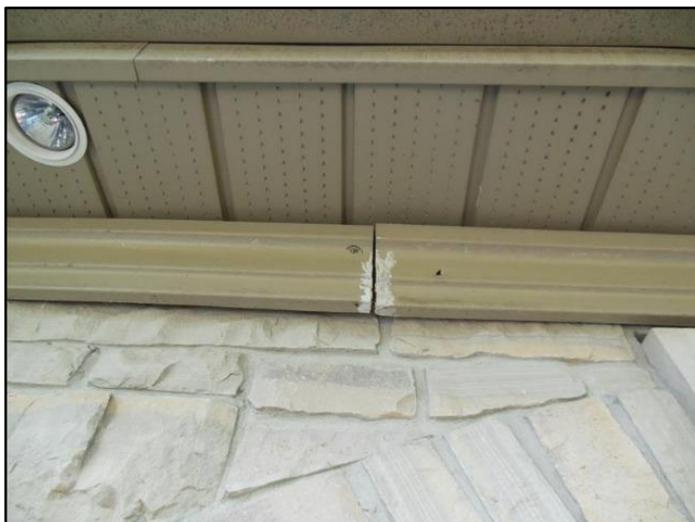
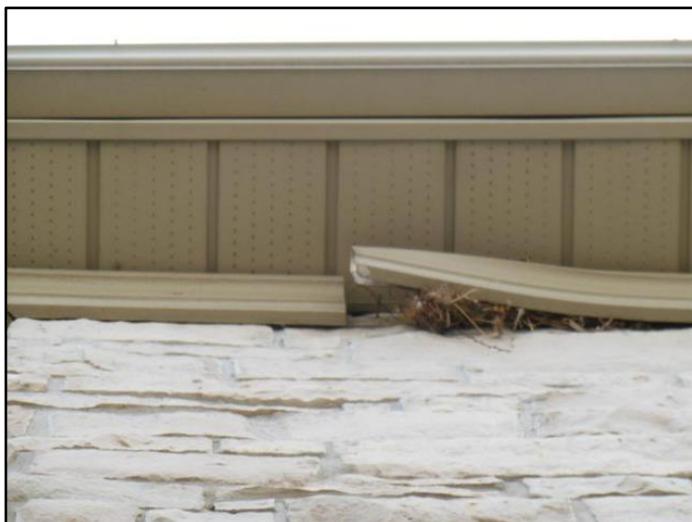
Damage

Implications: Chance of water damage to contents, finishes and/or structure

7. Damage

8. Damage

Task: Repair or replace

Time: Less than 1 year

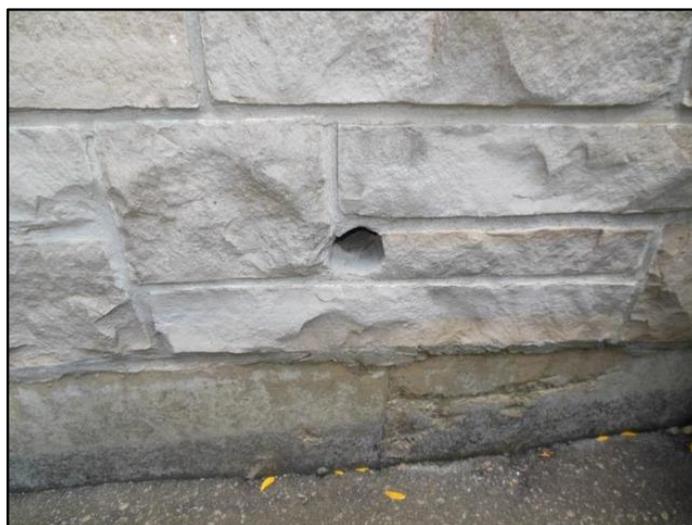
Mechanical damage

Implications: Chance of water entering building | Weakened structure

9. Mechanical damage

Task: Repair

Time: As soon as practical

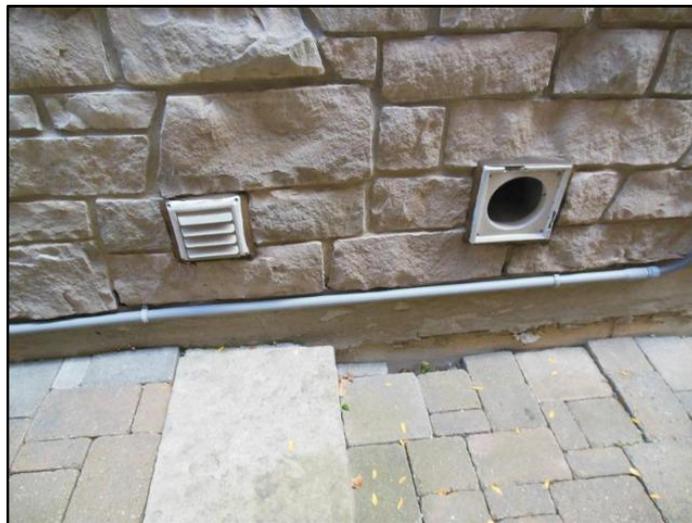
Cover missing

Implications: Chance of pests entering building | Increased heating and cooling costs

10. Cover missing

Task: Provide

Time: Less than 1 year

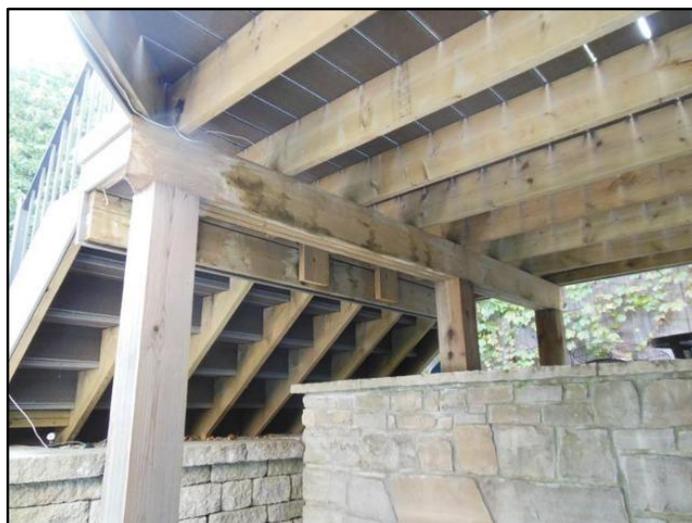
Connections weak

Implications: Chance of structural movement | Weakened structure

11. Connections weak

Notes: Have specialist check all connections and remedy as needed.

Task: Recommend further review by a qualified professional to determine the next best course of action

Time: Immediate

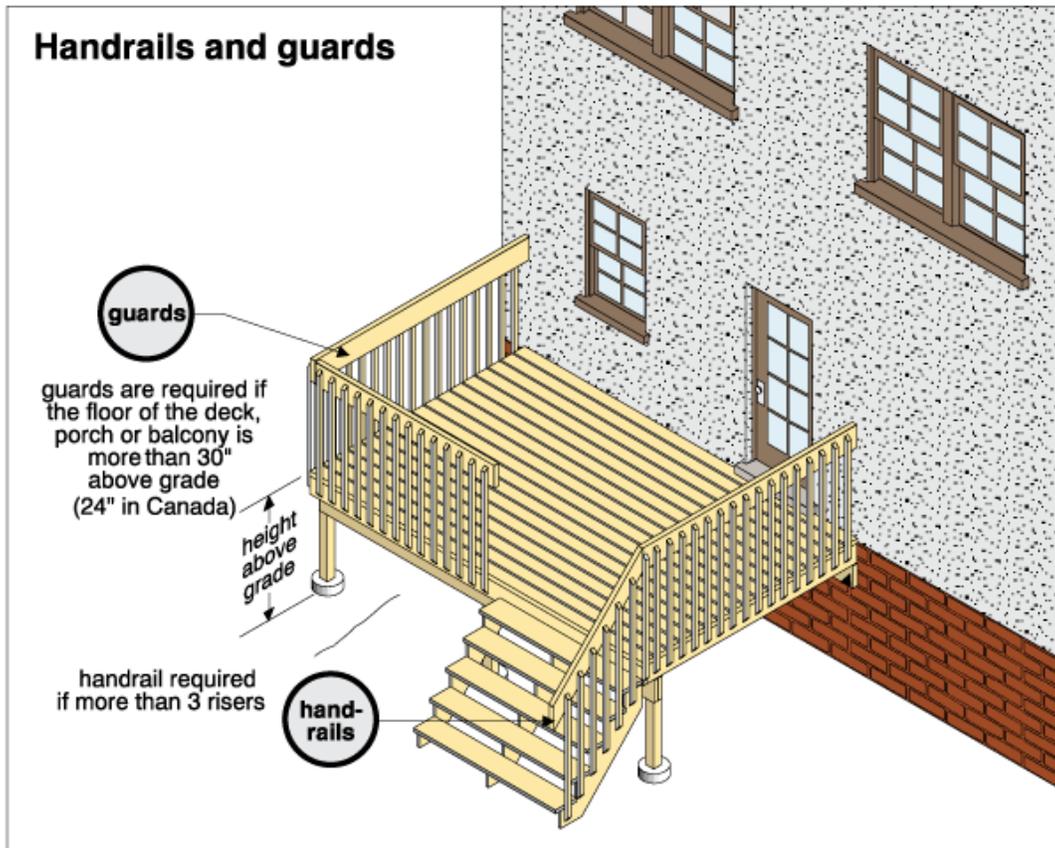
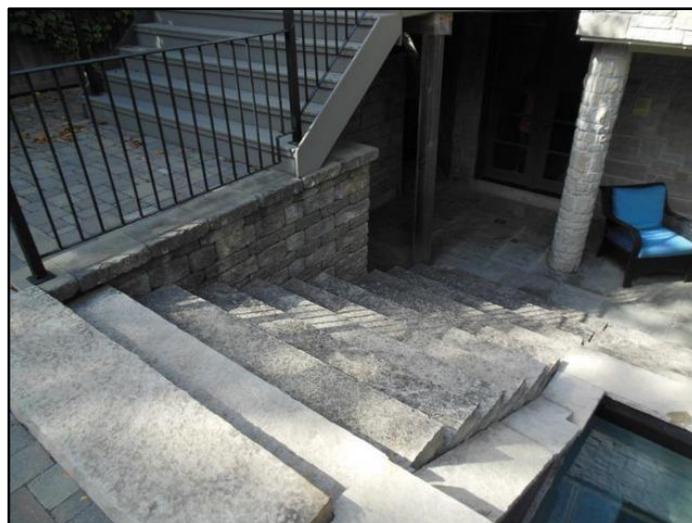
Missing

Implications: Fall hazard

12. Missing

Task: Provide

Time: As soon as practical

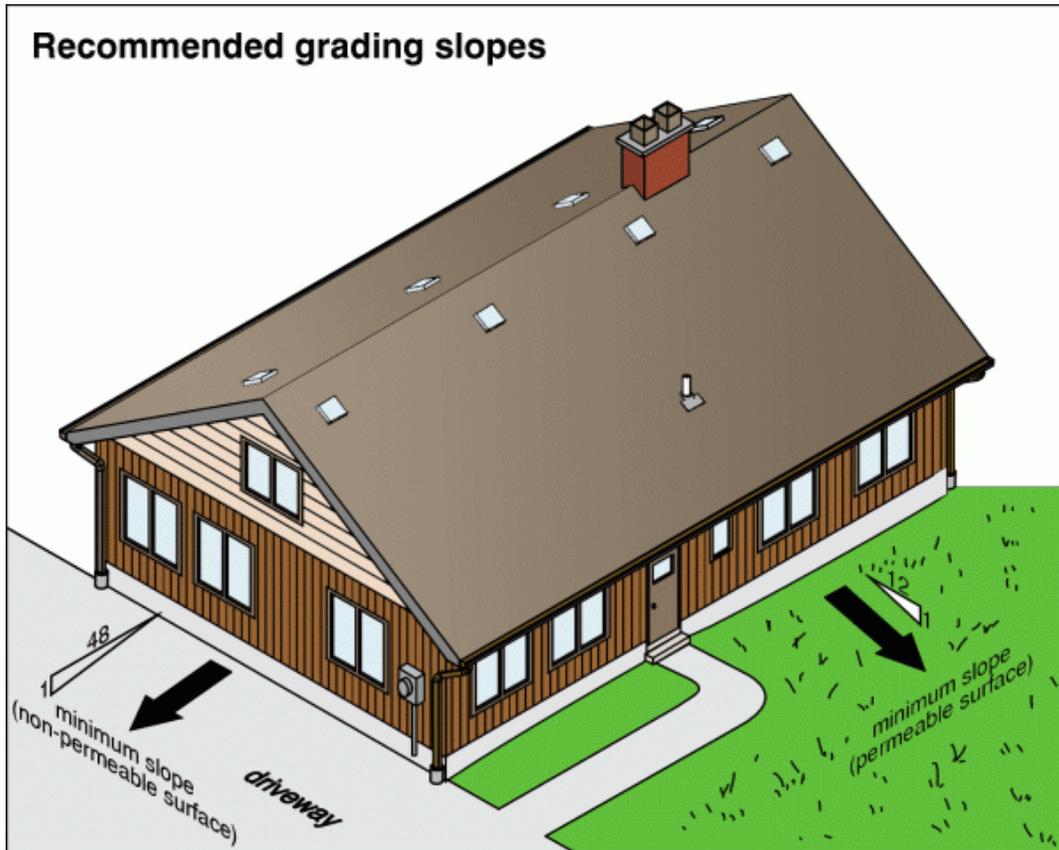
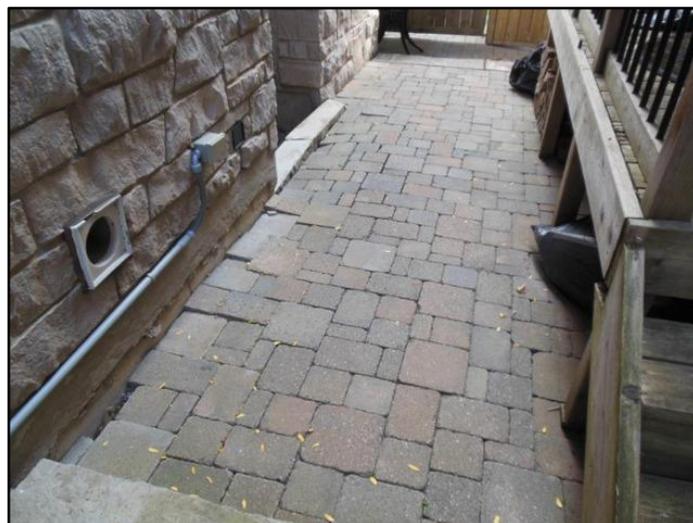
Improper slope or drainage

Implications: Chance of water damage to contents, finishes and/or structure

13. Improper slope or drainage

Notes: Watch for moisture problems in basement, and re-slope walkway if needed.

Task: Monitor

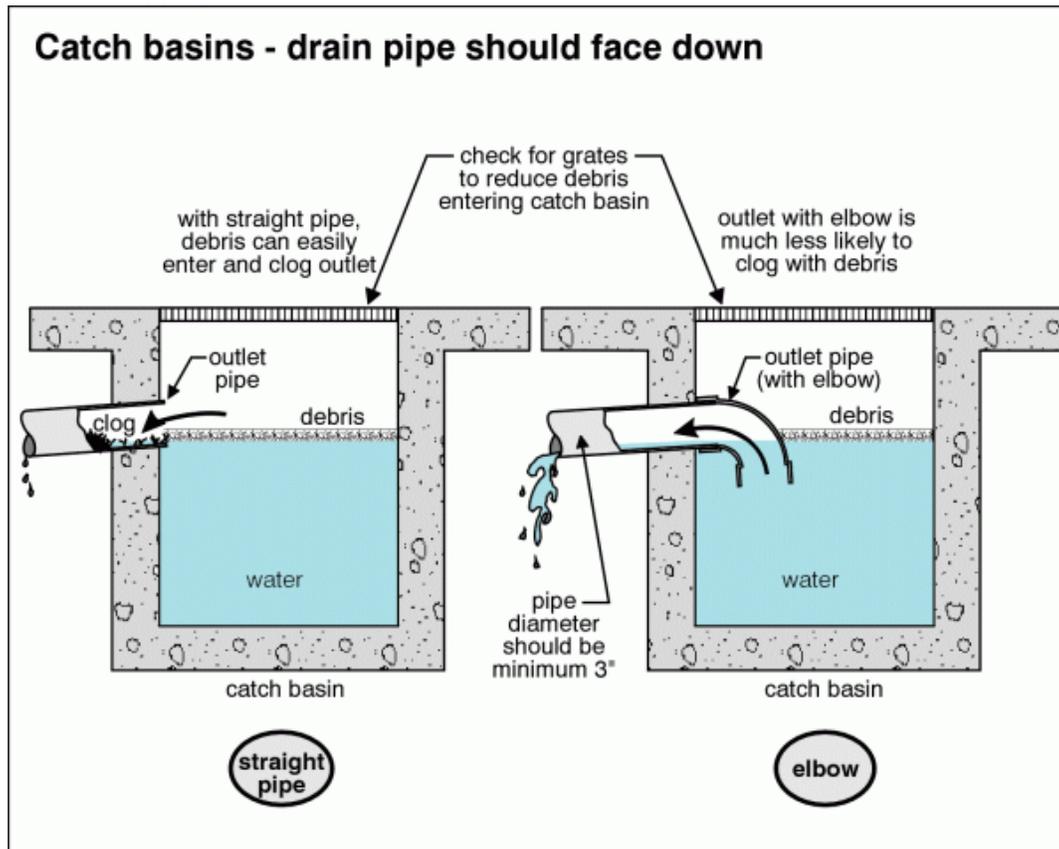
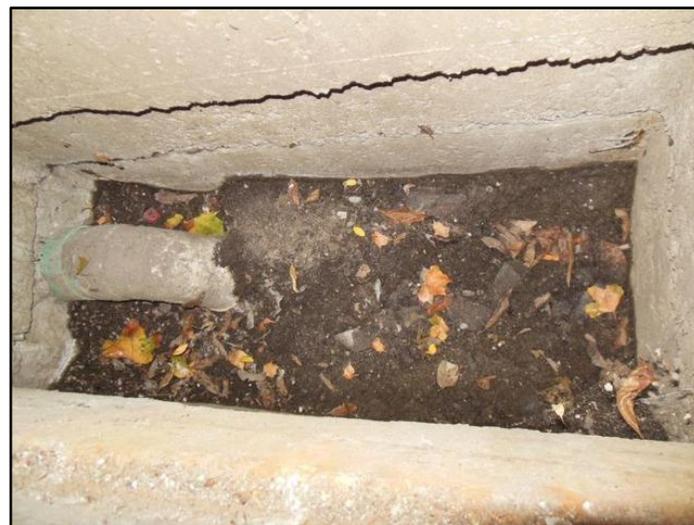
Clogged catch basin

Implications: Chance of water damage to contents, finishes and/or structure

14. Clogged catch basin

Task: Clean

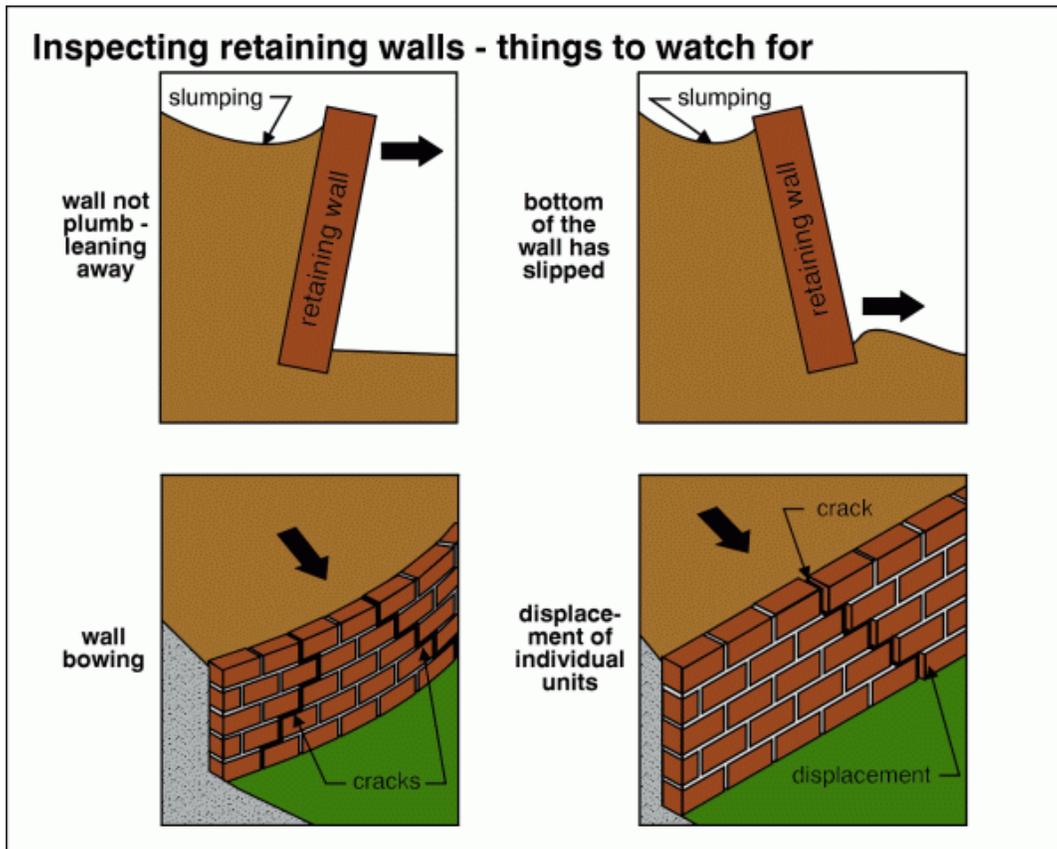
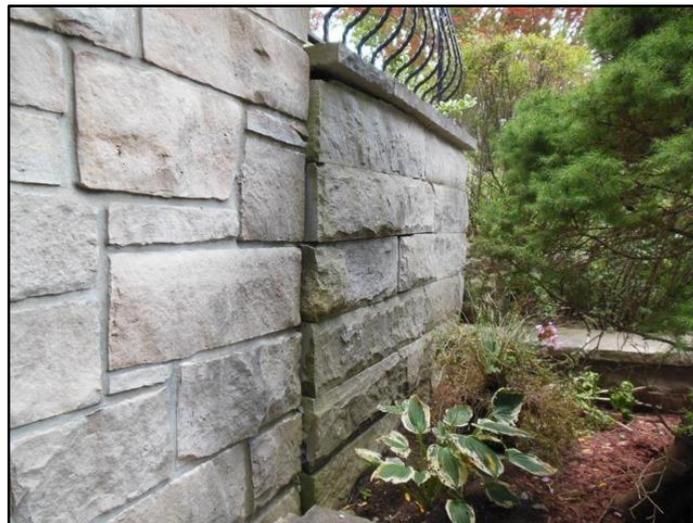
Leaning

Implications: Weakened structure | Chance of movement

15. Leaning

Notes: No repairs needed right now. Watch for further movement.

Task: Monitor

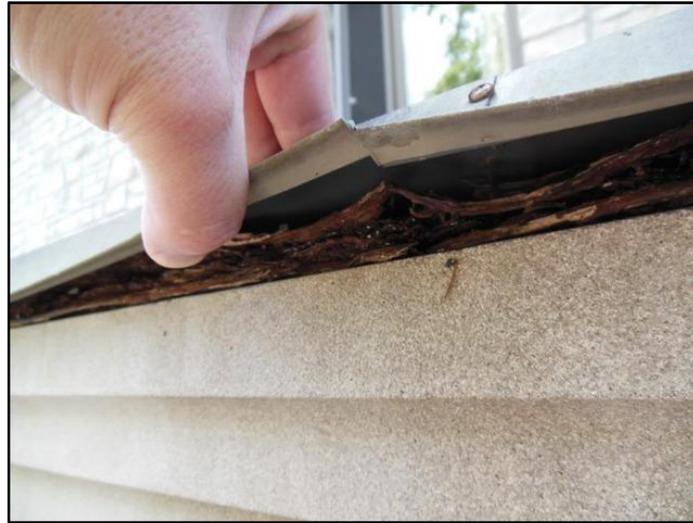
Damage

Notes: Extent of damage not determined. Check all sheathing when re-roofing.

Implications: Weakened structure | Chance of water damage to contents, finishes and/or structure

18. Damage

Task: Repair or replace

Time: As soon as practical

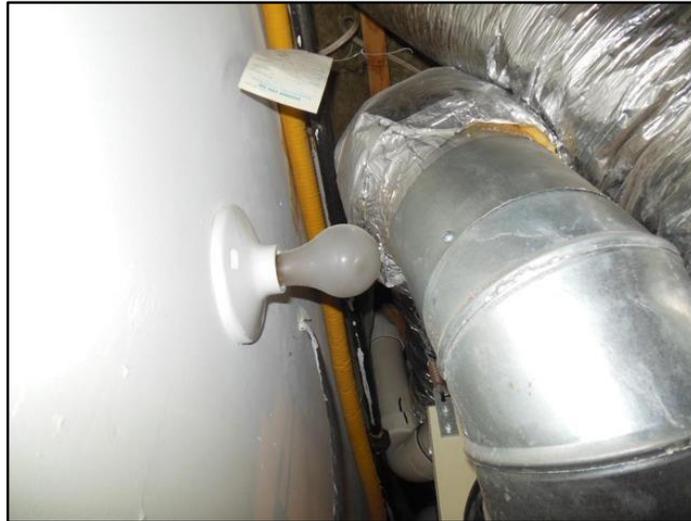
Exposed to mechanical damage (No cage or protective lens)

Implications: Physical injury | Glass breaking

21. Exposed to mechanical damage (No cage or...

Notes: Add a cage or lens to protect light bulb.

Task: Improve

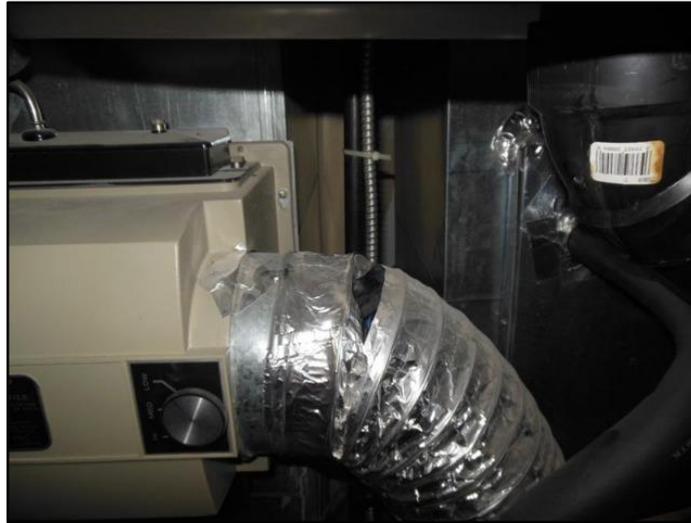
Ductwork damage

Implications: Reduced comfort

24. Ductwork damage

Task: Repair or replace

Time: Less than 1 year

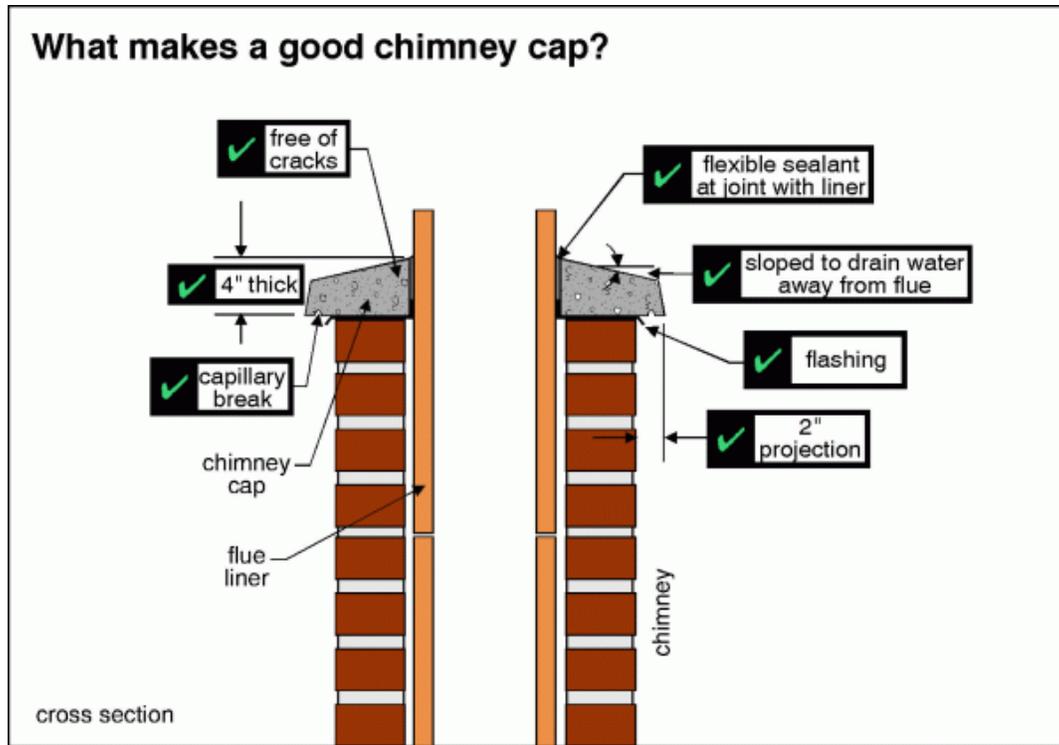
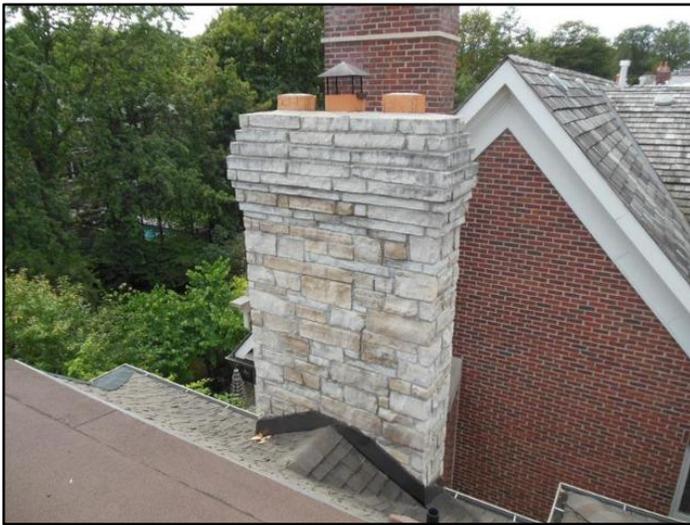
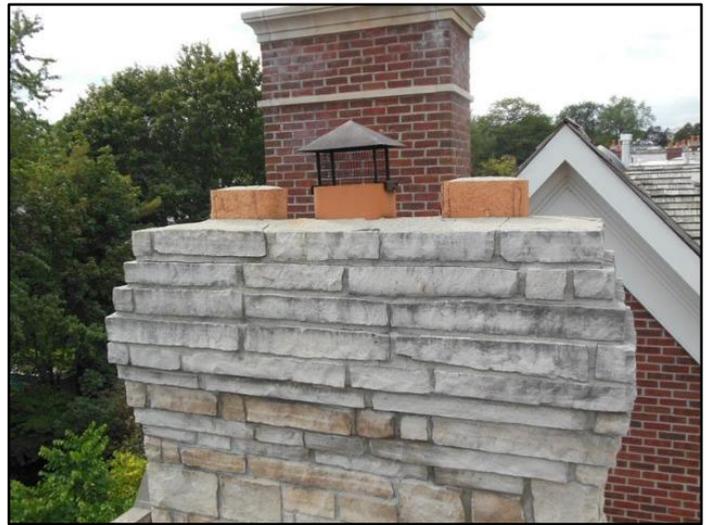
Missing

Implications: Shortened life expectancy of material | Chance of water damage to contents, finishes and/or structure

25. Missing

26. Missing

Notes: This is an improvement rather than a repair.

Task: Provide

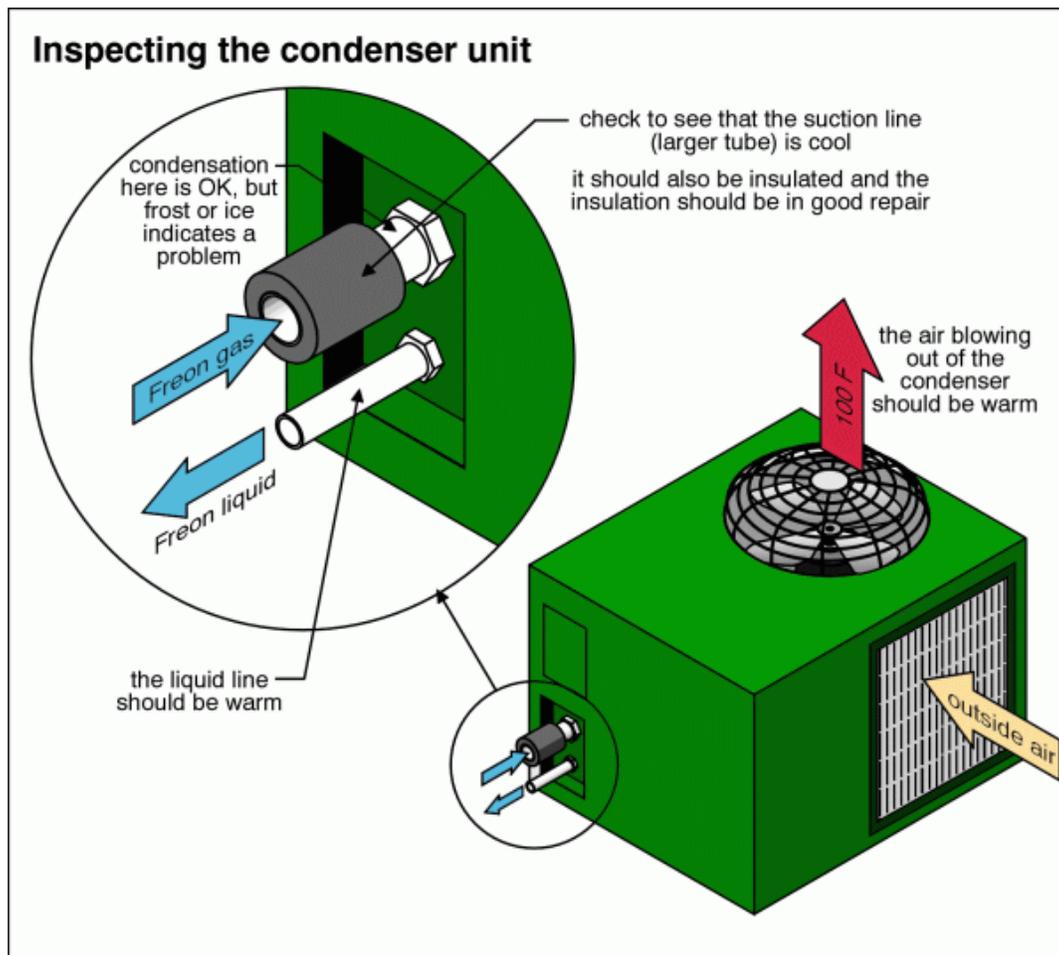
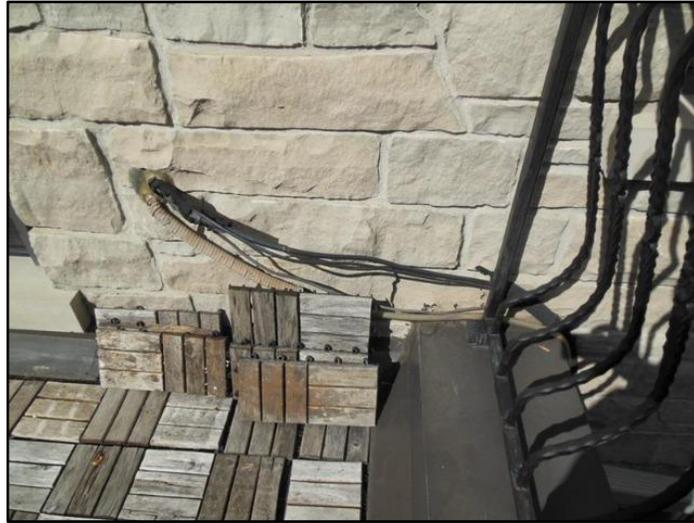
Insulation - missing

Implications: Increased cooling costs | Reduced comfort | Reduced system life expectancy

27. Insulation - missing

Task: Replace

Time: As soon as practical

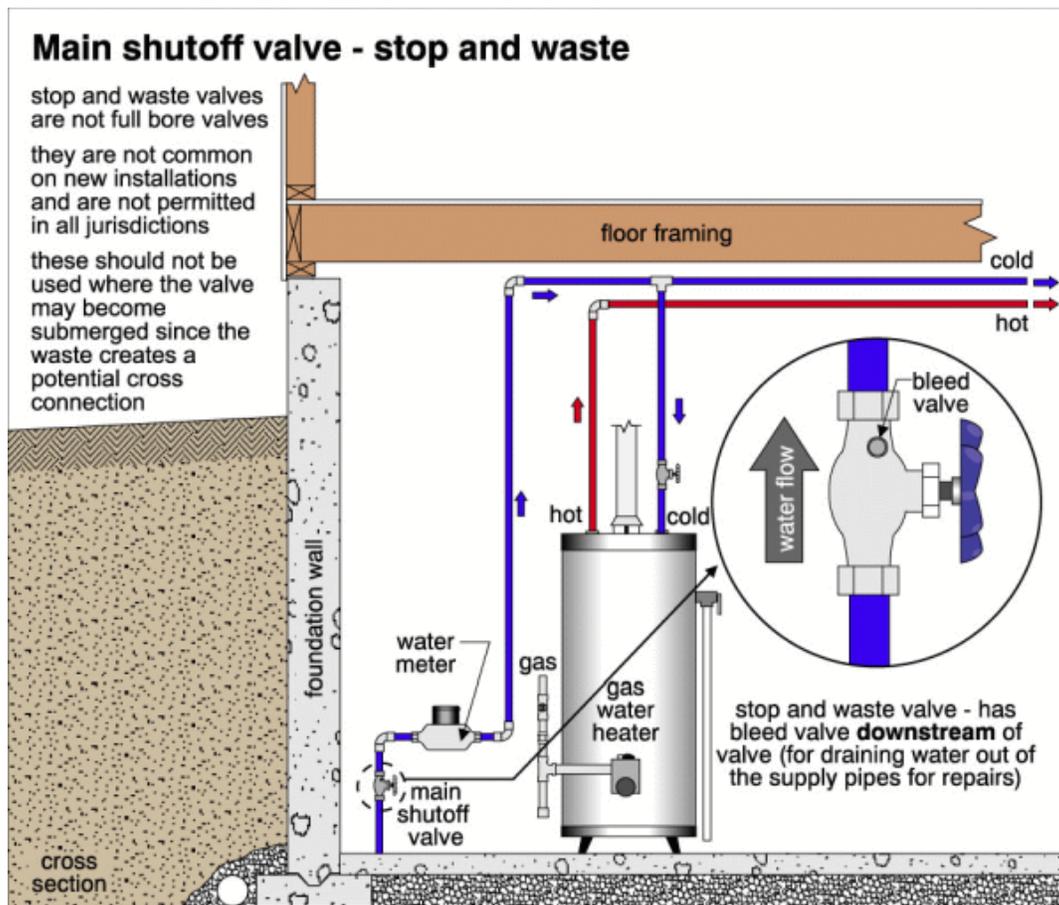
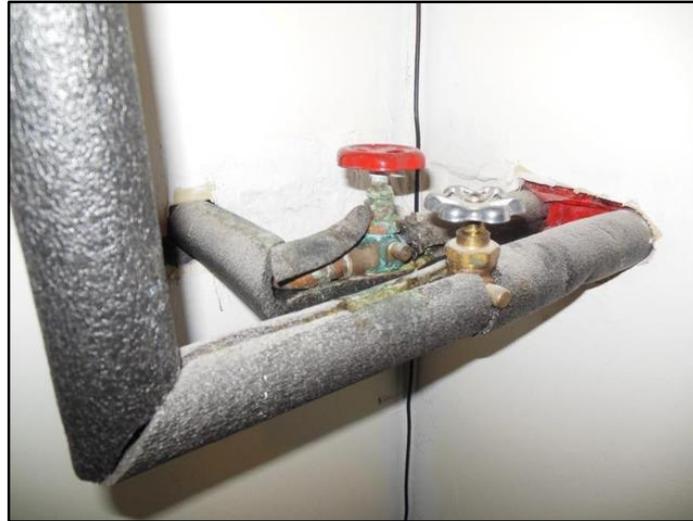
Leak

Implications: No water | Chance of water damage to contents, finishes and/or structure

28. Leak

Task: Repair

Time: As soon as practical

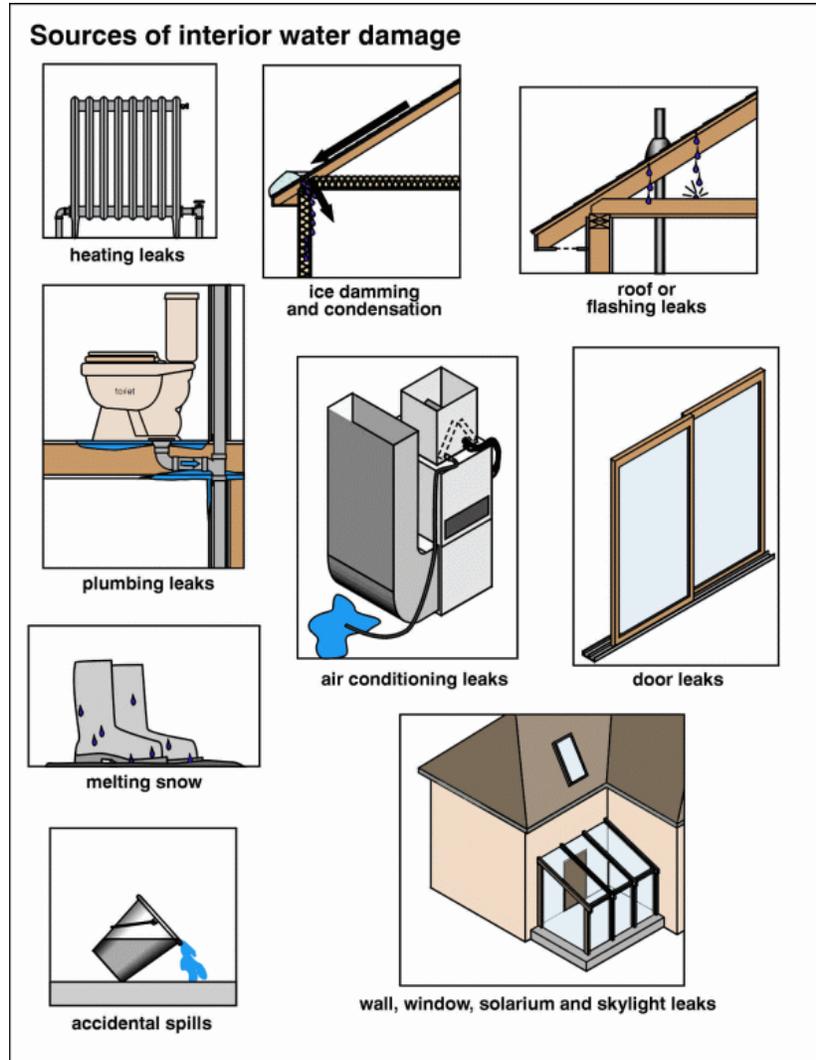
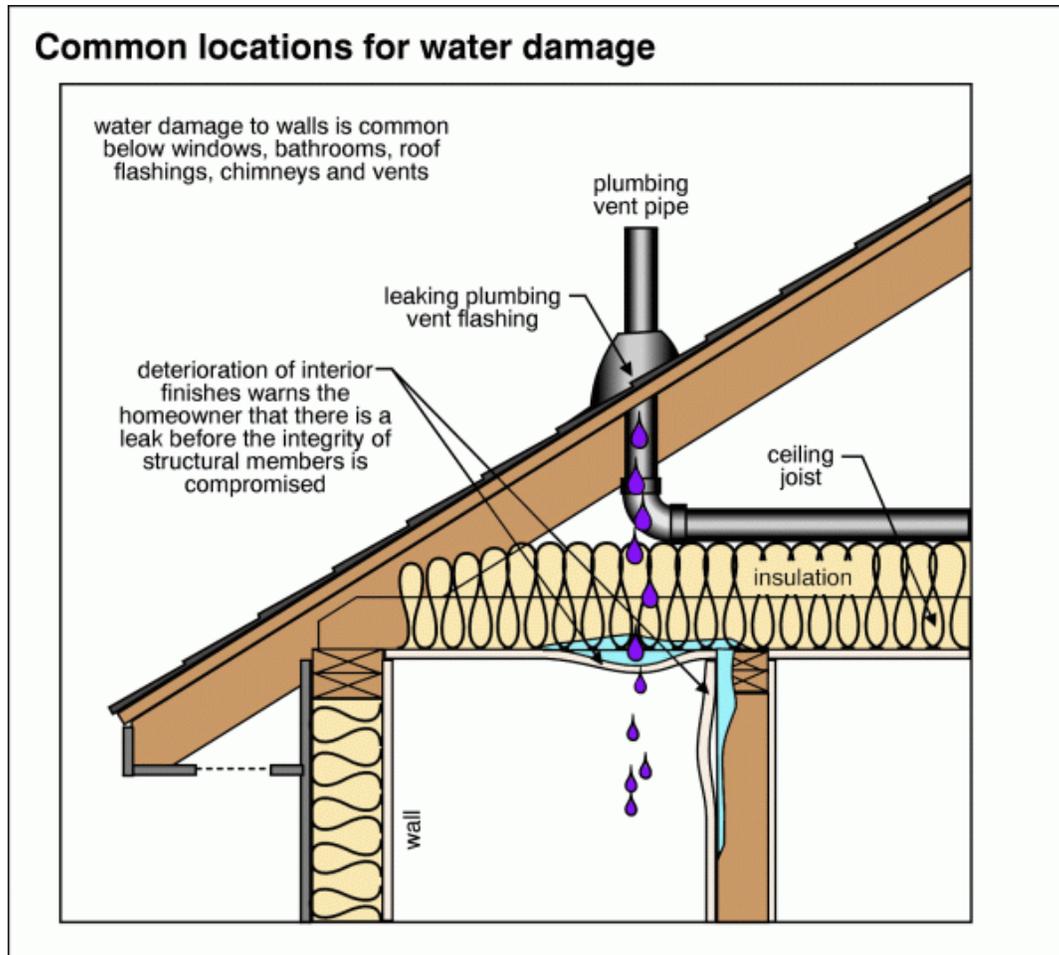
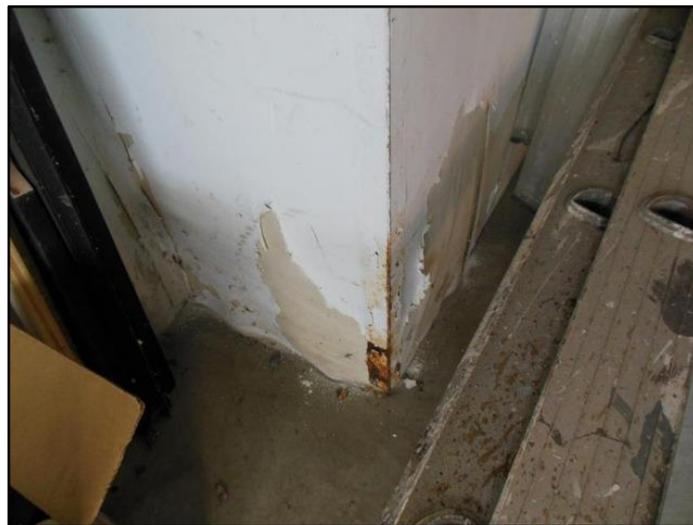
Water damage

29. Water damage

Task: Repair or replace

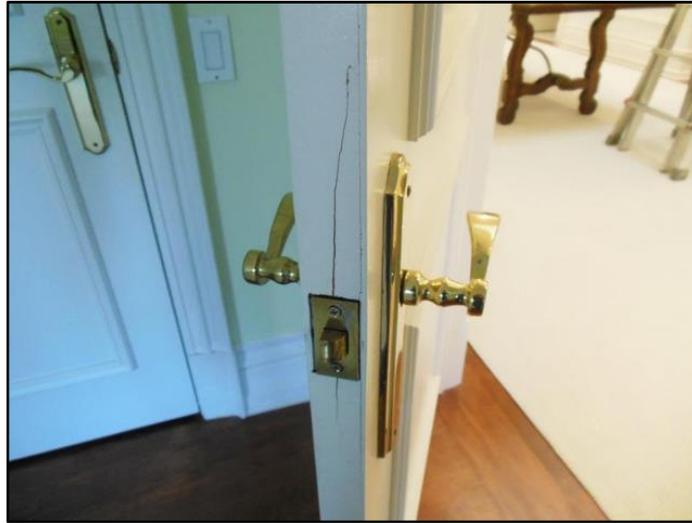
Damage

30. Damage

Task: Repair or replace
