INSPECTION REPORT

577 Halsey Avenue, Boston,
MA 02115

January 04, 2019

Carson, Dunlop & Associates Ltd.

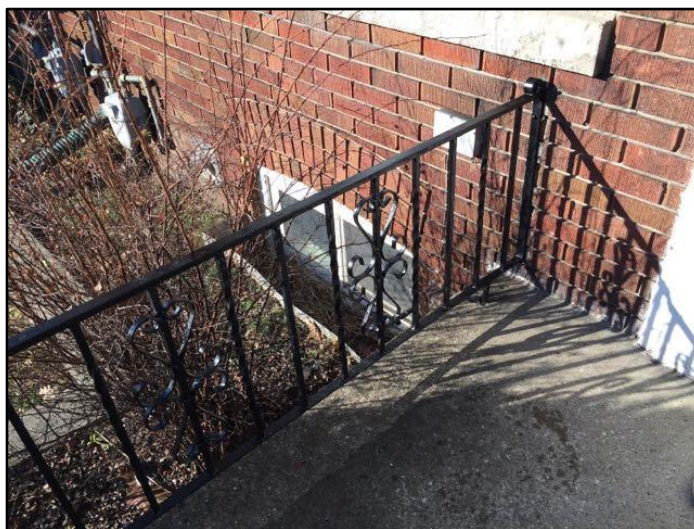
Porches, decks, stairs, patios and balconies\Handrails and guards[Too low](#)**Implications:** Fall hazard**Location:** Front Porch**Task:** Improve**Time:** As soon as practical**Cost:** Depends on approach

Railing is too low

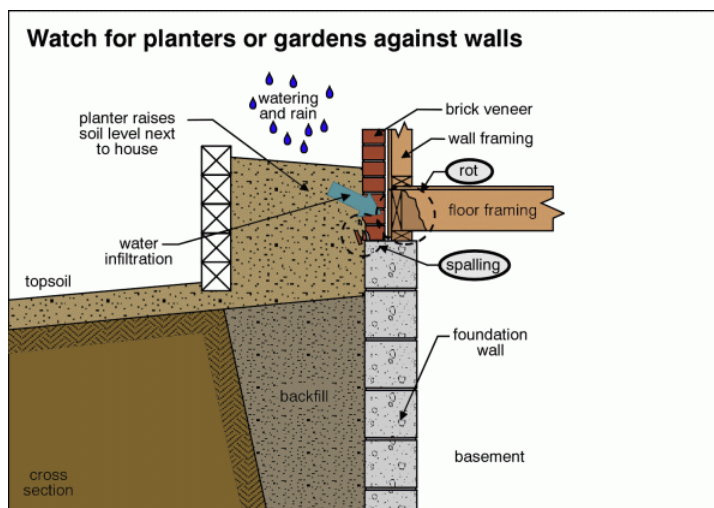
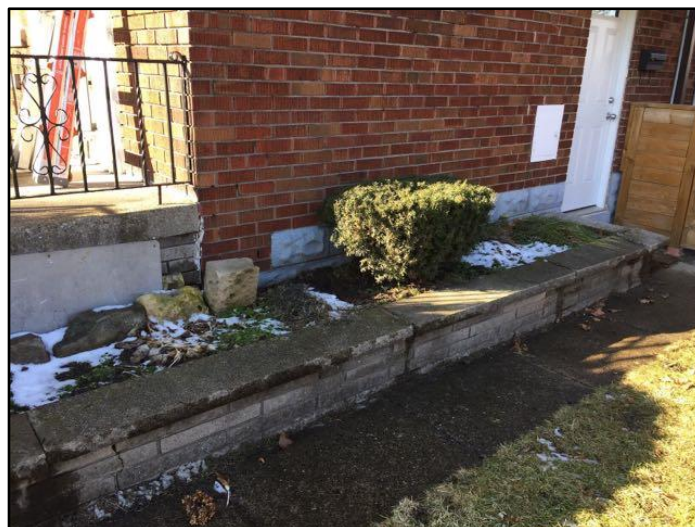
[Planters and gardens against walls](#)

Notes: Gardens and planters (and sprinklers) next to the house increase the risk of moisture problems in the basement, especially if they are watered regularly. Watch gardens next to house

Implications: Chance of water entering building | Chance of damage to structure | Chance of structural movement

Planters and gardens against walls

Task: Monitor and relocate

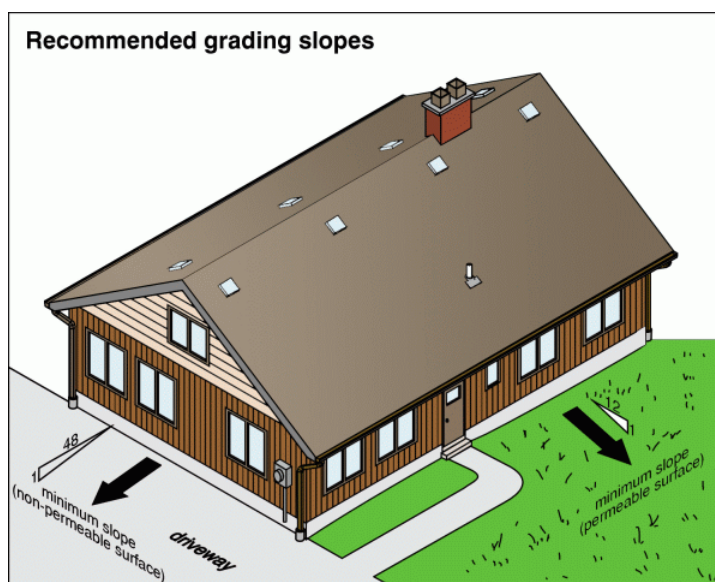
The grading around portions of the house is relatively neutral

Implications: When trying to minimize basement leakage, it is always best to be proactive and slope the grades away from the house. Maintain slope away from house

Task: Monitor/Improve

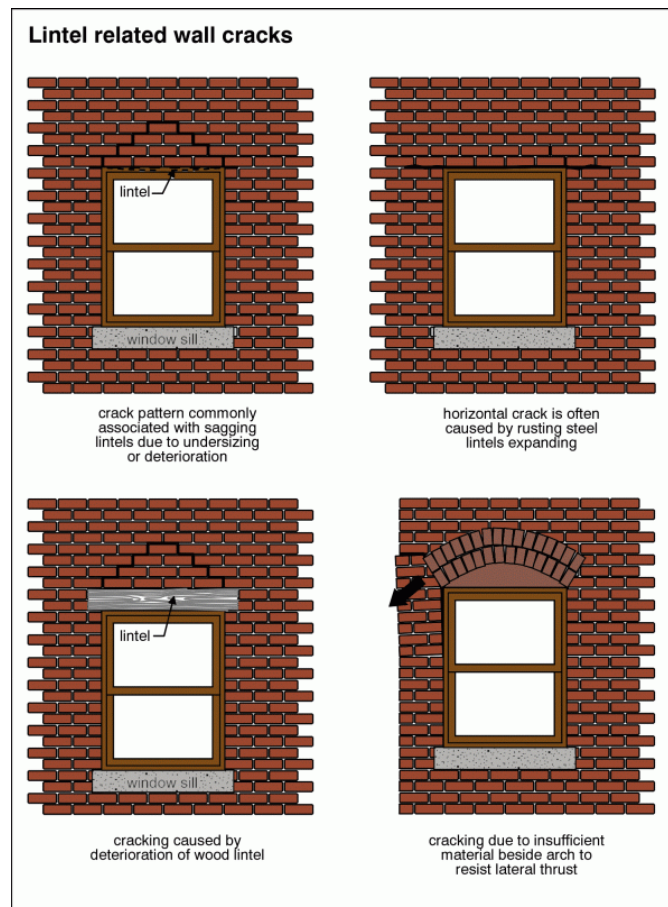
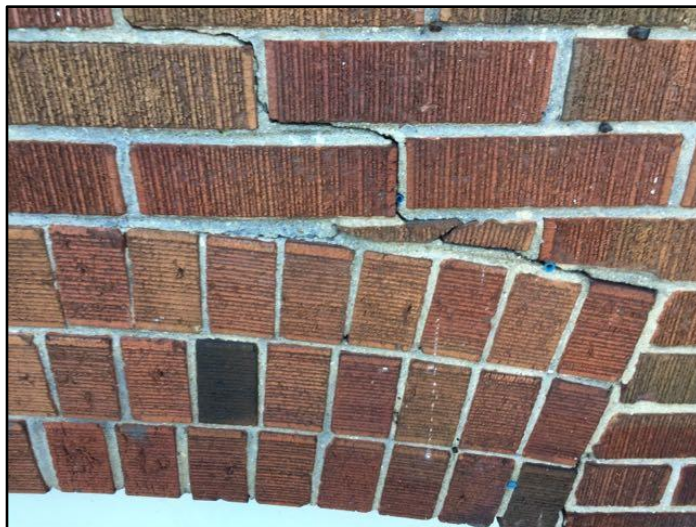
Cracked

Location: Rear first floor

Task: Monitor / Improve

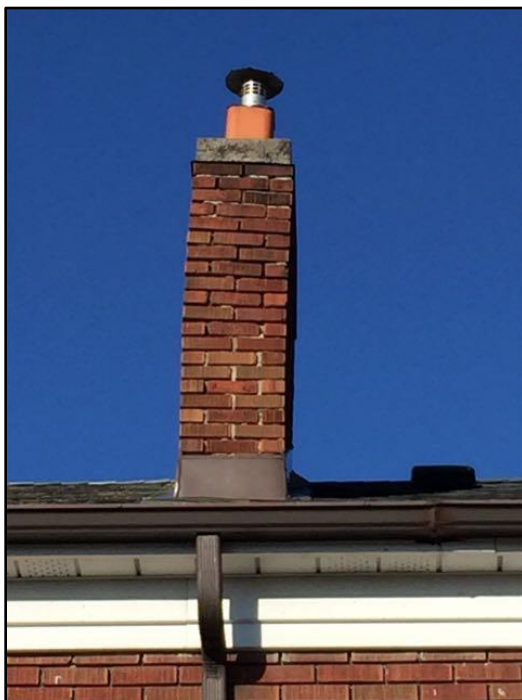
[Loose, missing or deteriorated mortar](#)

Notes: The chimney is leaning slightly to the east due to western wind driven rains that have affected the bricks and mortar over time.

Implications: Material deterioration

deteriorated mortar

Task: Improve

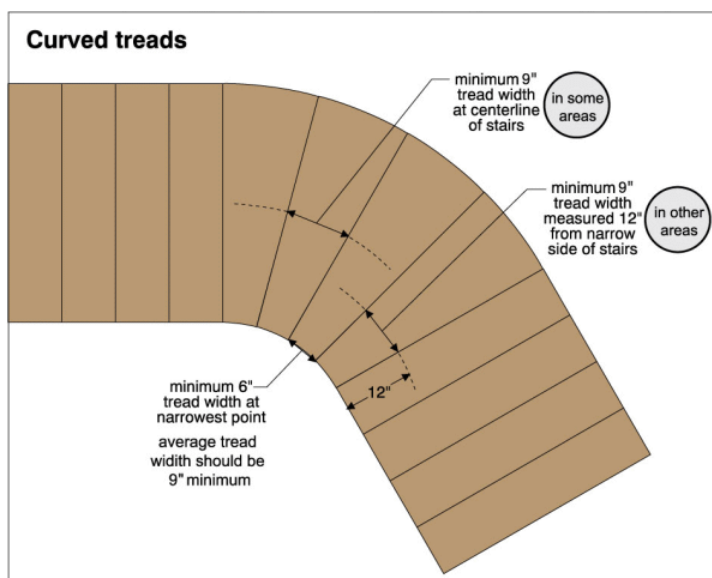
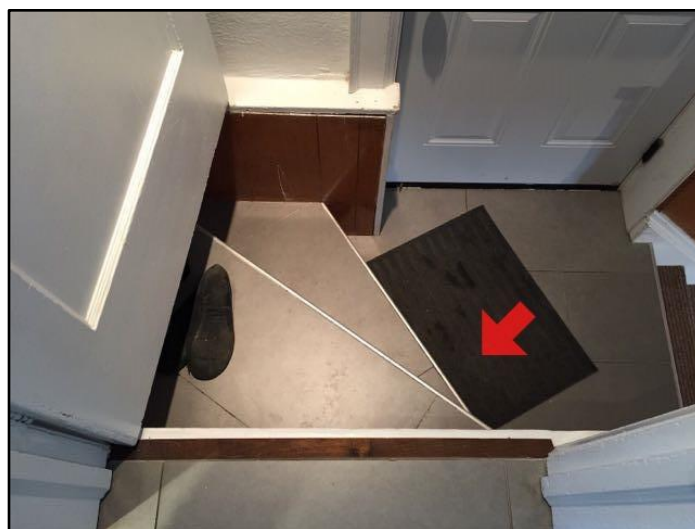
Implications: Trip or fall hazard

Width too small on curved treads

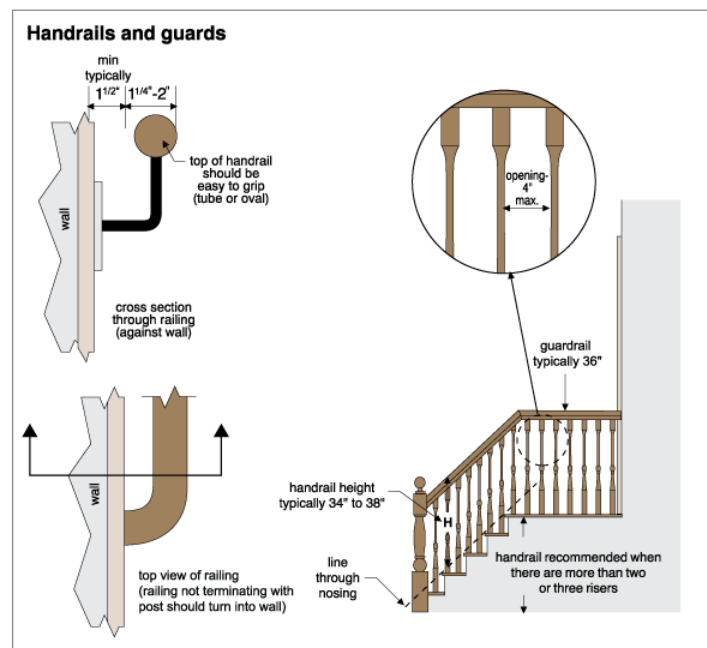
Stairs\Handrails and guardsMissing**Implications:** Fall hazard**Location:** Basement**Task:** Provide**Time:** Immediate**Cost:** Minor
