INSPECTION REPORT

For the Property at:
1567 TREETOP RD
PETERBOROUGH, ON

Prepared for: JANET MOWRY
Inspection Date: Tuesday, June 13, 2017
Prepared by: Bryan Coughlin

RE: Report No. 1206, v.3
1567 Treetop Rd
Peterborough, ON

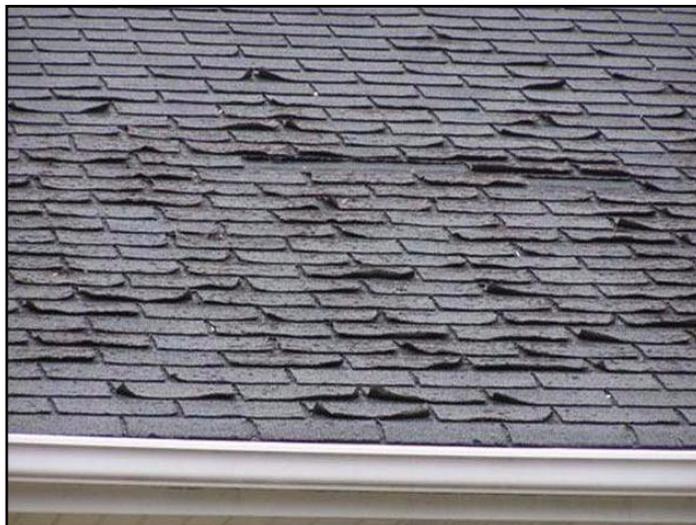
Condition: • [Cupping, curling, clawing](#)

Implication(s): Chance of water damage to contents, finishes and/or structure

Location: Various

Curling shingles

Task: Consult a Qualified Professional

Time: As soon as possible

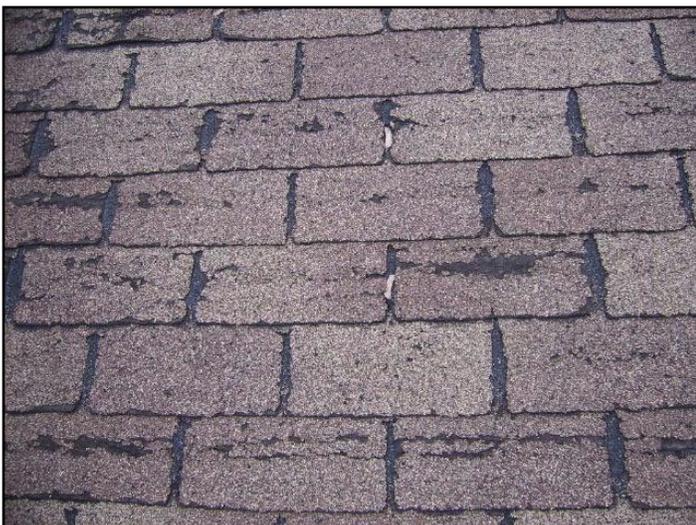
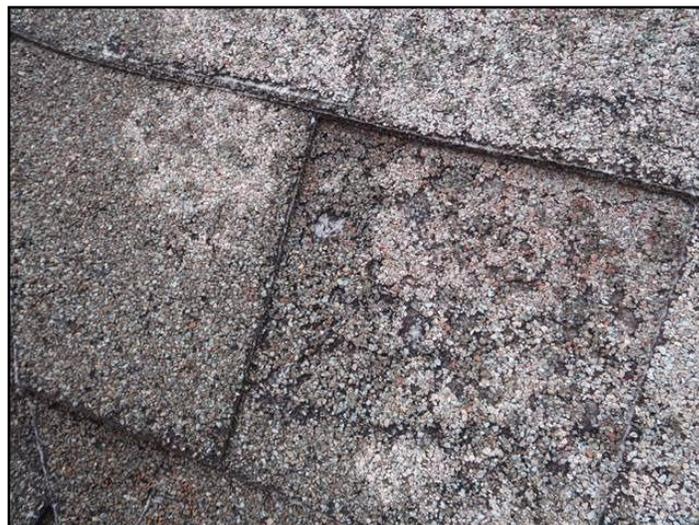
Condition: • [Granule loss](#)

Implication(s): Chance of water damage to contents, finishes and/or structure

Location: Various

Granule loss

Task: Consult a Qualified Professional

Time: As soon as possible

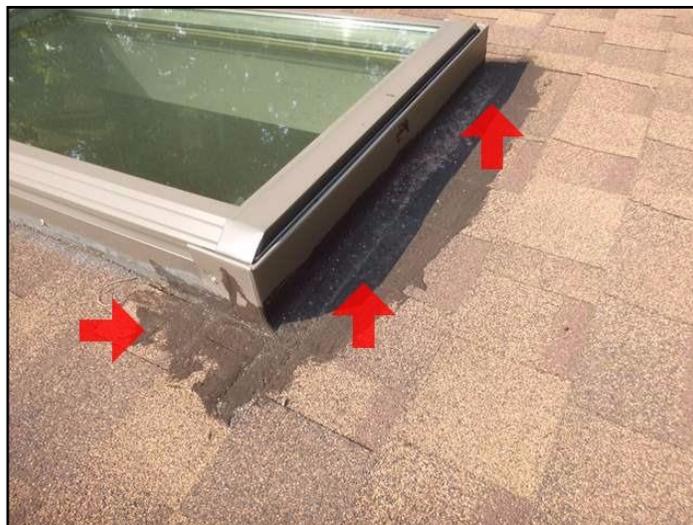
Condition: • [Damage, patched](#)

Repairs noted. No evidence of leakage at time of inspection.

Implication(s): Chance of water damage to contents, finishes and/or structure

Location: Rear

Patched skylight flashings

Task: Inspect / Monitor

Time: Annually

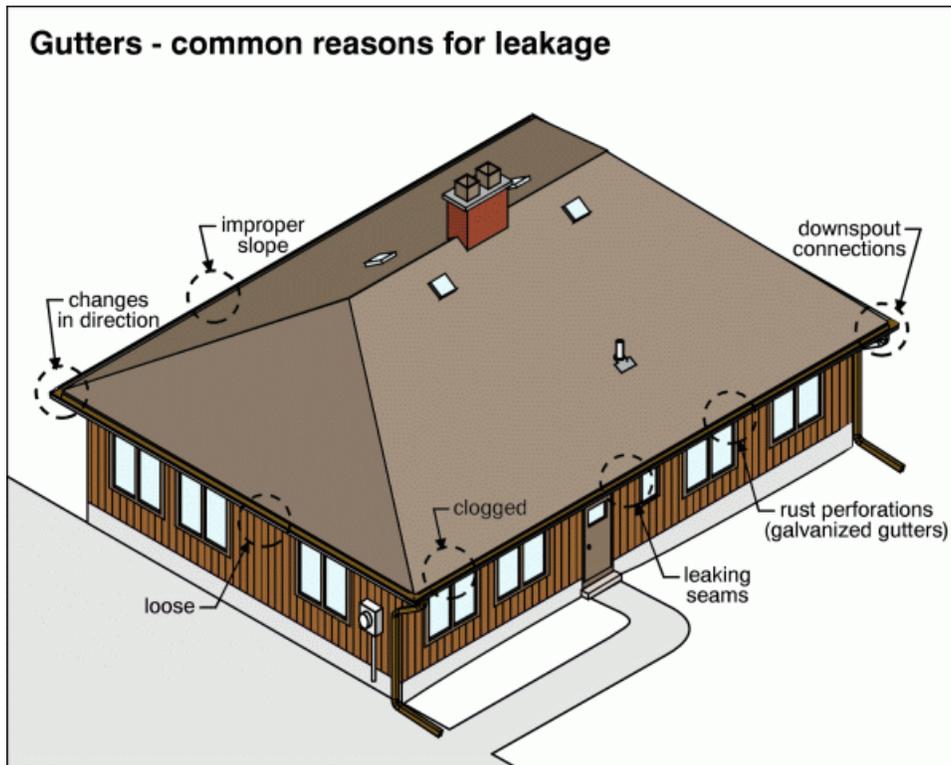
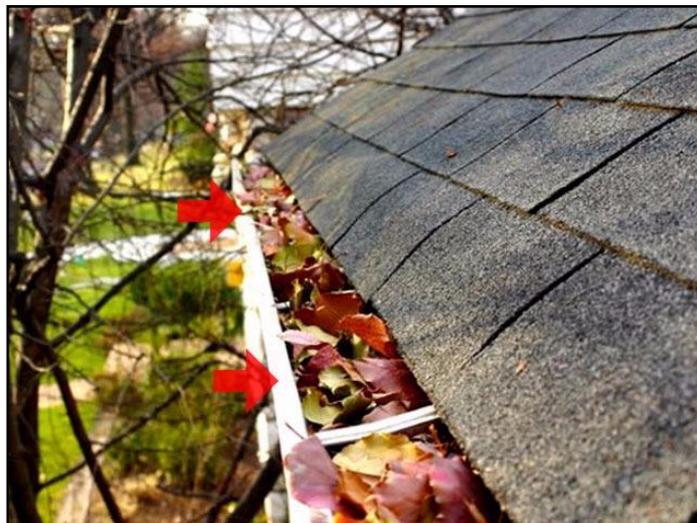
Condition: • [Clogged](#)

Implication(s): Chance of water damage to contents, finishes and/or structure

Location: Various

Clogged

Task: Clean & Service Annually

Time: As soon as possible

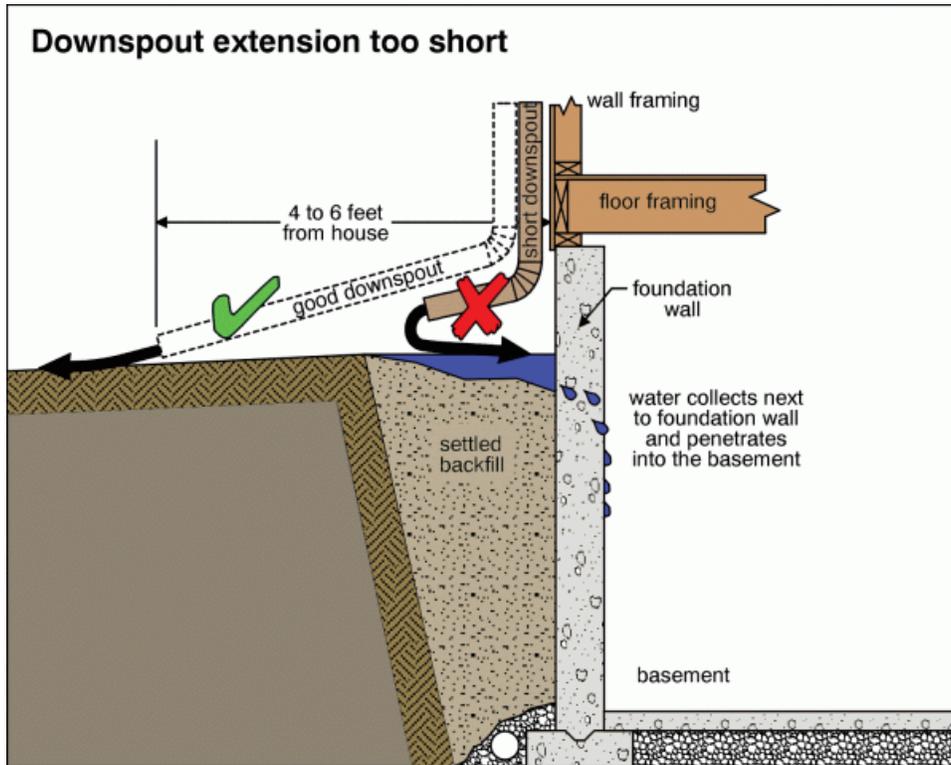
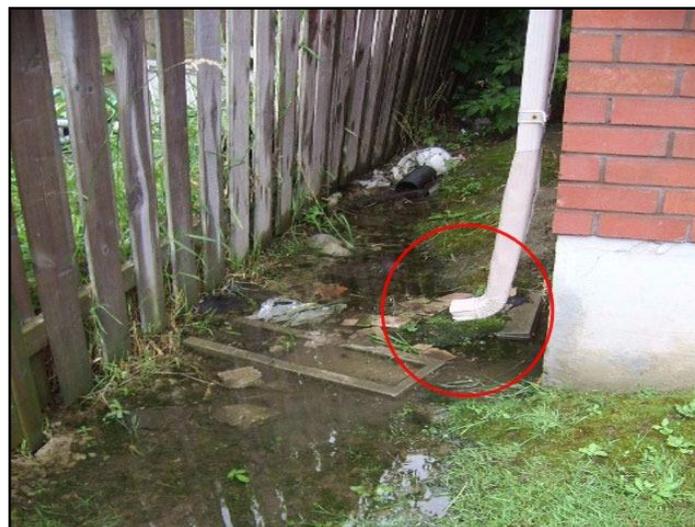
Condition: • [Should discharge 6 feet from building](#)

Implication(s): Chance of water damage to contents, finishes and/or structure

Location: Left side exterior

Should discharge 6 feet from building

Task: Provide downspout extension

Time: As soon as possible

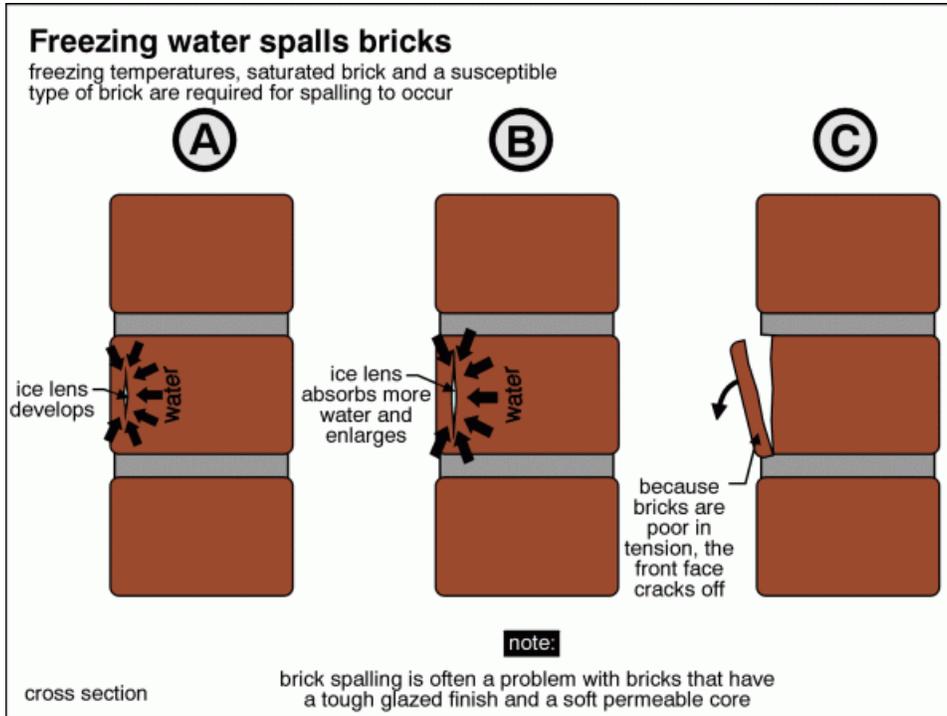
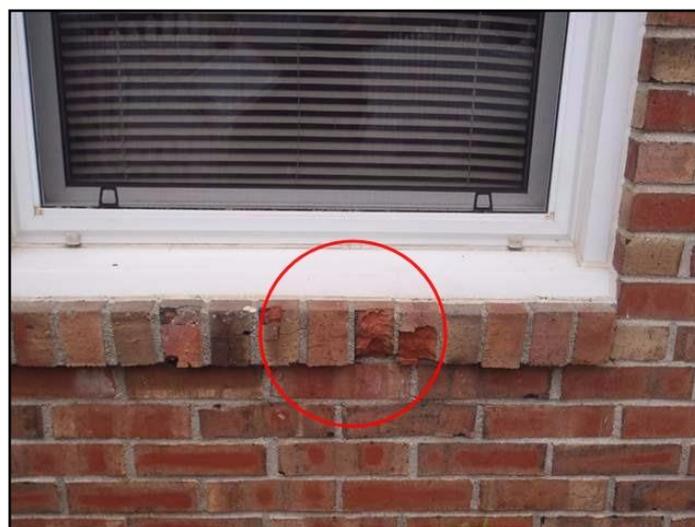
Condition: • [Spalling](#)

Spalling bricks were noted on some of the exterior windowsills.

Implication(s): Weakened structure | Chance of structural movement

Location: Various exterior windowsills

Spalling brick on windowsills

Task: Repair

Time: Less than 1 year

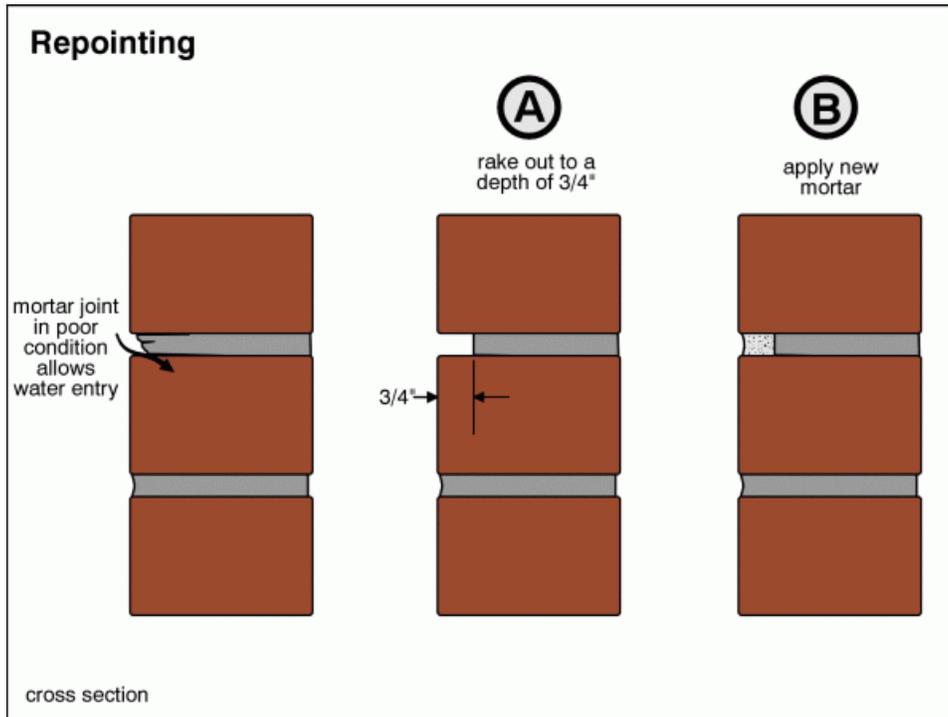
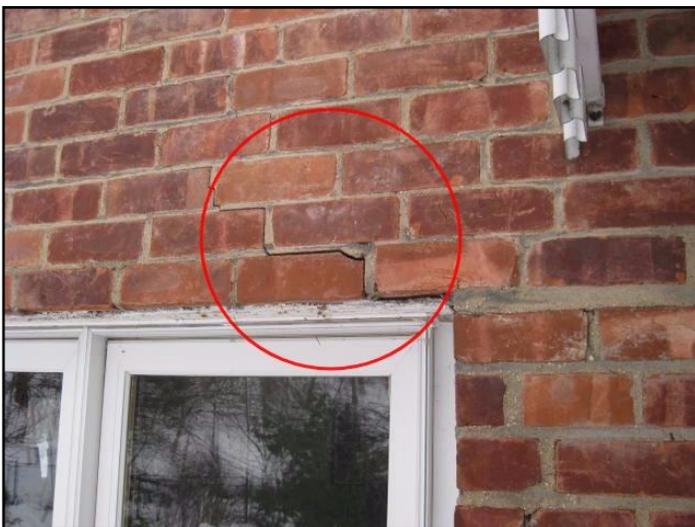
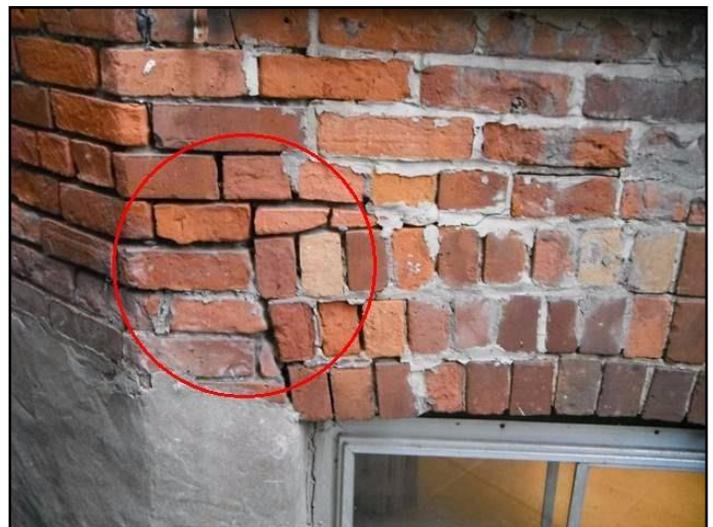
Condition: • [Mortar deterioration](#)

Implication(s): Chance of water entering building | Weakened structure | Chance of structural movement

Location: Various

Mortar deterioration

Task: Repair

Time: Less than 1 year

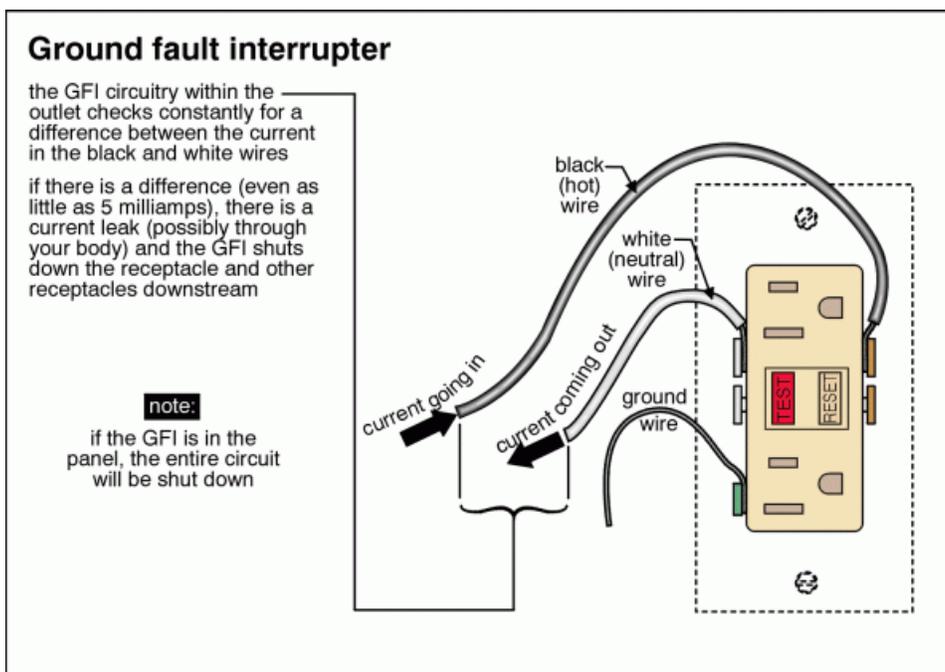
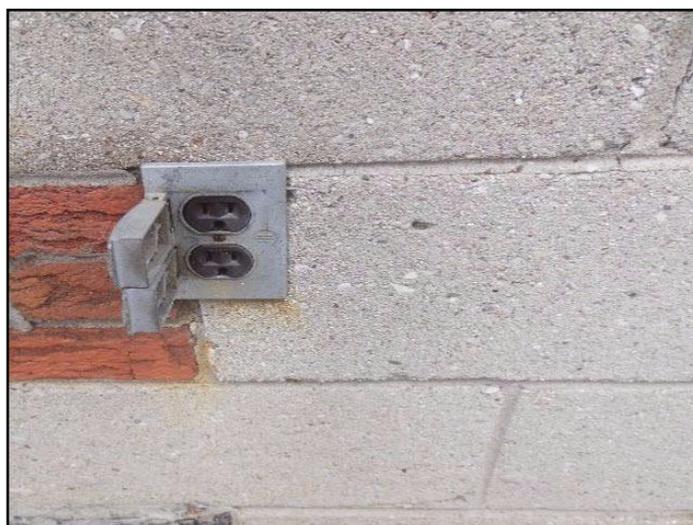
Condition: • [GFCI/GFI needed \(Ground Fault Circuit Interrupter\)](#)

All exterior outlets should be GFCI protected.

Implication(s): Electric shock

Location: Outlets on all exterior walls

Task: Provide

Time: Immediate

Replace with GFCI outlet

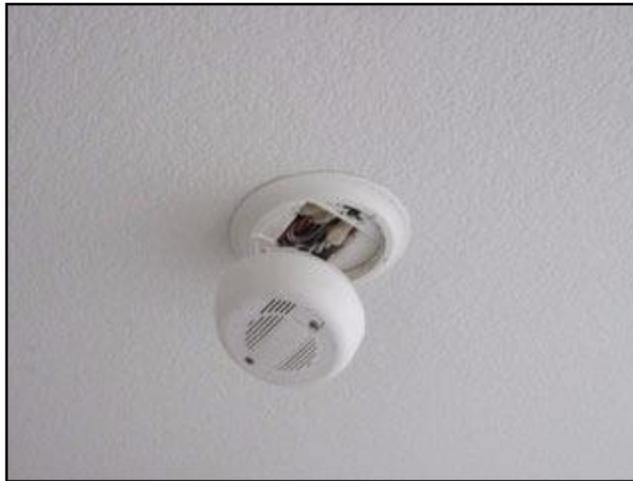
Condition: • [Damaged](#)

Implication(s): Fire hazard

Location: First floor hall

Damaged smoke detector

Task: Repair or replace

Time: Immediate

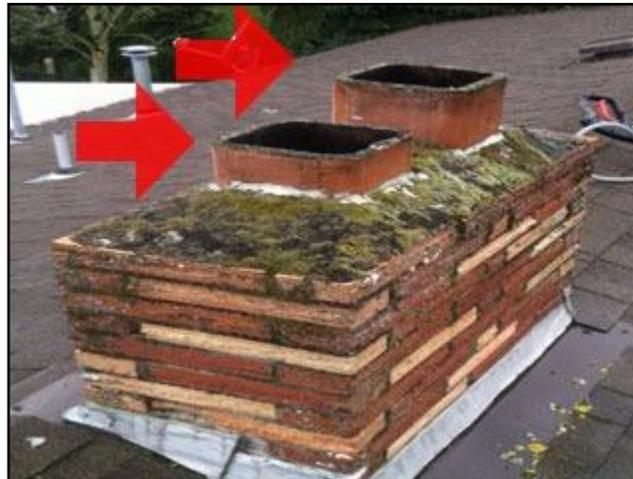
Condition: • [Rain cap missing or damaged](#)

Implication(s): Chance of water entering building | Chance of pests entering building

Location: Rear of roof

Rain caps missing

Task: Provide

Time: As required

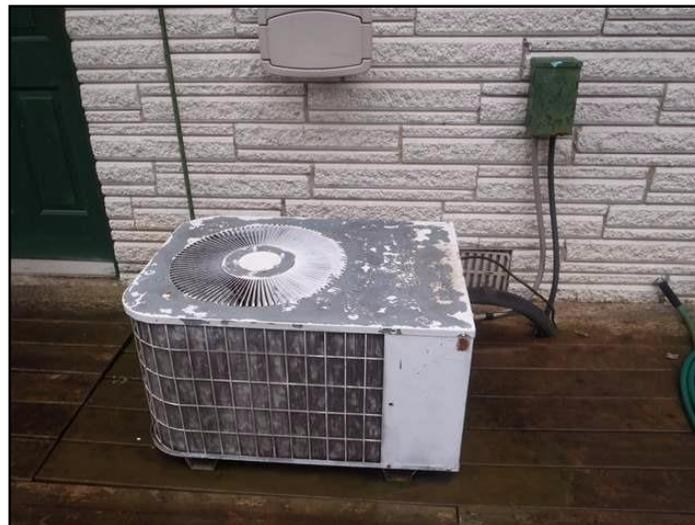
Condition: • [Old](#)

The AC unit is 15 years old. Remaining service life is limited. Continue to operate until replacement is necessary.

Implication(s): Equipment failure | Reduced comfort

Location: Left Side Exterior

Old AC unit

Task: Monitor / Replace

Time: Unpredictable

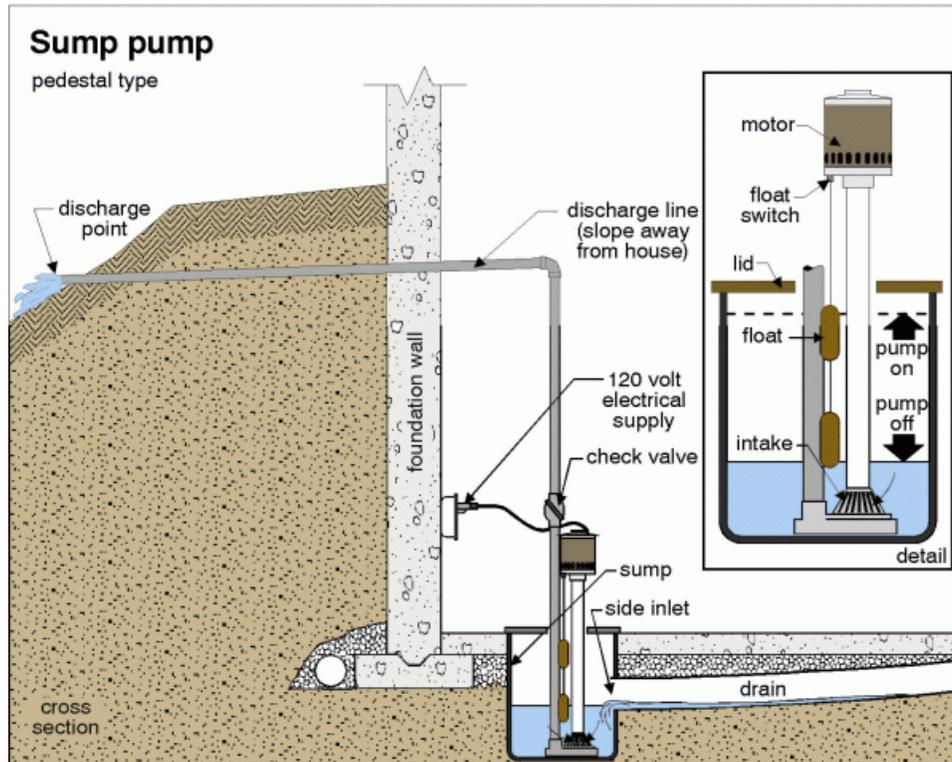
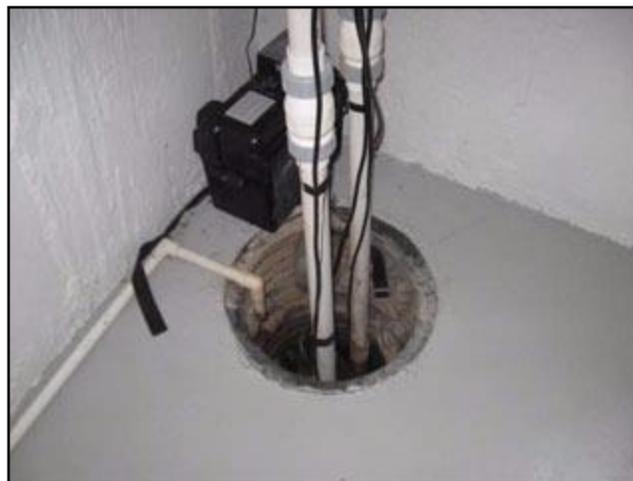
Condition: • [Lid missing, rotted or not secure](#)

Implication(s): Trip or fall hazard

Location: Basement laundry area

Lid missing

Task: Provide

Time: As soon as possible

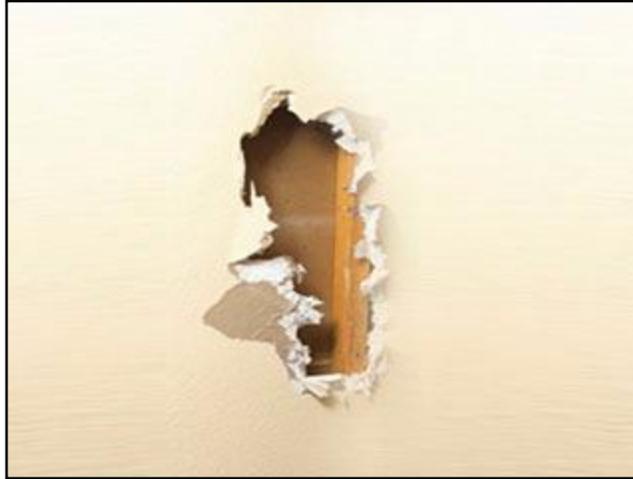
Condition: • Damaged

Location: Upstairs Spare Bedroom

Damaged drywall

Task: Repair or replace

Time: Immediate
