# INSPECTION REPORT

443 Madison St.  
Chicago, IL

INSPECTION DATE:  
Thursday, March 1, 2018

RE: Report No. 3284  
443 Madison  
Chicago, IL

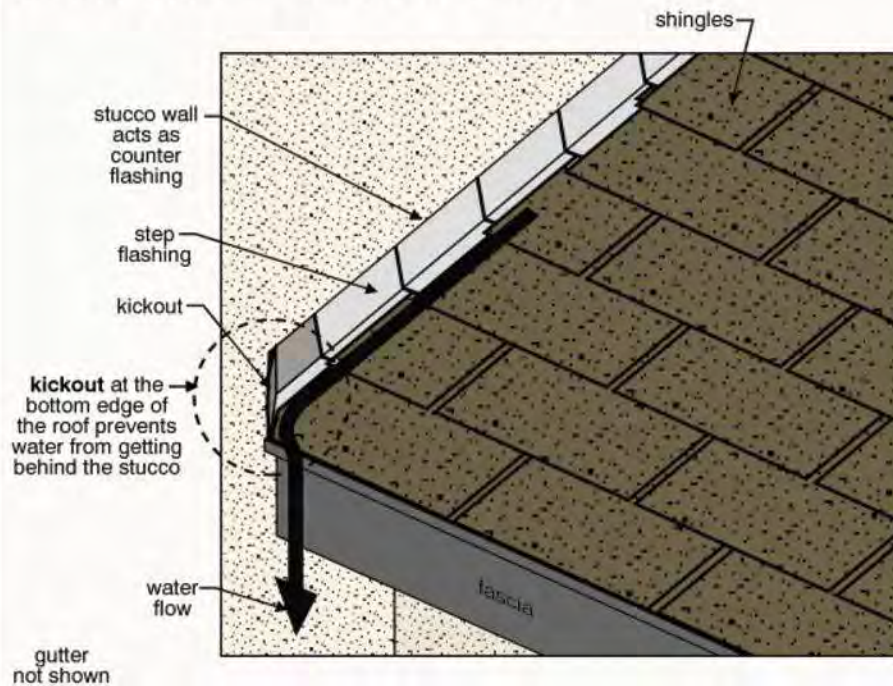
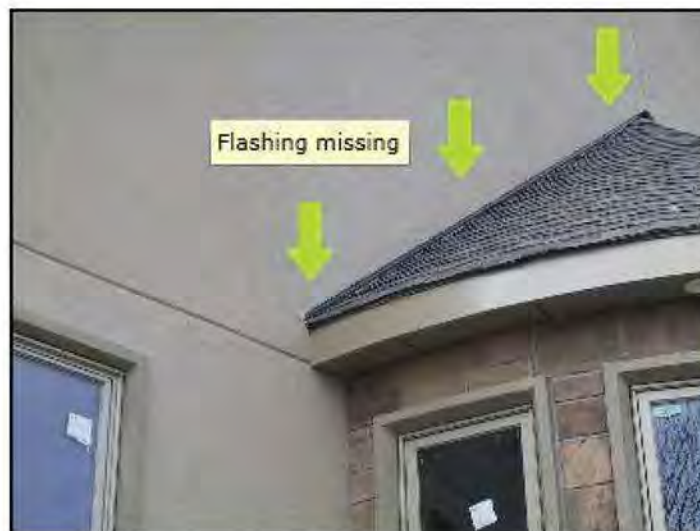
1. Condition: • [No kickout flashing](#)

Implication(s): Chance of water damage to contents, finishes and/or structure

*No kickout flashing at roof/sidewall junction*

Task: Improve

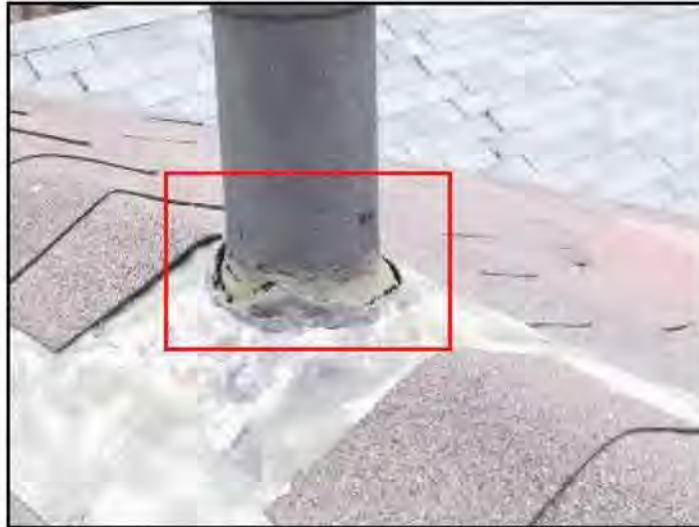
**2. Condition:** • [Leak](#)

**Implication(s):** Chance of water damage to contents, finishes and/or structure

*Leak*

**Task:** Repair

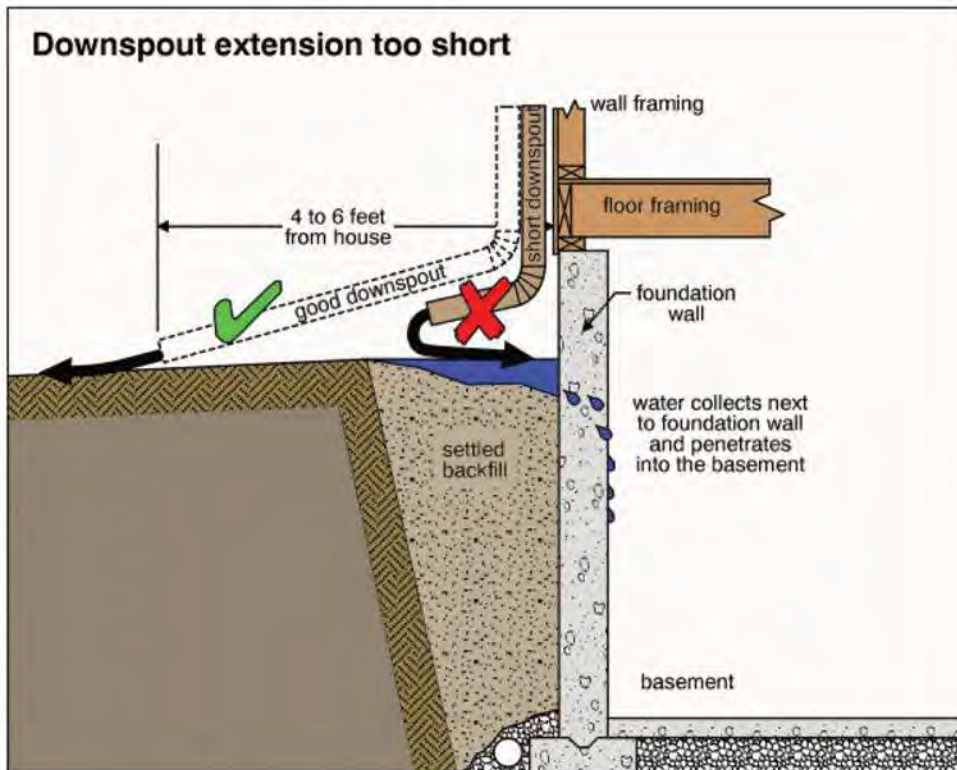
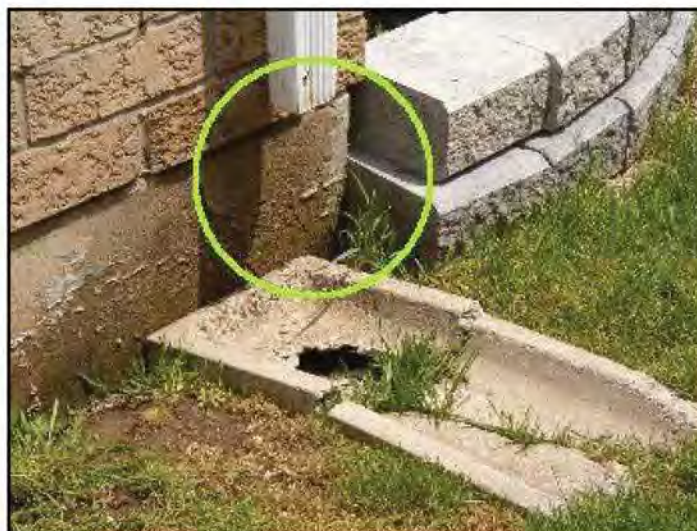
#### 4. Condition: • Downspouts discharge too close to building

**Implication(s):** Chance of water damage to contents, finishes and/or structure

*Downspouts discharge too close to building*

The downspout should be extended to discharge at least 6 feet from the home. The splash block can be discarded.

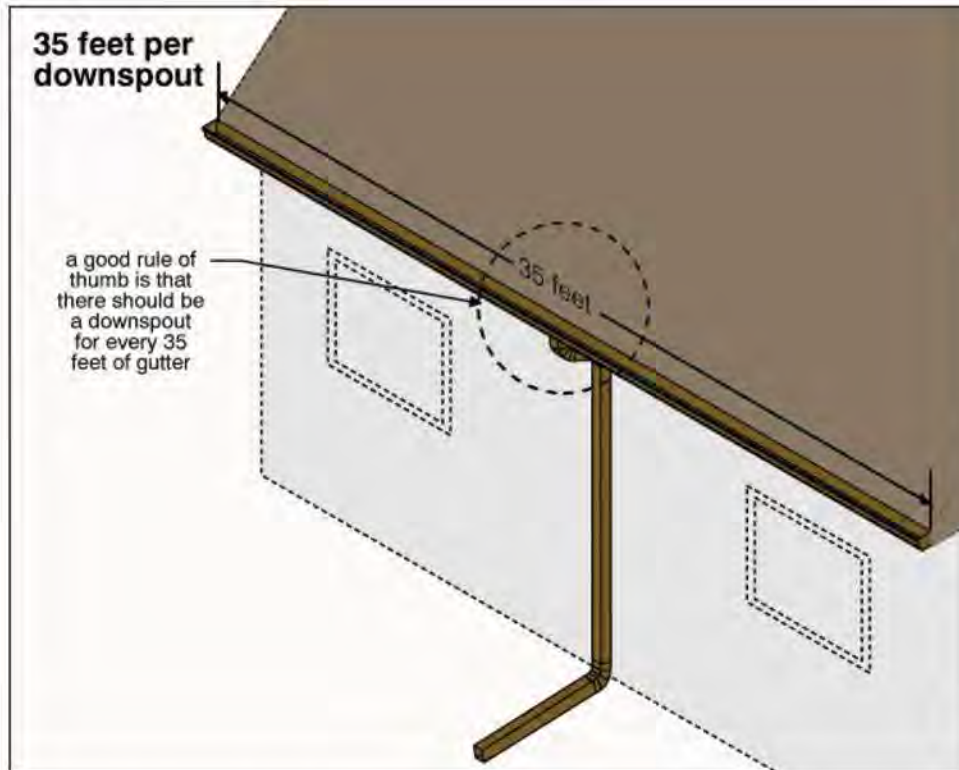
## 5. Condition: • [Too few](#)

**Implication(s):** Chance of water damage to contents, finishes and/or structure

**Task:** Provide

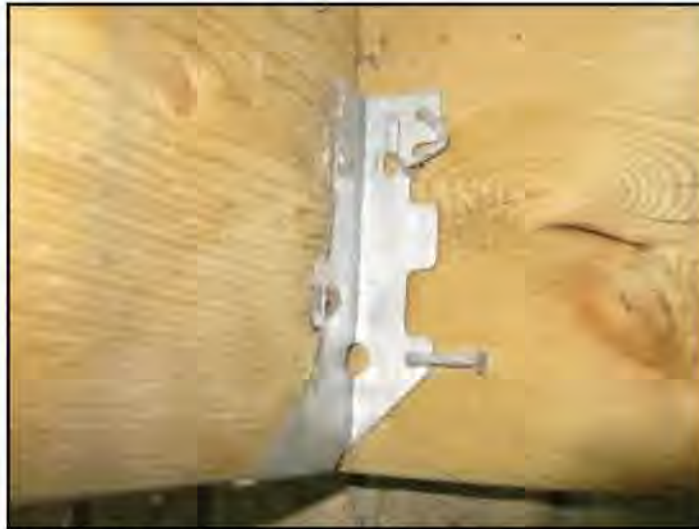
### 6. Condition: • [Fastener problems](#)

Joist hangers for wood deck are not properly nailed.

**Implication(s):** Weakened structure | Chance of movement

*Poor end bearing, joist hanger connections*

**Task:** Improve

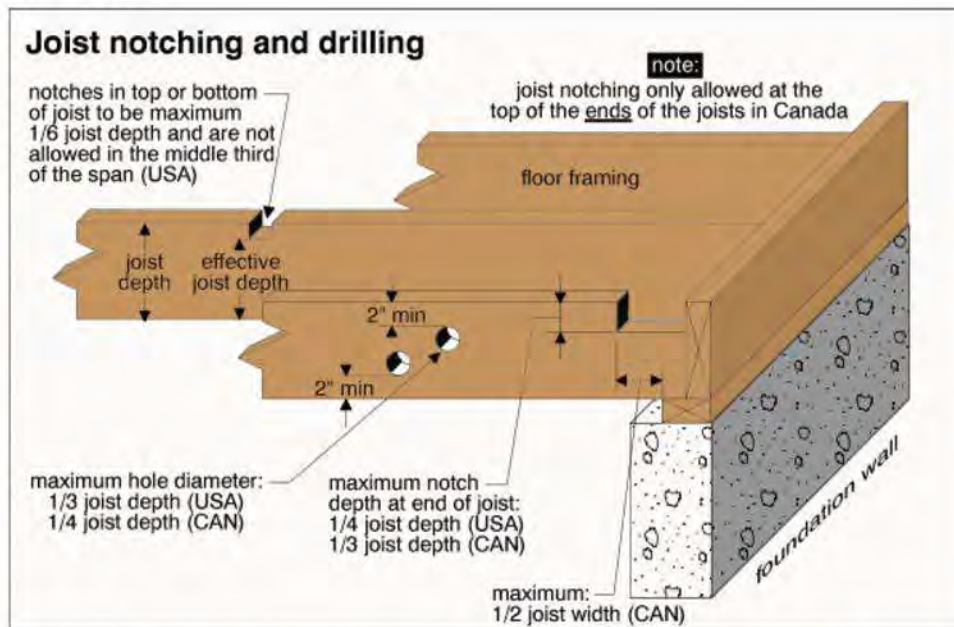
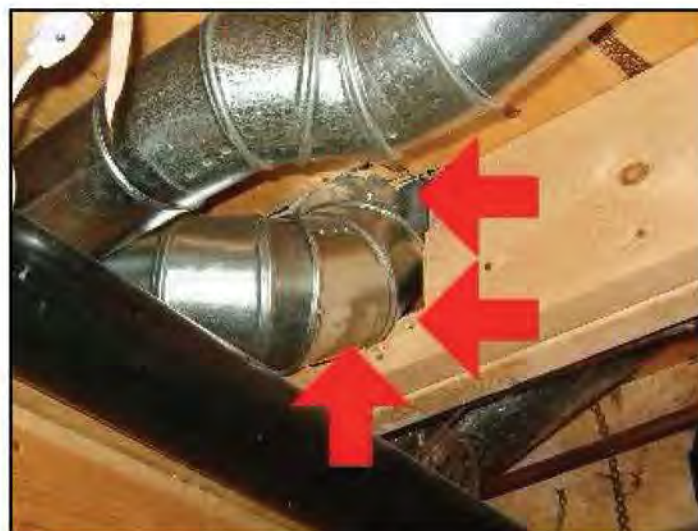
**Condition:** • [Notches or holes](#)

Previous repairs noted.

#### 8. Condition: • Notches or holes

**Implication(s):** Weakened structure

*Joists are notched and weakened*

**Task:** Repair

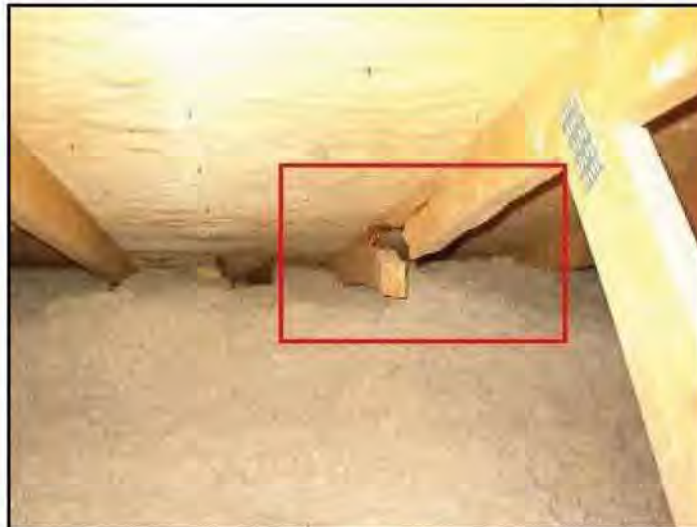
9. Condition: • [Split](#)

Implication(s): Weakened structure | Chance of structural movement

*Top chord of truss is split*

Task: Replace

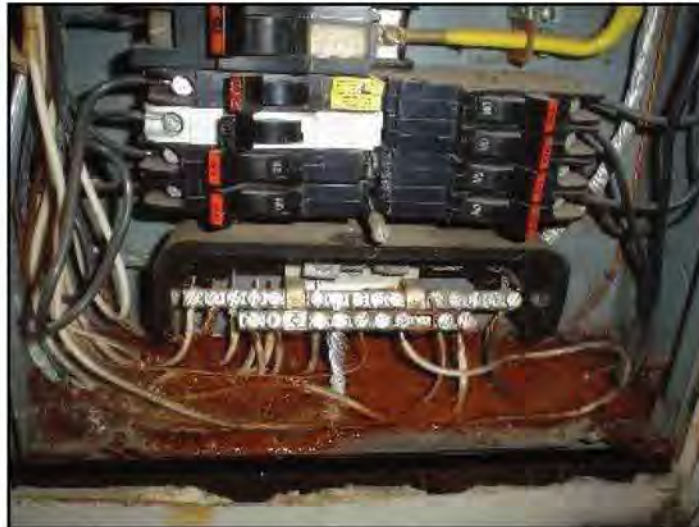
**Condition:** • [Rust or water in panel](#)

**Implication(s):** Electric shock | Fire hazard

**11. Condition:** • [Rust or water in panel](#)

*Water and rust in bottom of panel*

**Task:** Replace

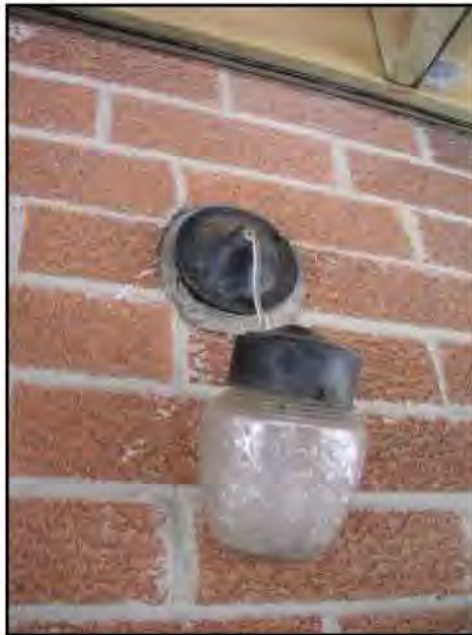
**14. Condition:** • [Loose](#)

**Implication(s):** Electric shock | Fire hazard

*Light fixture is not well secured*

**Task:** Repair or replace

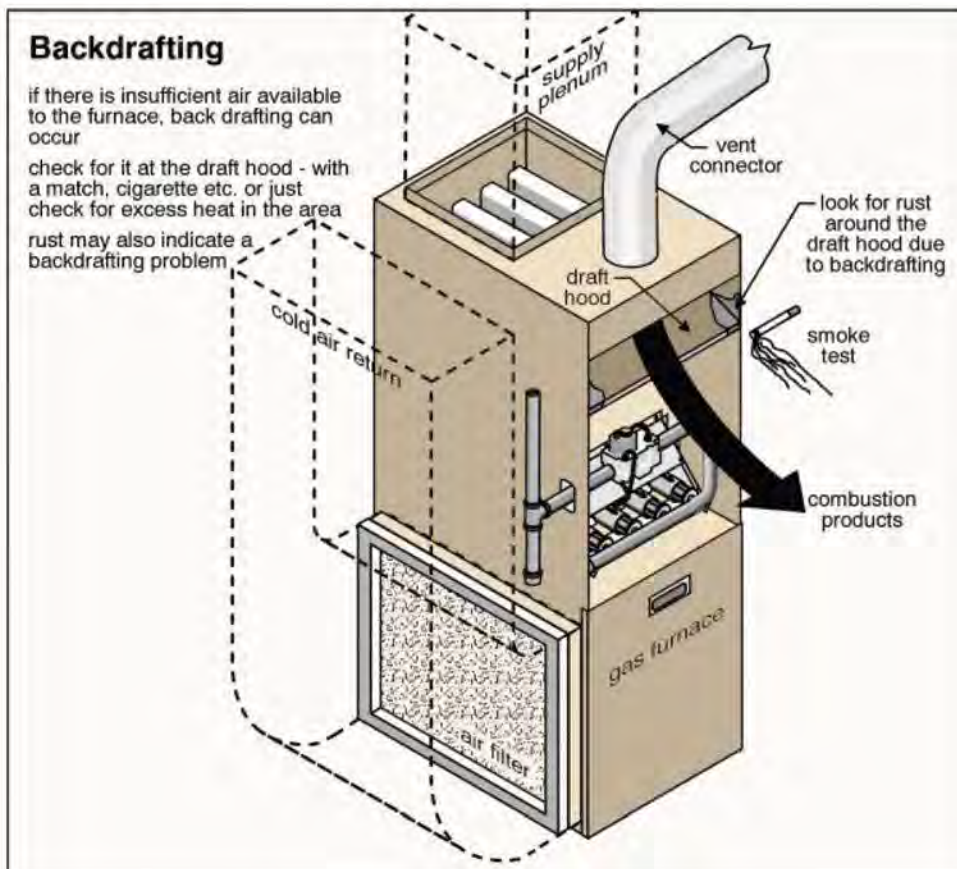
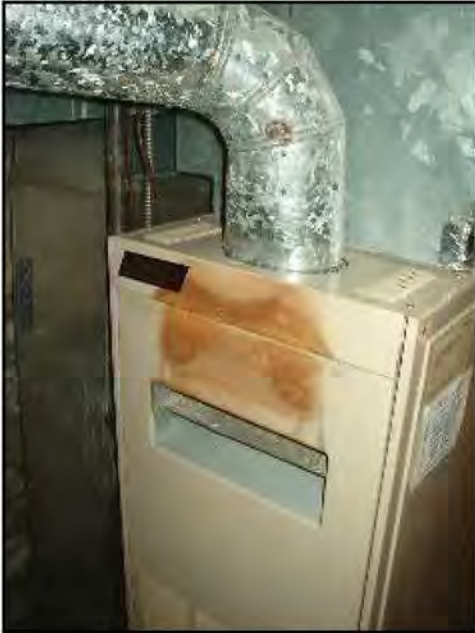
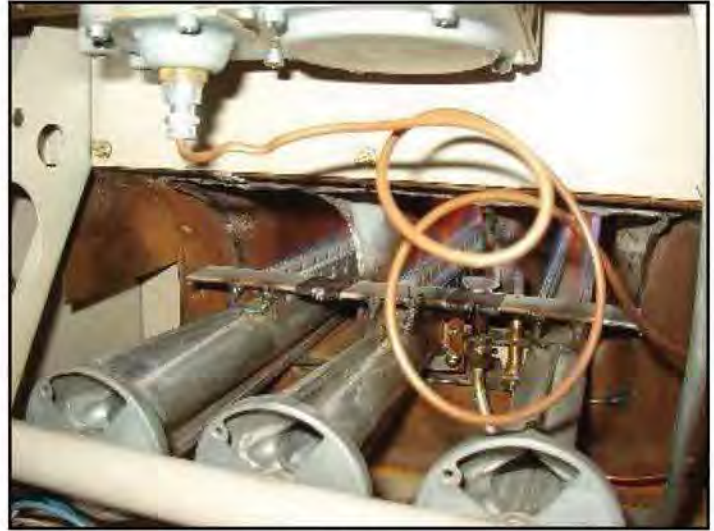
16. Condition: • [Draft hood spillage or backdraft](#)

A considerable amount of rust was noted on the front of the furnace.

This suggests a back-drafting problem, with combustion products entering the home.

This is a safety issue that should be addressed without delay.

**Implication(s):** Equipment not operating properly | Hazardous combustion products entering home

*Draft hood spillage or backdraft*

**Task:** Correct

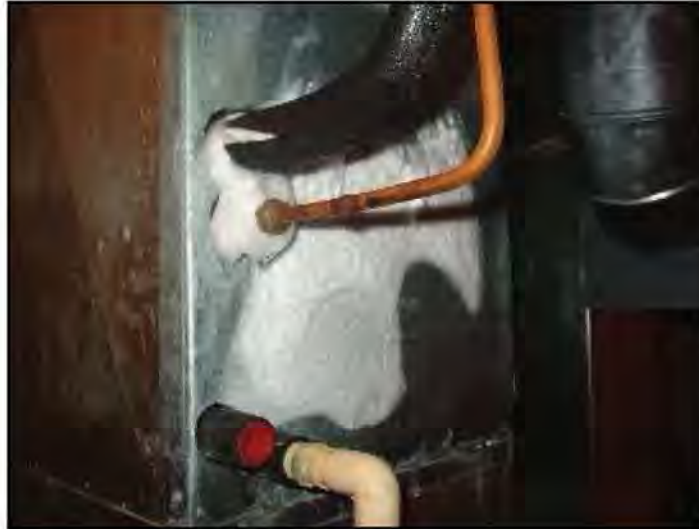
**17. Condition:** • [Frost](#)

**Implication(s):** Increased cooling costs | Reduced comfort

*Frost*

**Task:** Repair

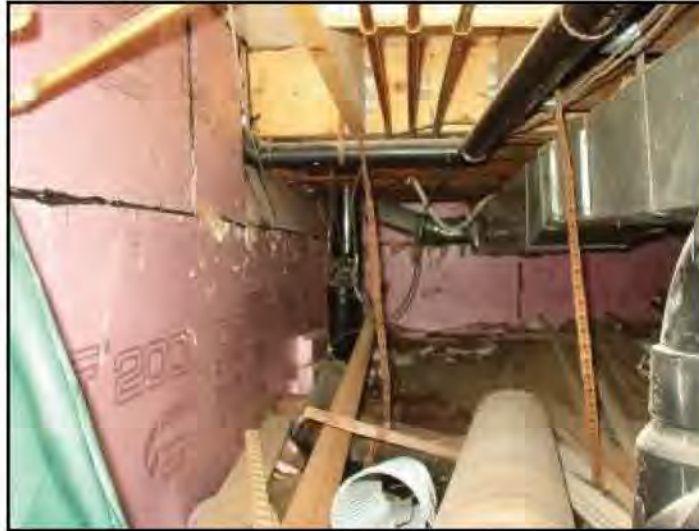
**18. Condition:** • [Exposed combustible insulation](#)

**Implication(s):** Fire hazard

*Exposed combustible insulation*

**Task:** Remove or cover with drywall

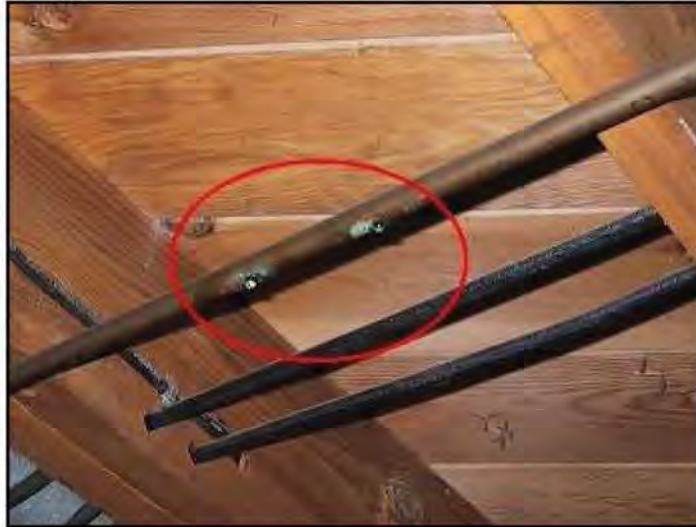
**19. Condition:** • [Leak](#)

**Implication(s):** Chance of water damage to contents, finishes and/or structure | System inoperative

*Leak*

**Task:** Replace

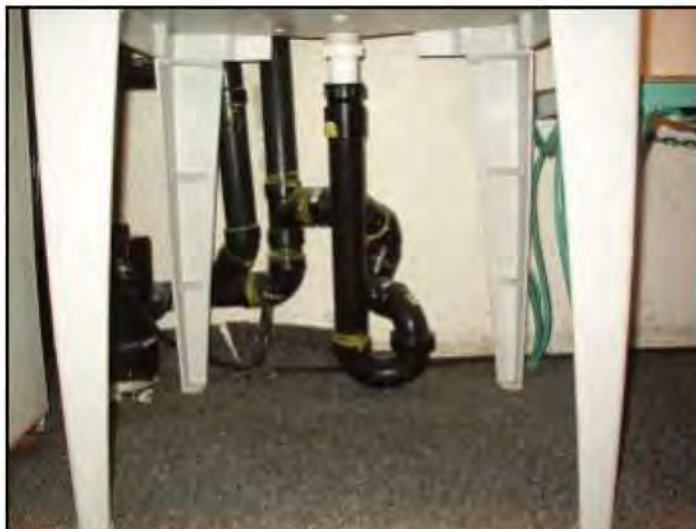
**20. Condition:** • [Nonstandard shape or material](#)

**Implication(s):** Reduced operability | Fixtures slow to drain

*Poor trap arrangement*

**Task:** Improve

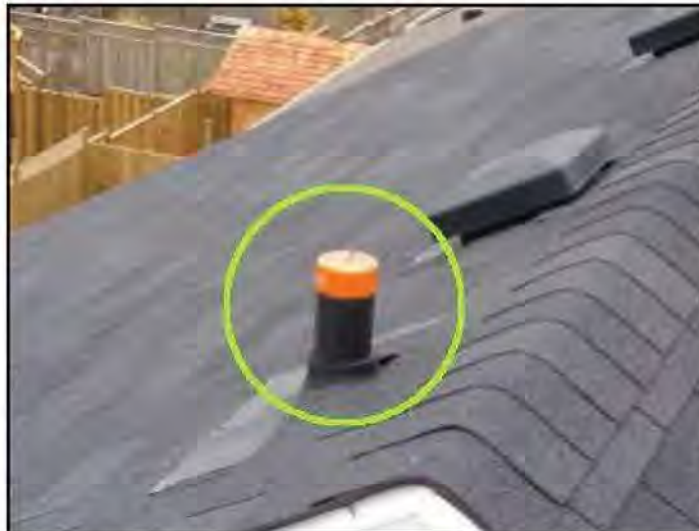
21. Condition: • [Vent termination problems](#)

Implication(s): Reduced operability | Sewer gases entering the building

*Plumbing stack is capped*

Task: Remove cap

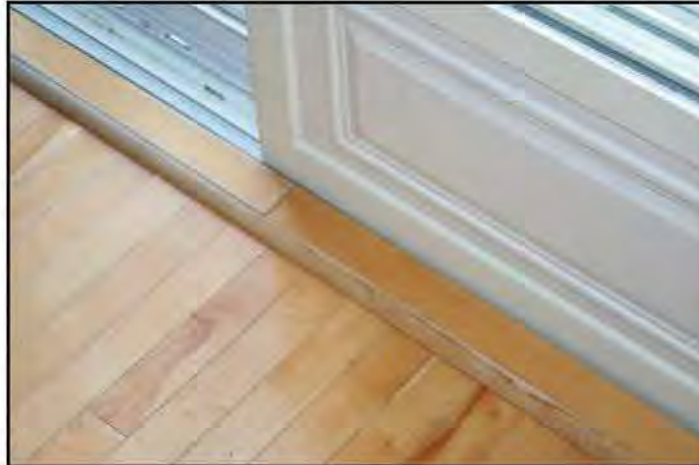
**22. Condition:** • [Stained](#)

**Implication(s):** Chance of water damage to contents, finishes and/or structure

*Stained*

**Task:** Replace

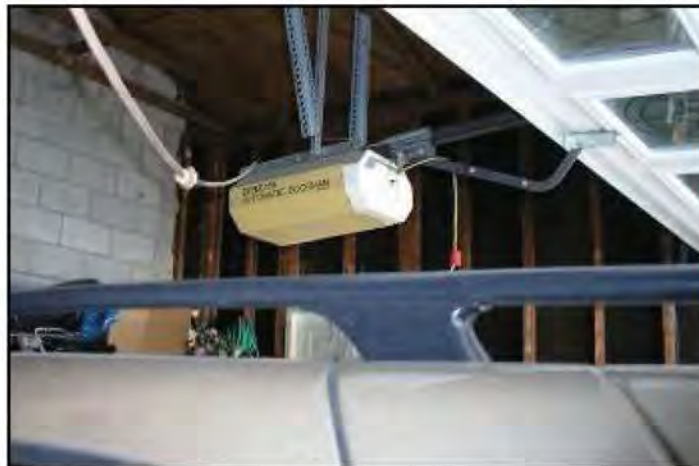
**23. Condition:** • [Extension cord for opener](#)

**Implication(s):** Electric shock

*Extension cord for opener*
