INSPECTION REPORT

Friday, July 26, 2019

2499 Worthington Drive

Horizon Professional Inspection Services Ltd.

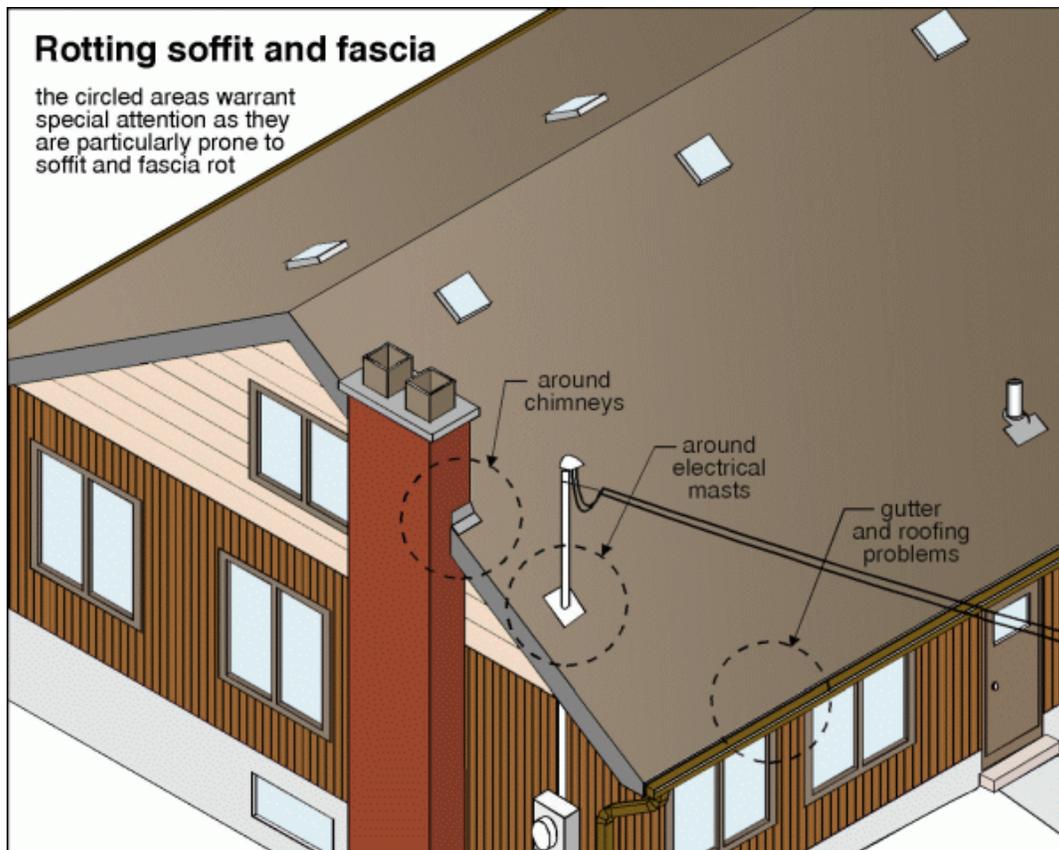
Damage

Implications: Chance of water damage to contents, finishes and/or structure

Task: Repair or replace

Time: Less than 1 year

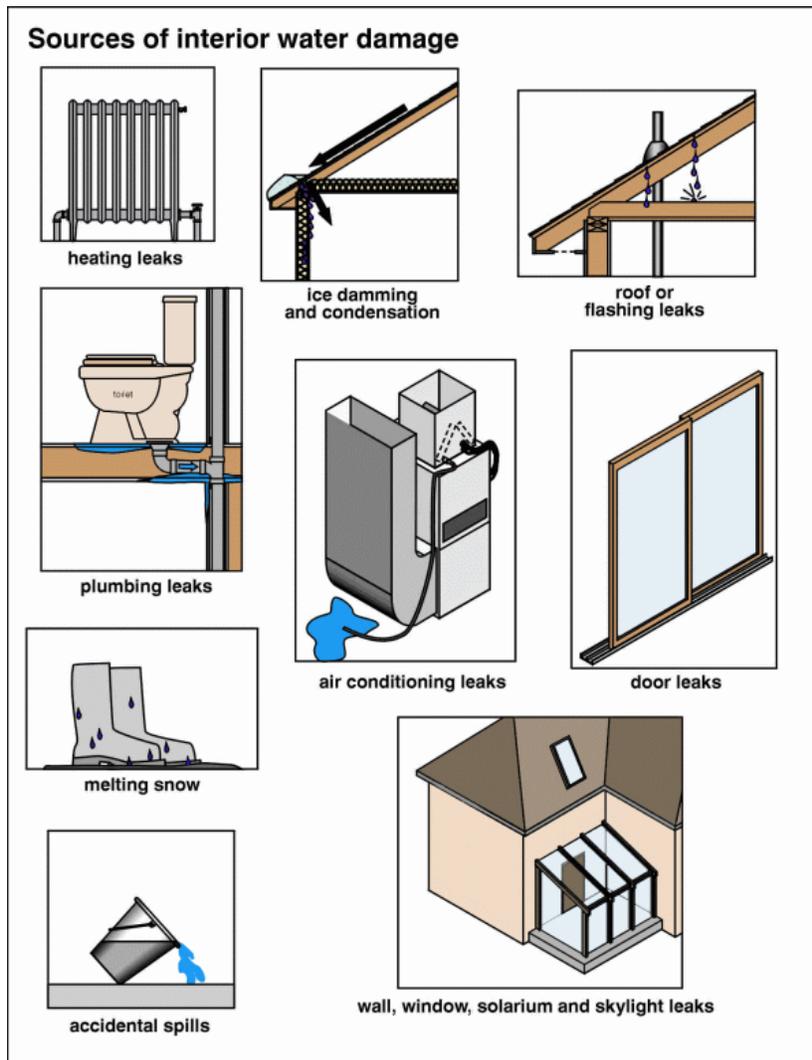
Common locations for water damage

water damage to walls is common below windows, bathrooms, roof flashings, chimneys and vents
