Exterior

INTRODUCTION

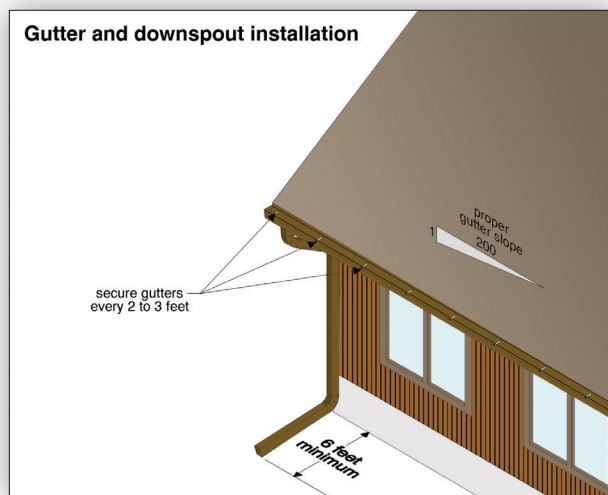
SIZE On most houses, the gutters are attached to the fascia board at the edge of the eaves. In some houses, gutters are integral to the design of the eaves. The two most common sizes of gutters are four-inch and five-inch widths. Four-inch gutters are good for relatively small roof areas; however, five-inch gutters are preferred because of their additional capacity. Five-inch gutters are also less likely to allow water to overshoot the gutters when the water is draining off a steeply pitched roof.

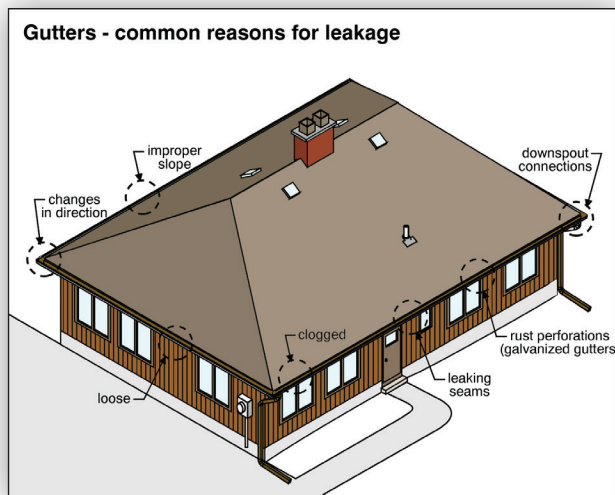
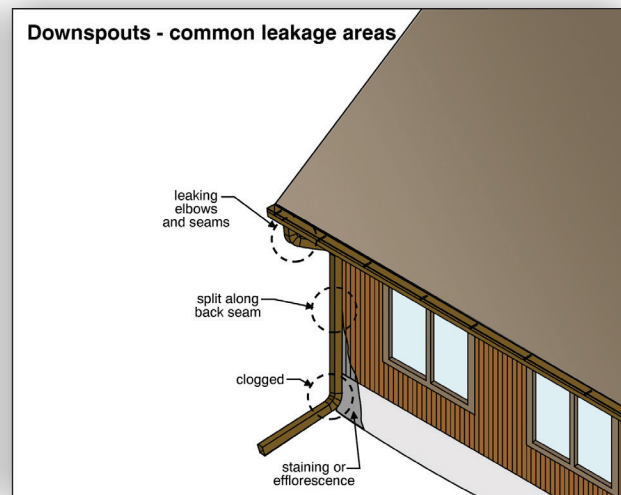
- LEAKAGE – HOLES/SEAMS/ END CAPS** The most common problem with gutters is leakage. Leakage will occur with galvanized gutters as they rust through. Holes can develop in copper gutters as well. All gutters are prone to leakage at the joints and seams. Missing end caps and poor connections to downspouts are other common sources of leakage. Leakage can cause considerable damage to fascias, soffits and walls below. Leaks can also result in basement water problems.

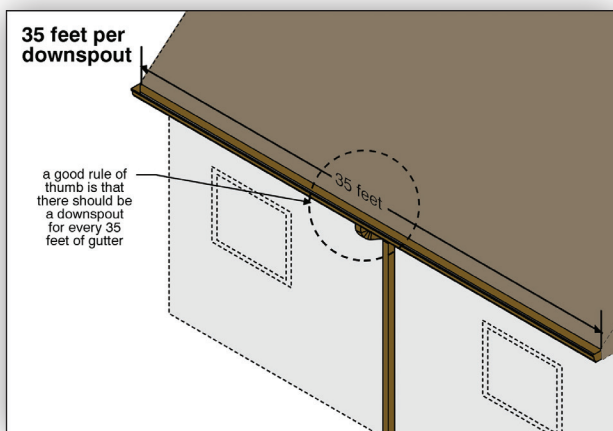
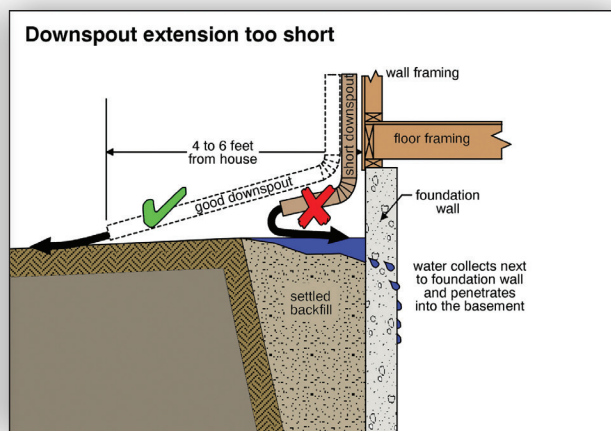
- DOWNSPOUT DISCHARGE** Downspouts collect water from the gutters and discharge it into drains or onto the ground. Underground drains (usually made of clay tile, cast iron or plastic) become clogged or break below grade. If an underground downspout malfunctions, water problems will likely develop in that part of the basement. There are two options. Exterior digging and repairs can be undertaken; however, it is faster and cheaper to simply disconnect the downspout and redirect it to discharge away from the house. It's also easier to monitor the performance, and problems are corrected easily.

- Downspouts should discharge above grade onto the ground at least six feet from the home. The slope of the ground in this area should be away from the house, to direct water away from the basement.

On older homes, (pre-1950) downspout drains are often connected to floor drains in the basement. If there is a significant amount of debris in the discharge from the downspouts, it can plug the basement floor drains and cause backup. A more complete discussion of wet basement problems is included in Section 10 of the Interior chapter.

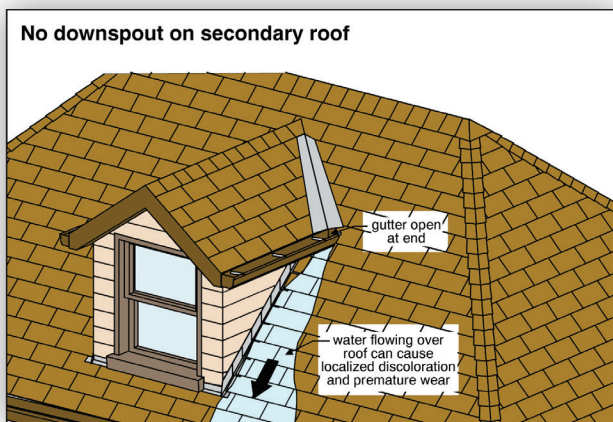
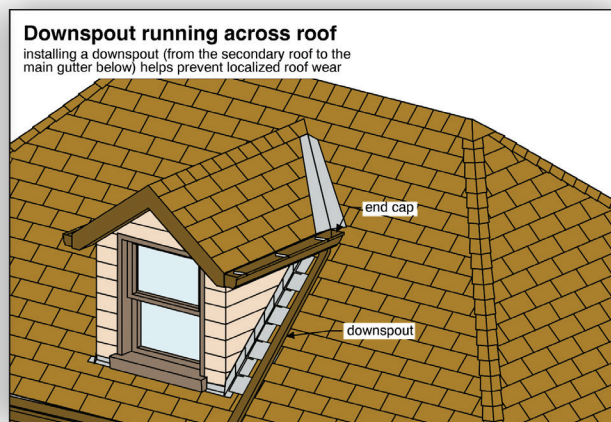
DISCHARGE ONTO ROOF Where gutters or downspouts discharge onto roof below, the lower roof in the path of the water will deteriorate quickly. The lower roof can be protected by extending the downspout along the lower roof to discharge directly into the lower roof gutter.

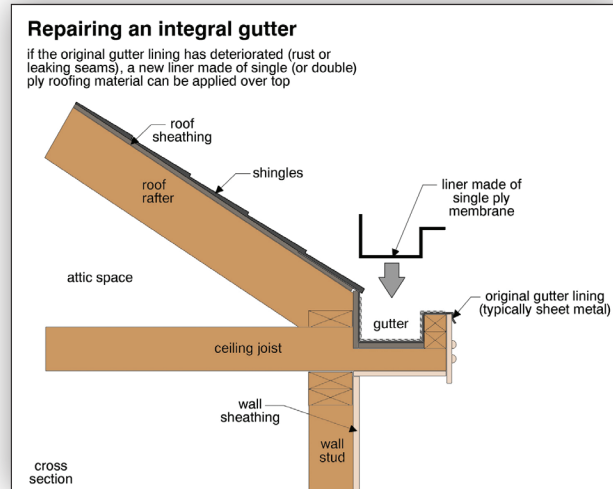
INTEGRAL OR BUILT-IN GUTTERS Malfunctioning integral gutters can be very serious. The leaking water usually ends up in the structure, causing rot and other damage. Repairs often include adding a single-ply roofing membrane as a gutter liner.

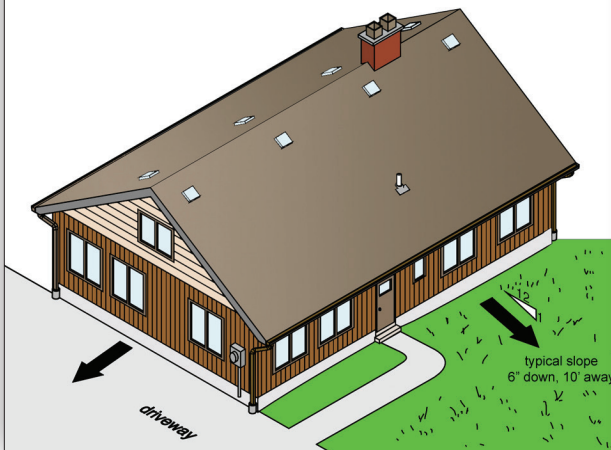
Recommended grading slopes

WET BASEMENTS The theory is simple. If there is no water in the soil on the outside of the foundation wall, no water will get into the interior. Most wet basement problems can be eliminated or dramatically reduced with good grading and proper performance of gutters and downspouts. The ground around the home should slope down six inches for the first ten feet away from the home. This can often be done by adding topsoil (not sand or gravel).

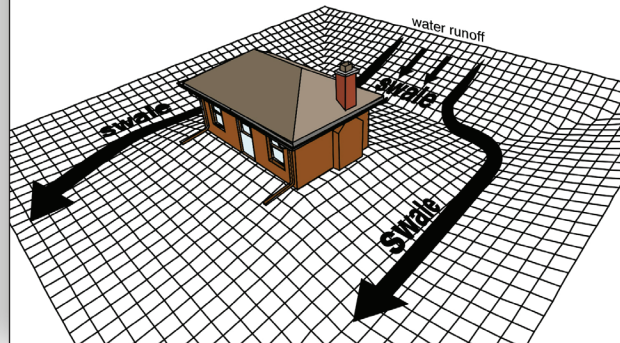
Swales

when the overall lot drainage is toward the house, swales can be used to direct surface water away from the foundation

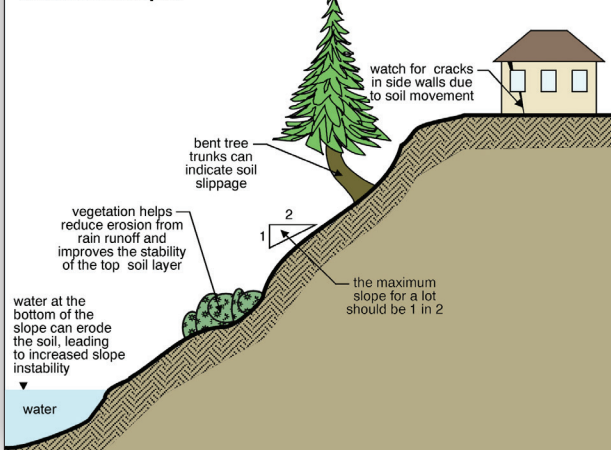
Maximum slopes

From a one-time visit, it is not possible to determine the rate of erosion (if any); however, mature trees and heavy vegetation on the slope suggest little movement and their roots help prevent erosion.

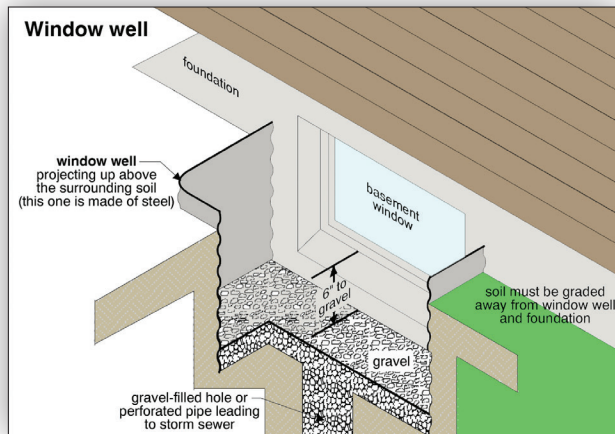
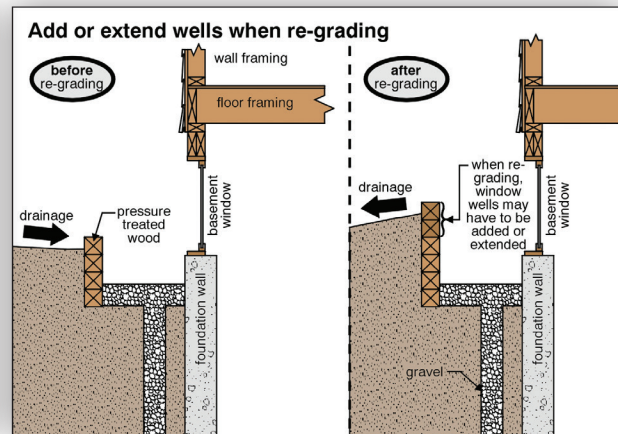
DRAINAGE AND COVERS Ideally, the bottom of the window well should contain several inches of gravel to allow water to drain from the well. A drainage pipe, filled with gravel (to prevent it from collapsing, but still allowing water to pass) should extend down to the drainage tile around the perimeter of the footing (if one exists). As an alternative, a clear plastic dome cover is installed over the window well to keep water and debris out.

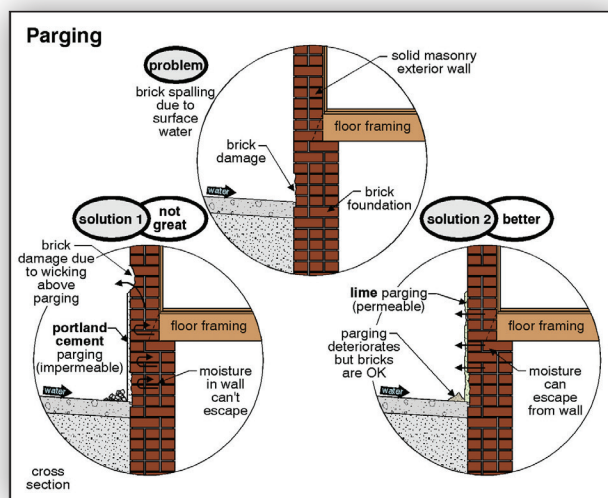
Lime based parging is better than Portland cement based because it is more permeable. Impermeable parging breaks off in large sections, due to moisture trapped behind it. The impermeable parging also causes dampness to rise up the wall to a level above the parging where evaporation can take place. Evaporation results in efflorescence (defined on Page 12) forming on the wall surface and within the wall itself. This causes spalling brickwork and mortar deterioration. Lime-based parging prevents this phenomenon from happening as moisture can pass through it. The parging itself is subject to efflorescence and spalling, but this is treated as sacrificial material.

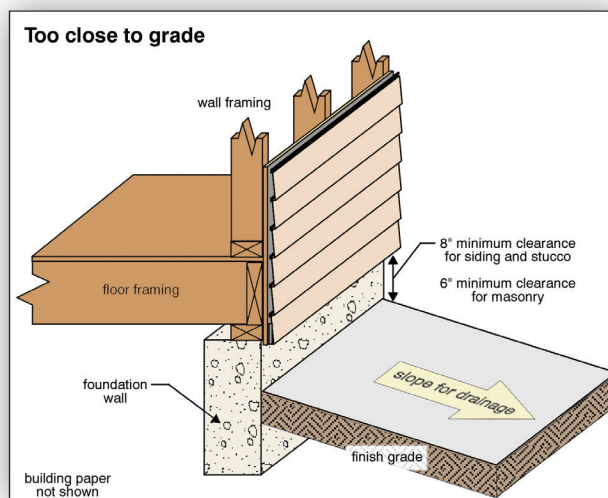
SIDING TOO CLOSE TO GRADE

Siding materials are not meant to be in contact with the ground and will deteriorate if they are at or below grade. On virtually every house, at least the top four to six inches of the foundation wall should be visible outside. We prefer to see six inches for masonry and eight inches for wood siding. There are two reasons – the first is that siding may deteriorate from chronic dampness. The second is the risk of rot and/or insect infestation to the structure. Even brick homes have wood structural members inside.

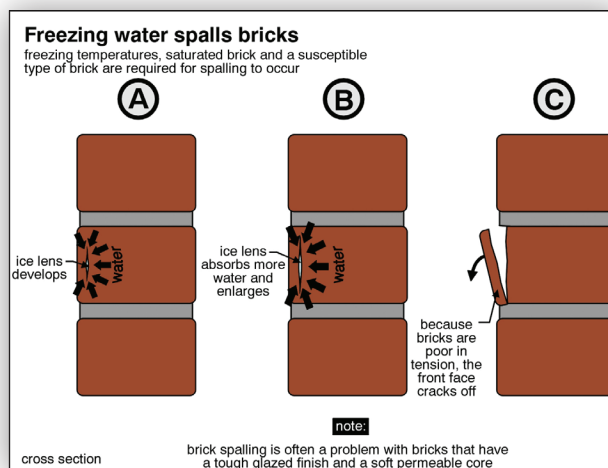
SANDBLASTED Brick is usually damaged by sandblasting. Brick with a soft core and a harder crust is common on older houses (the same houses that tend to require brick cleaning). Sandblasting removes the outer crust and makes the brick more prone to deterioration. Once a house has been sandblasted, it may deteriorate relatively quickly. The rate of deterioration can't be determined during a single home inspection. This often requires monitoring to determine if any remedial action is necessary. Sandblasting and high pressure liquid cleaning often damage mortar, and re-pointing is usually necessary.

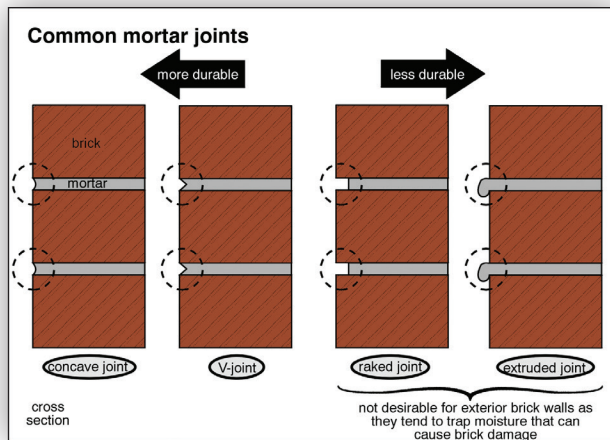
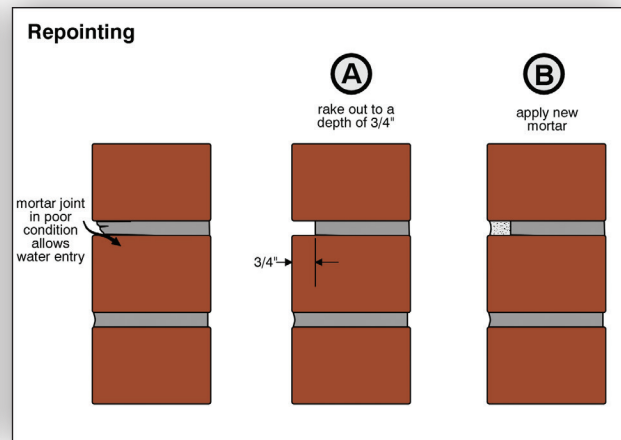
MORTAR PROBLEMS Mortar often deteriorates more quickly than the brick. Mortar may crack or crumble. Mortar repairs are typically called repointing.

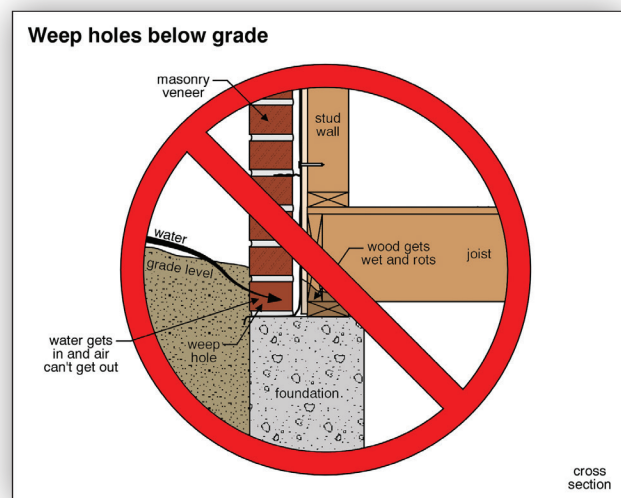
WEEP HOLES IN BRICK WALLS BELOW GRADE Some brick walls have weep holes at the bottom to allow water to drain out. If these drain holes are not several inches above grade, water may drain into rather than out of the wall system and damage the wood framing behind the brick.

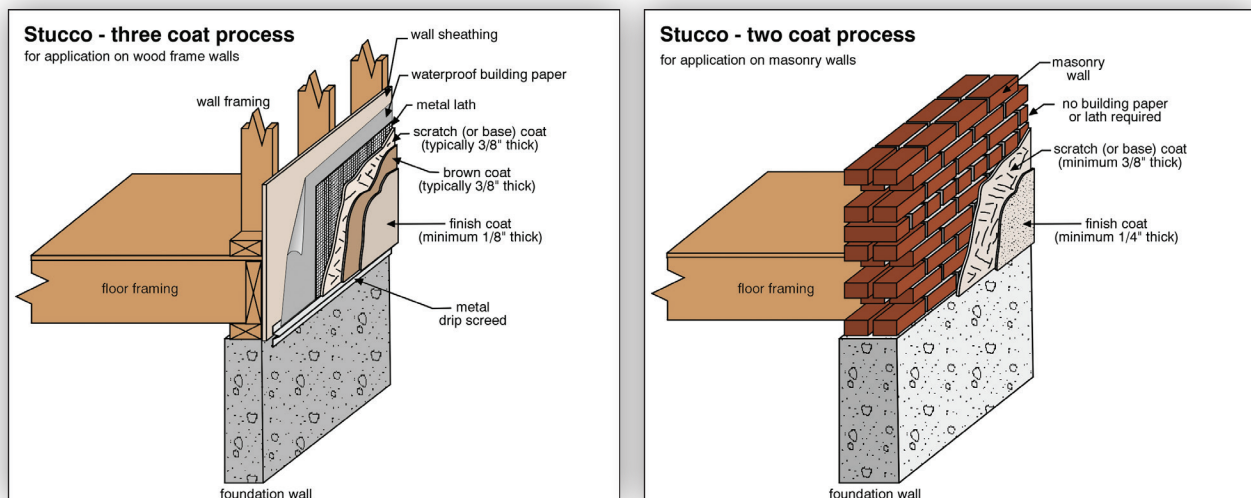
DESCRIPTION Stucco is the exterior equivalent of plaster, made of cement, lime, aggregate and water. Stucco can be thought of as a thin coat of concrete, with the cement and lime acting as binders, the aggregate providing the bulk and the strength, and the water initiating the chemical reaction. Much like plaster, stucco requires periodic maintenance as cracks develop. The amount of maintenance required depends largely upon the mix of the stucco, the lath used (if any), and the surface to which the stucco is applied. Stucco is typically applied in a two-or three-step process.

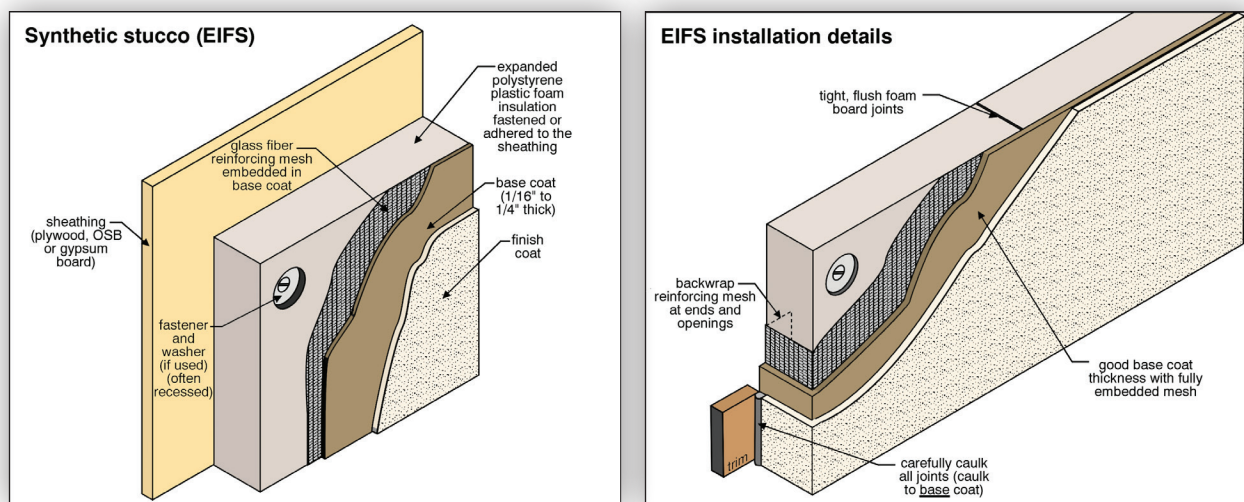
DESCRIPTION Exterior Insulated Finish Systems (EIFS) look similar to stucco but are different. Rigid wall sheathing, such as plywood, is covered with foam insulation board. A thin base coat reinforced with fiberglass mesh is then applied and covered with a thin acrylic finish coat. It is a two-step process, and the finished coating is more flexible than conventional stucco.

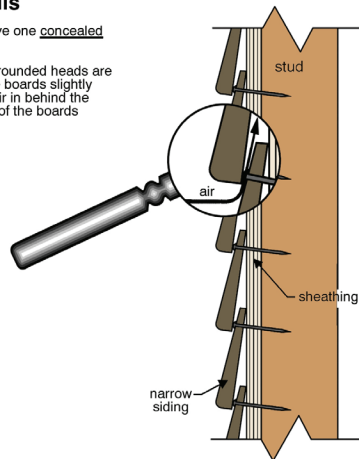
Horizontal wood siding

narrow siding may have one concealed nail per nailing point

siding nails that have rounded heads are often used to keep the boards slightly separated - allowing air in behind the siding to dry the back of the boards

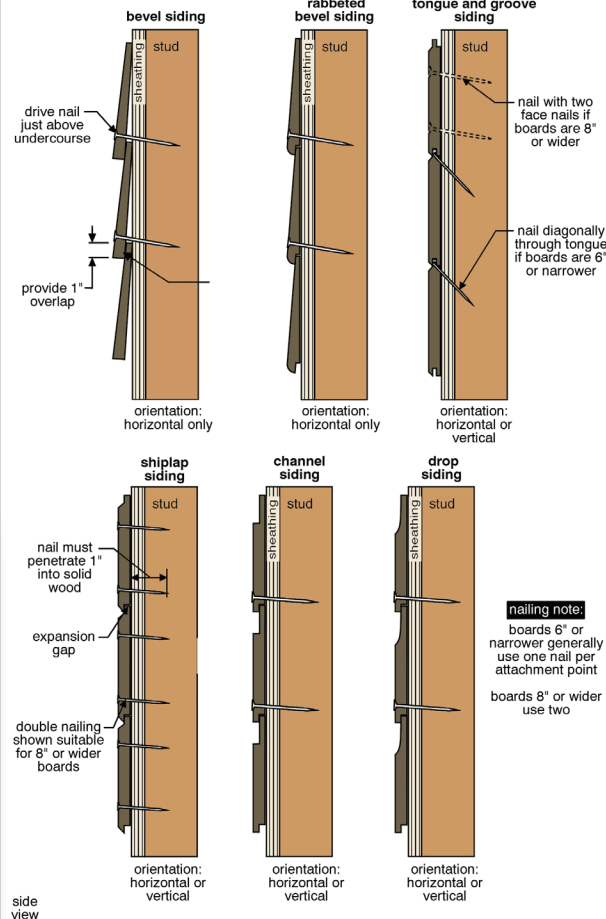
Water penetration and rot problems are most common at joints, penetrations and changes in direction or material. Joints should prevent water penetration. The horizontal joints on clap-board siding, for example, overlap one another; however, most vertical joints do not. Therefore, vertical joints should be protected with flashings or caulking. Caulking is a maintenance issue.

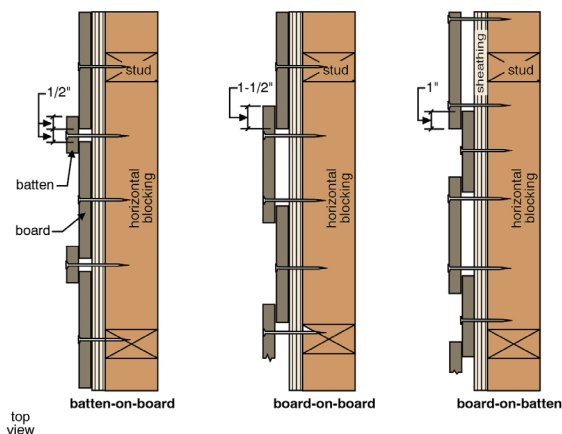
board-and-batten siding is always installed vertically as with horizontal siding, one nail is used per nailing point with boards 6" or narrower while 2 nails are used with boards 8" and wider

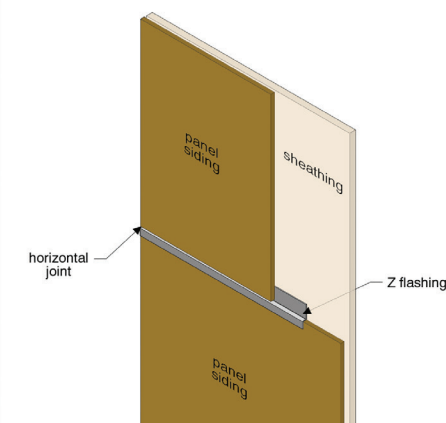
Z flashings

Many wood siding systems require pieces of wood trim to be installed over the joints. The top surfaces of these pieces of trim are prone to rot. The rotted wood eventually allows water penetration at the joints. Horizontal surfaces should be kept well stained or painted, should be slightly sloped so water will drain off, and should be caulked where they meet vertical surfaces.

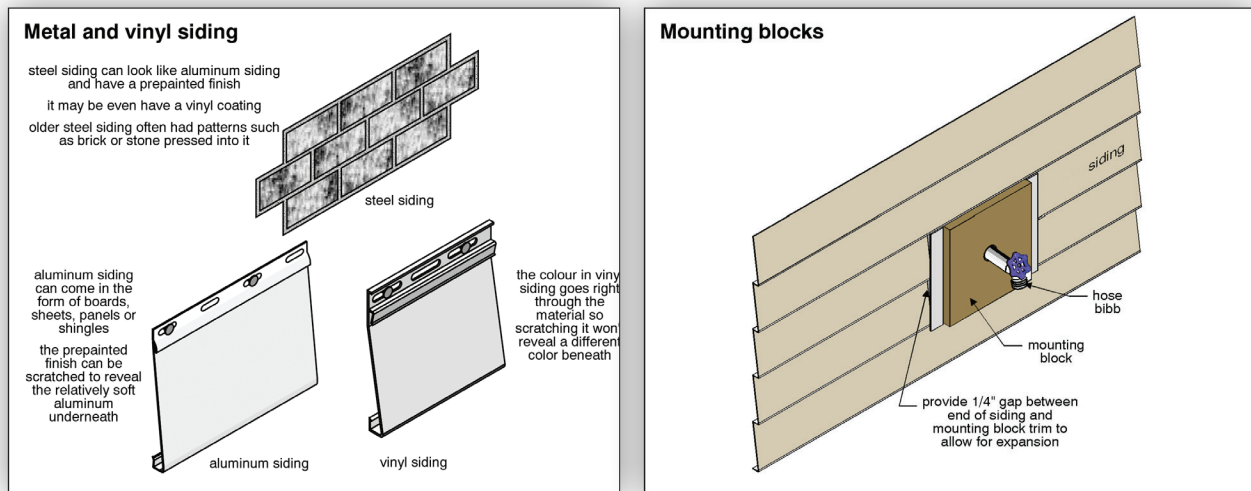
DESCRIPTION A variety of metal sidings are available. They can be boards or panels, with a variety of surface treatments, often intended to mimic wood. Some are installed vertically, while others are installed horizontally. The most common material is aluminum although steel is also used.

Metal sidings usually have a baked-on enamel finish and, generally speaking, the painted surfaces stand up well. However, some lower quality or older sidings tend to fade and chalk.

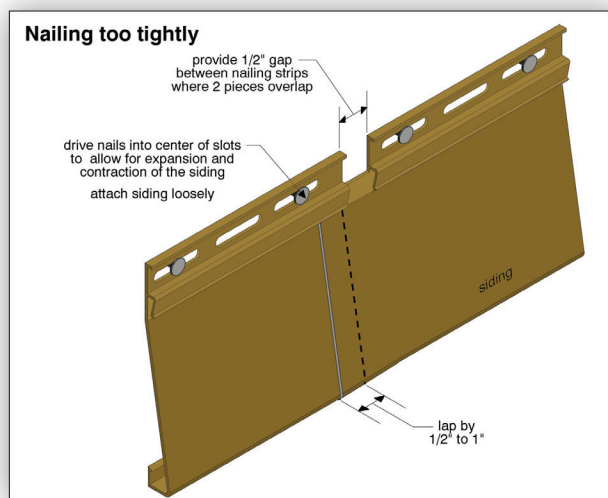
DENTING/BUCKLING Metal sidings are prone to denting (particularly aluminum). Damaged sections can be replaced on an individual basis. Metal sidings expand and contract with changes in temperature. It is not uncommon to hear expansion noises when sunlight warms a wall of the house. Slots in the siding accommodate the nails. As the siding expands and contracts relative to the substrate, the siding can slide. If the nails are secured too tightly, the siding may buckle.

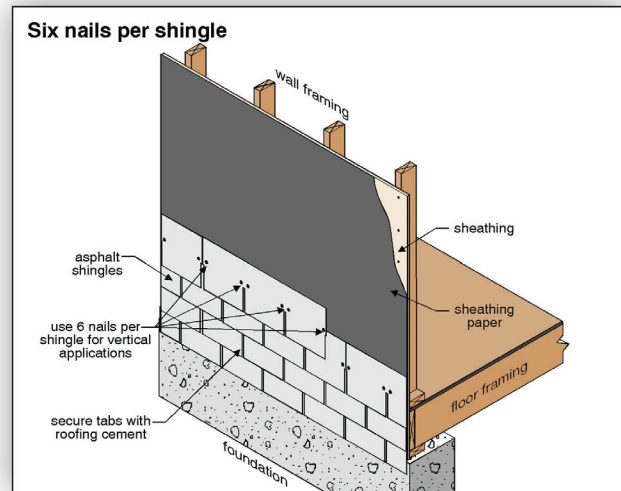
DESCRIPTION Asphalt roofing shingles are sometimes used as siding. See the Roofing chapter for a description of asphalt shingles. Where roofing shingles are typically secured with four nails or staples per shingle, six fasteners per shingle, six fasteners per wall shingle is typical.

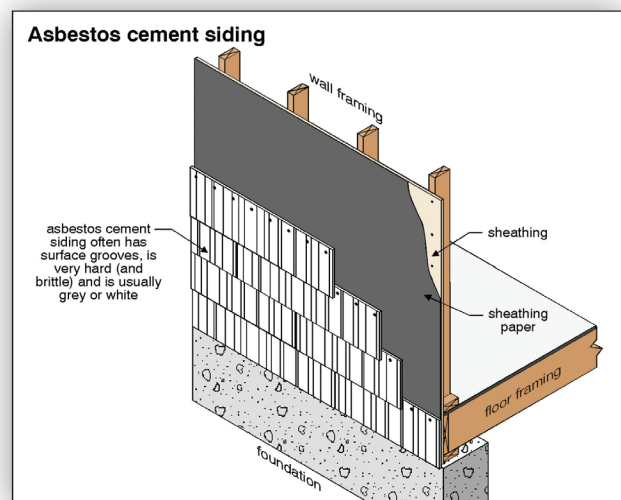
DESCRIPTION Fiber cement siding comes in shingle, plank and panel form. This is a strong, rigid siding that typically performs well. Older versions used asbestos as the fiber and were called asbestos cement siding.

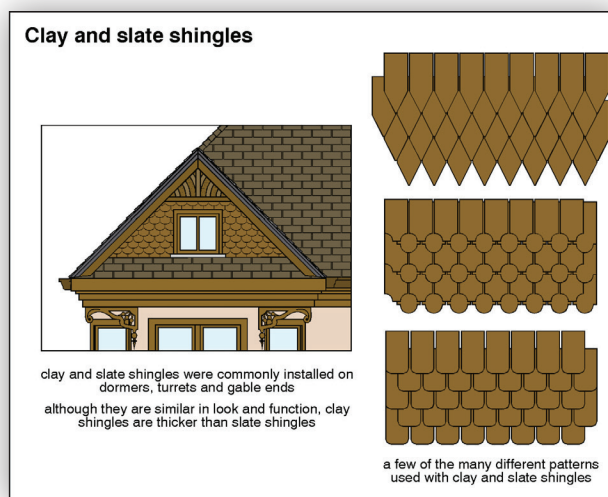
CRACKED/ BROKEN These shingles will easily last 100 years; however, they are brittle and subject to mechanical damage.

FAILED FASTENERS Clay tile and slate can often last a long time, but the nails that hold them in place rust, allowing the tiles/slates to slip out of position. Patching can be undertaken; however, it is often difficult to match the color and texture. The general rule is that if more than ten to fifteen percent of the tiles/slates are damaged, an alternative siding material should be considered.

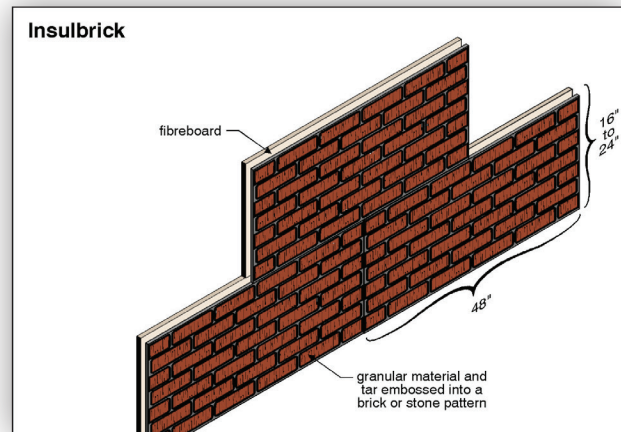
DESCRIPTION Despite its name, Insulbrick has very little insulating value. Various types of Insulbrick were commonly used from the 1930s to the 1950s. Insulbrick can be considered the forerunner to aluminum siding.

Insulbrick consists of a fiberboard sheathing coated with tar and sprinkled with granular material. The surface is embossed to look like brick, or sometimes stone.

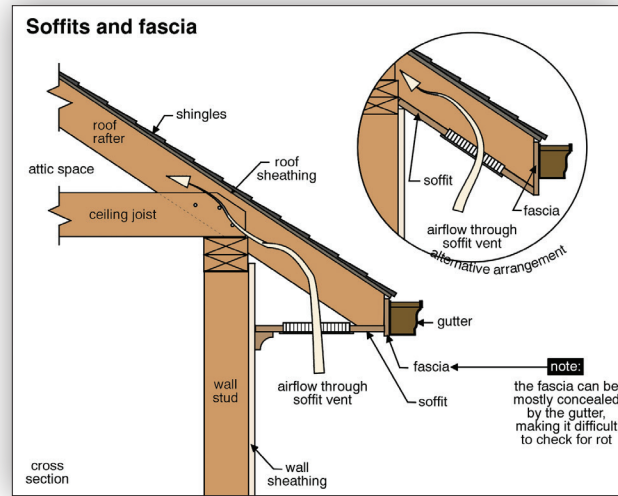
DESCRIPTION The purpose of doors and windows is apparent. We will focus on door and window trim here. Doors and windows are discussed in the Interior chapter. The trim on the exterior of a house helps protect the structural components from weather, prevent the entry of vermin, cover joints at changes in material or direction, and improve the appearance of the house. Trim is most often wood, vinyl or aluminum, although other materials, including stone, are also used.

Trim is usually found around doors and windows, and at the eaves. The two most common components of the eaves are soffits and fascia. The soffit is installed horizontally, and covers the underside of the eaves. The fascia is a vertical component at the edge of the eaves. Gutters are often fastened to the fascia.

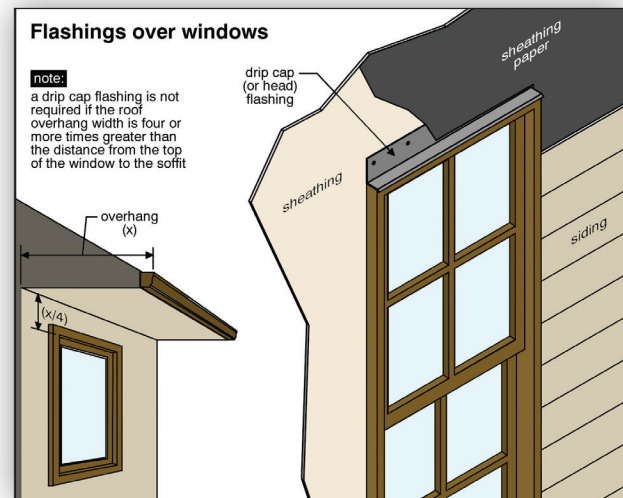
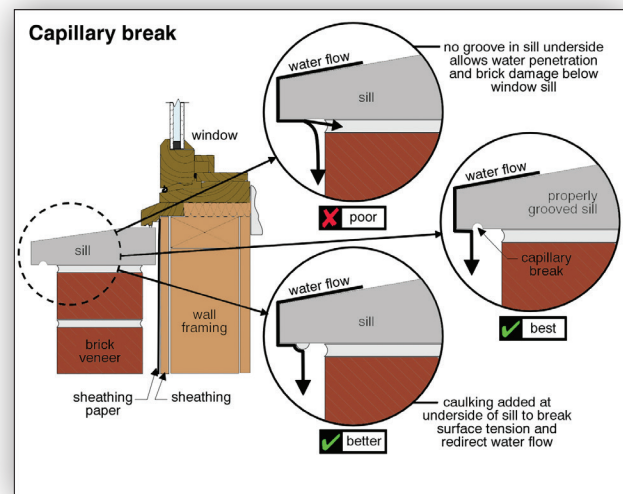
DESCRIPTION Some exterior doors and windows project out horizontally from the wall surface. Water can collect on the top, rotting the trim and leaking behind it. Metal flashings are often provided in these areas. The exposed edge of the metal flashing is bent out to prevent water from dripping on the surfaces below. The flashing tucks up behind the siding above or is let into a mortar joint in brick construction. (Most windows in masonry houses do not require flashings because the window frames are recessed.)

Flashing is not required where the opening is protected by a roof overhang. As a general rule, if the distance from the window or door to the overhang is less than one-quarter of the overhang width, no flashing is needed.

SILL SLOPE Door and window sills should be sloped so that water drains away from, rather than toward the door or window. The sill should project far enough out so that water can drip off without wetting the area below. Good design incorporates a capillary break (groove or projection on the underside of the sill), which prevents the water from being drawn back into the siding by capillary action.

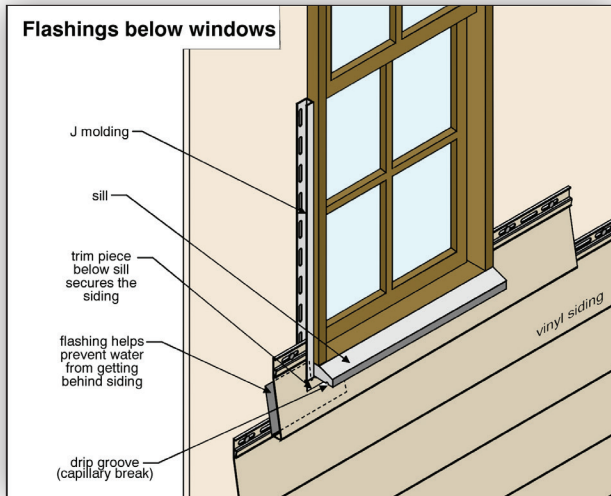
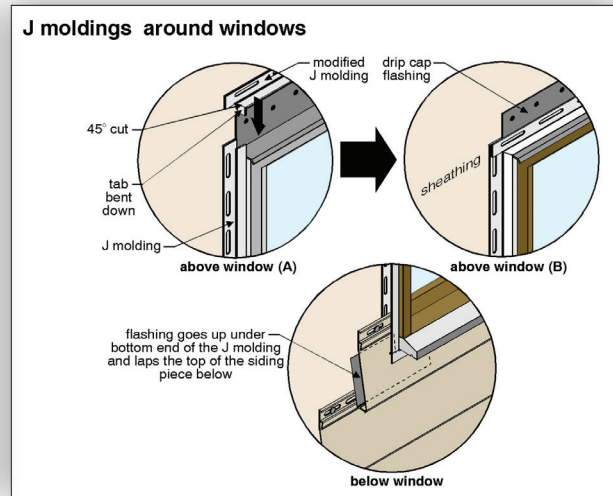
PAINT/ROT/ Wood components rot if water does not drain freely away or if maintenance is poor. Flashing, **LOOSE/MISSING/** window sill and door threshold details are common problem areas. If doors and windows are **DAMAGED/** not fit and maintained properly, water can get into the wall system and damage the **WATER ENTRY** structure.

LOW THRESHOLD Door thresholds should be at least six inches above exterior grade, steps, decks or landings in climates where snow may accumulate.

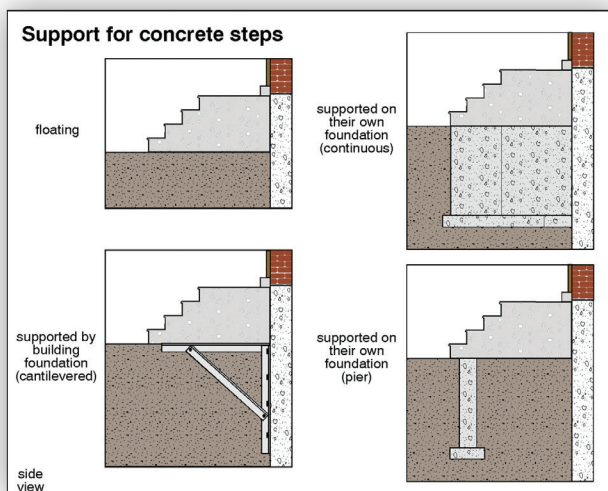
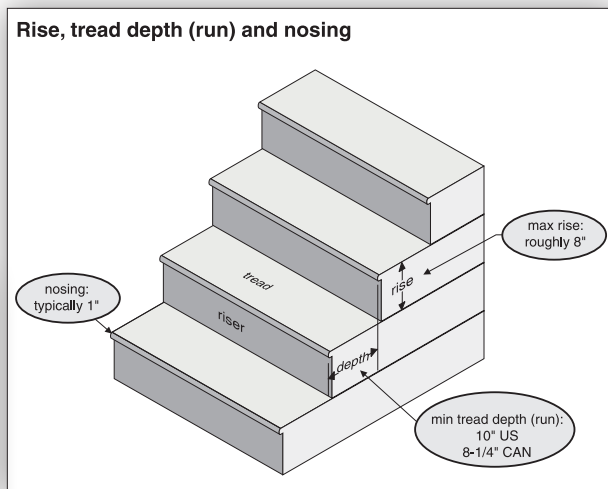
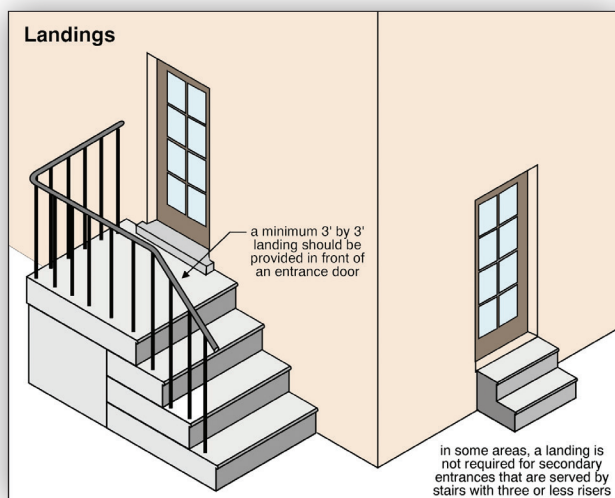
DESCRIPTION Steps are commonly made of wood, concrete or masonry. Wood steps should be sturdy enough not to flex with typical traffic. One to 1-1/2 inch thick treads are normally fine, depending on the spacing of the stringers that support the treads.

Concrete steps may have a footing to avoid settling and frost heaving. They may also be attached to the building, or may be floating prefabricated concrete units.

RISE AND RUN Regardless of the material used, all steps should be easy to negotiate. Steps should have at least 10-inch deep treads and be no more than roughly 8 inches high. Steps should be sloped slightly to drain water.

LANDINGS When stepping through a door, it is easier to have a landing to step on than stairs. Landings are typically at least three feet by three feet. Landings should be six inches below door thresholds so water does not leak in through the door.

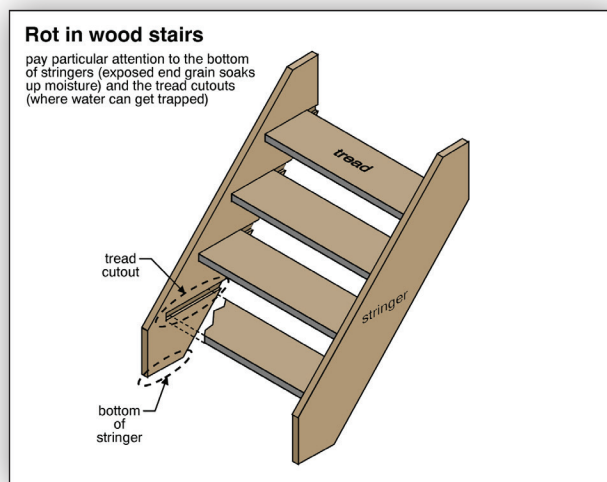
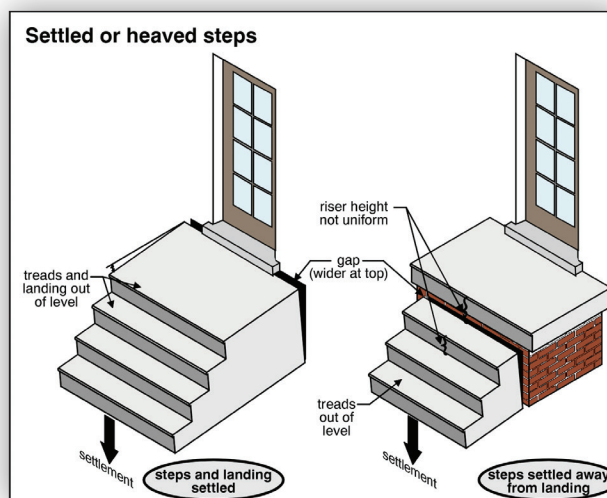
ROT/INSECT DAMAGE The most common problems associated with wood steps are rot and attack by insects. Direct wood/soil contact should be avoided to minimize damage by rot or insects. Carpeting on wood steps retains moisture and promotes rot. Plywood is not a good material for steps, since the layers of glue tend to trap moisture, creating rot and delamination of the plywood.

SPALLED OR DAMAGE Concrete steps tend to crack or spall. Avoid using salt on these surfaces. Some steps are constructed of brick. Certain types of brick should not be in contact with the soil as they absorb a considerable amount of moisture and suffer deterioration from freeze/thaw action.

SETTLED OR HEAVED This is a common problem with concrete steps.

RISE/RUN/ UNIFORMITY/ LANDINGS Steps should be uniform so that they can be traveled easily. The rise should not be more than 8 inches, and the run should be at least 10 inches. Landings should be provided where needed at the top of steps, so people do not get knocked over by opening doors.

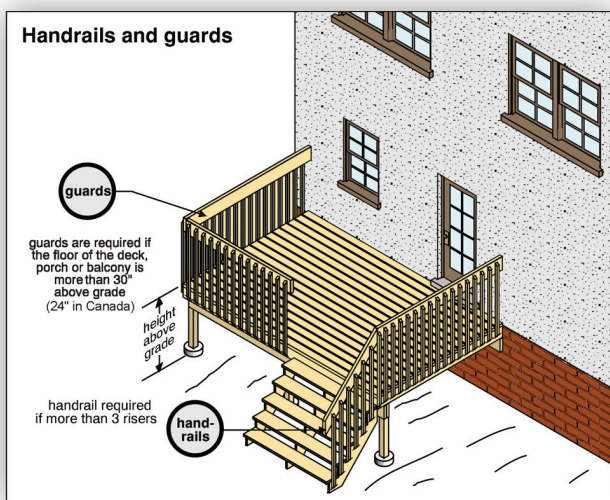
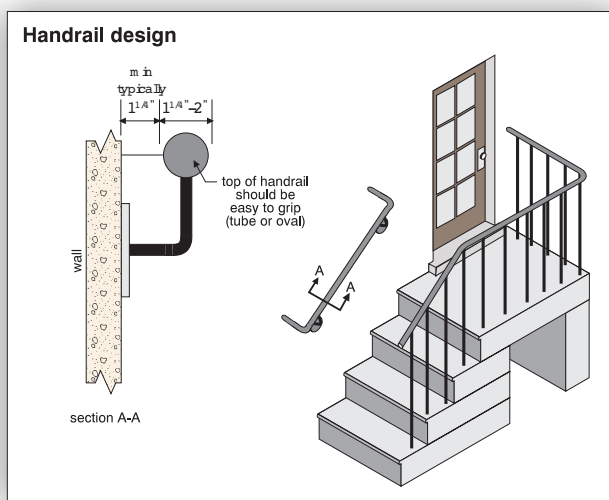
DESCRIPTION Railings should be provided wherever there is a danger of falling, or when the deck is more than 24 to 30 inches off the ground. Railings should be sturdy enough to resist a person's weight and openings in the railing should be small (four inches or less) so children cannot crawl through. Railings should be high enough to provide adequate protection; 36 inches is common. On wide stairways, railings should be provided on both sides. Railings should not prevent drainage of water off porches, decks and balconies. They should not have horizontal members that children may climb.

Railings should be easy to grab to help prevent a fall.

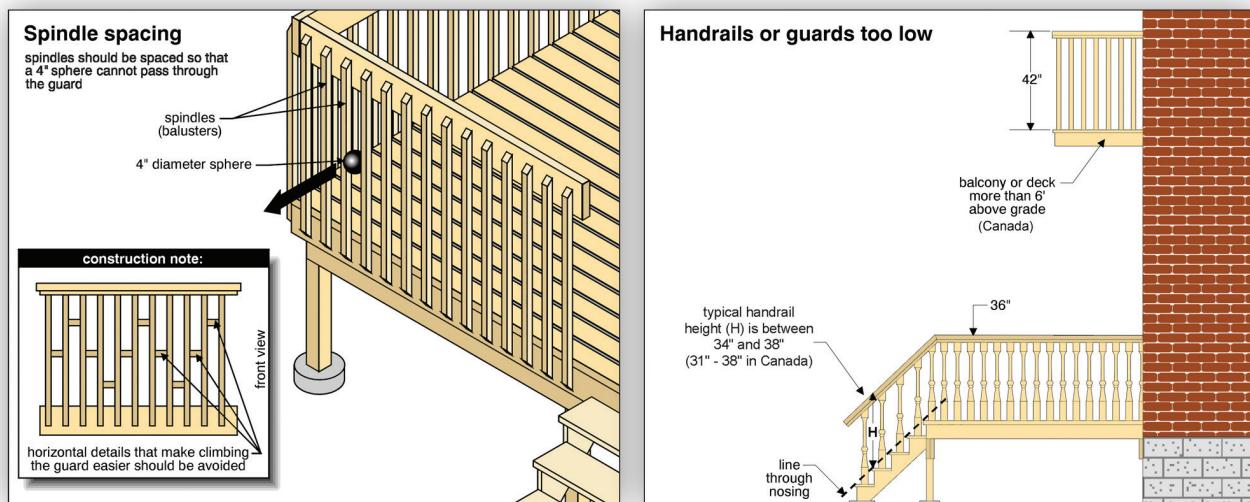
- MISSING/ LOOSE/ ROT/ RUST** The most common problem is missing railings. Railings are also often loose, rotted or rusted. Many railings are not strong enough or not well enough secured to prevent someone falling through the railing. This is difficult to determine without damaging the railing.
- POOR DESIGN** Railings may be too low, have openings that people may fall through, or have horizontal members that make it easy for children to climb the railings. These are safety issues.

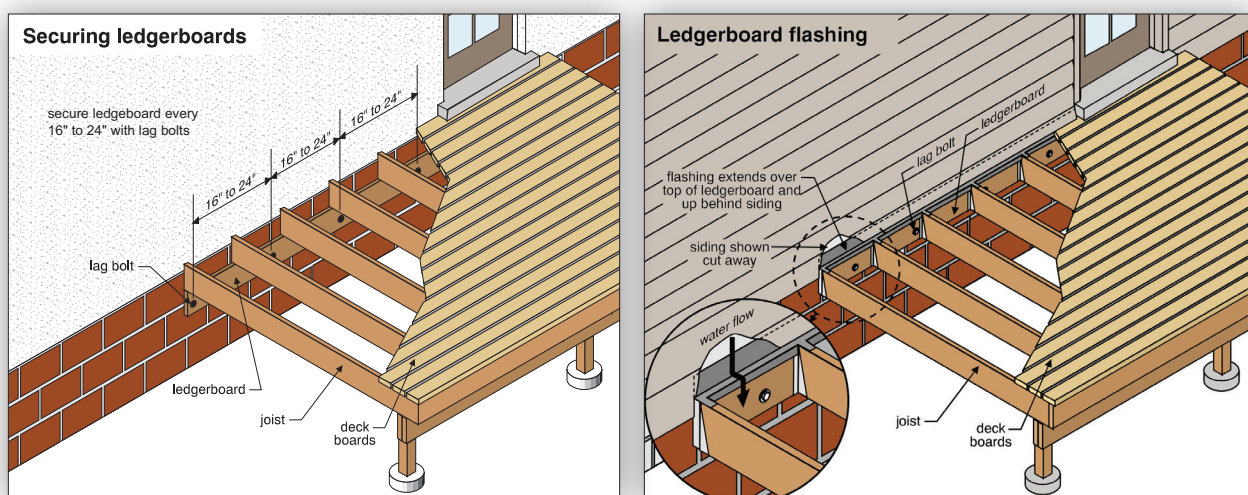
SAGGING The most common problem with porch beams is that they are undersized (overspanned), resulting in sagging. Overspanned joists result in a springy floor system. Additional supports can often be added to stiffen structural members, or they can be enlarged or replaced.

END BEARING Porch beams are often poorly supported when columns have been removed or have shifted. Joist and beam ends should rest on 1-1/2 inches of wood support, or on three inches of concrete or masonry support, respectively.

DECKS HAVE TO BE WELL SECURED TO BUILDINGS Joists should be well secured to the building. A board that is lag-bolted to the structure may support the joists from below. Joist hangers may also be used. Many serious injuries have resulted from improper deck support. This detail should also be protected with flashing so the water does not get into the wall system. After construction it is difficult to determine whether support is adequate. Alternatively, the deck may be completely detached from the building.

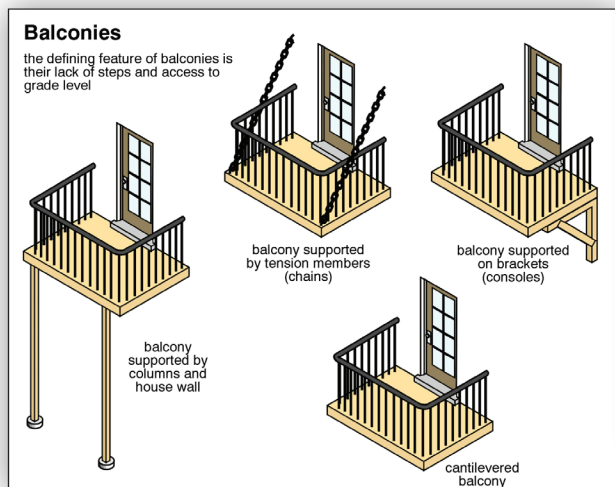
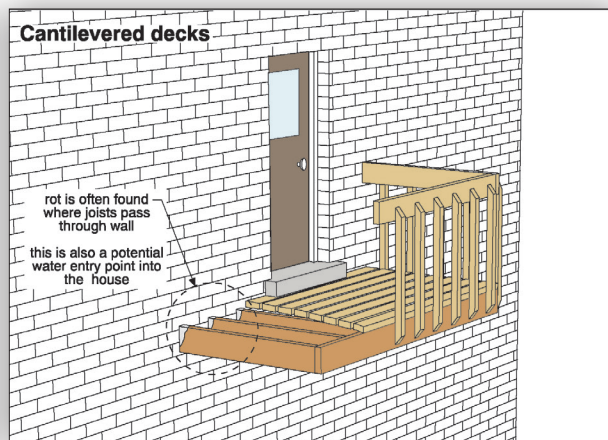
ROT Trapped moisture in a porch or deck structure rots wood beams or joists, weakening the structure and providing an ideal environment for insects. Many porch beams are concealed in a roof structure and are not visible, but years of roof leaks cause beams and joists to rot and the roof system to sag.

CANTILEVERED DECKS AND BALCONIES – ROT These have special problems, usually related to the support joists that extend through the building wall. These structures may be weak due to poor initial construction, or the joists may rot where they go through the building wall. The building wall may also rot as a result of water penetration around cantilevered joists.

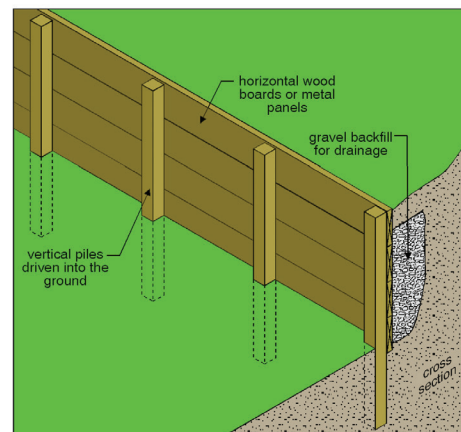
Pile retaining walls (shoring)

WOOD WALLS Wood retaining walls are common. Horizontal members are tied back into the soil with anchors (tie-backs) – wood members heading back into the soil. Tie-backs are staggered through the wall system to provide resistance to movement. In some cases, “dead men” are attached to the ends of the anchors to help secure the anchors. These horizontal members run parallel to the retaining wall itself. These walls do not extend below the frost line.

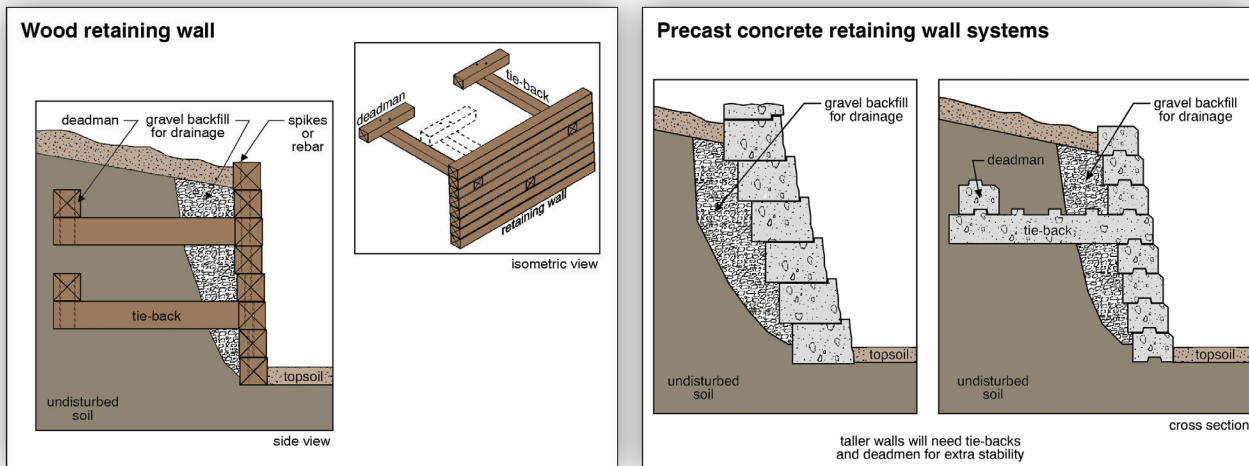
PREFAB WALLS Precast concrete wall systems with interlocking sections also use tie-backs and dead men.

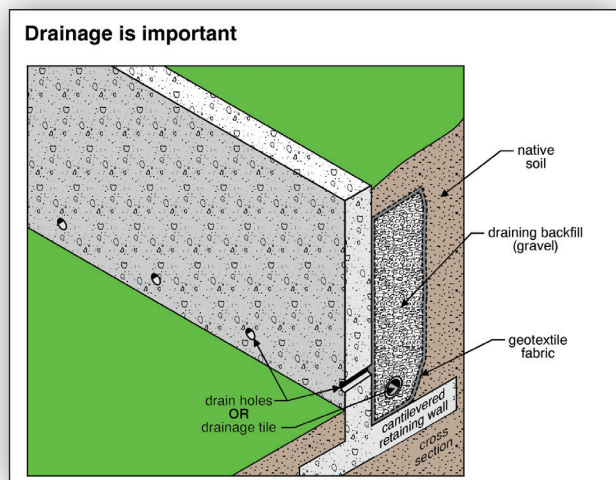
MOVEMENT / CRACKED/ROT The single biggest enemy of retaining walls is water. Saturated soil puts pressure on retaining walls. If saturated soil freezes, expansion forces can be significant. Walls may move as a single unit, leaning away from the hill or may crack and break apart. Water also promotes rot of wooden retaining wall systems.

POOR DRAINAGE Well-built retaining walls have a layer of gravel behind the wall and weep/drainage holes at the bottom. We don't want water trapped behind the wall. Open wall systems with wood timbers for example, have enough natural openings that drainage holes are not needed.
