INTERIOR

INTRODUCTION

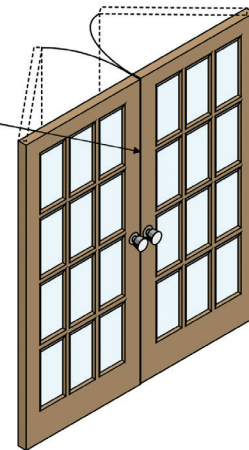
true French doors meet at the middle with no mullion or frame - this compromises weathertightness and security look for evidence of problems at the meeting point of the two doors
