Roofing/Flashings/ Chimneys

1.0 Roofing

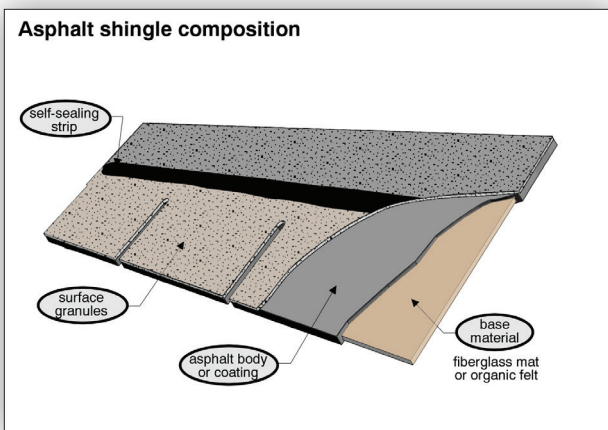
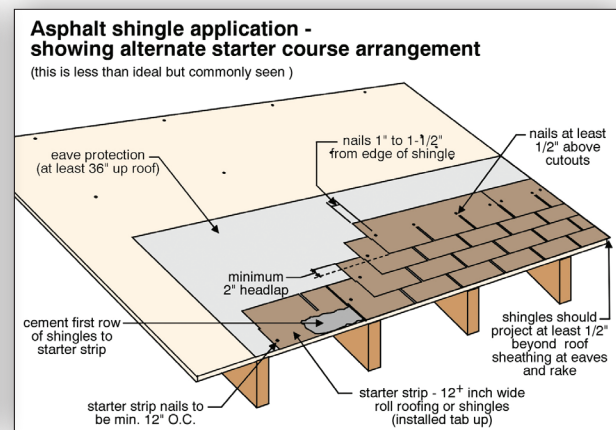
DESCRIPTION Asphalt shingles (also called composition shingles) are the most common roofing material used today. The shingles consist of asphalt-impregnated felt paper or glass fiber mats, coated with a layer of asphalt and covered with granular material.

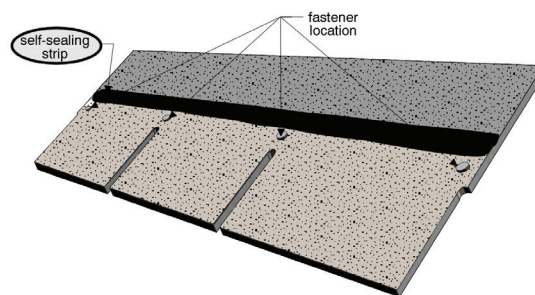
Self-sealing tabs

SELF-SEALING SHINGLES Most asphalt shingles have self-sealing strips, a strip of asphalt running across the middle of the shingle. The shingle above overlaps the lower shingle, with the bottom edge covering this strip. When the sun warms the roof surface, the two shingles stick together. This protects the shingles from being blown off in a heavy wind. Shingles installed in cold weather do not seal themselves until the weather warms up. They are vulnerable to wind damage during this period.

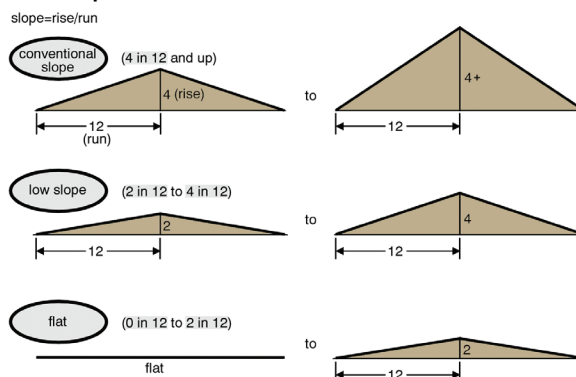
Roof slopes

The difference between sloped roofs and flat roofs is the slope, or pitch, of the roof. The slope is described as a ratio of the vertical rise over a set horizontal run. The run is always defined as 12 feet. Therefore, a 6-in-12 roof would have a vertical rise of 6 feet over a horizontal distance of 12 feet. Roofs with a slope greater than 4-in-12 are considered **sloped**. Roofs with a slope between 4-in-12 and 2-in-12 are considered **low slope**, and roofs with a slope less than 2-in-12 are considered **flat**.

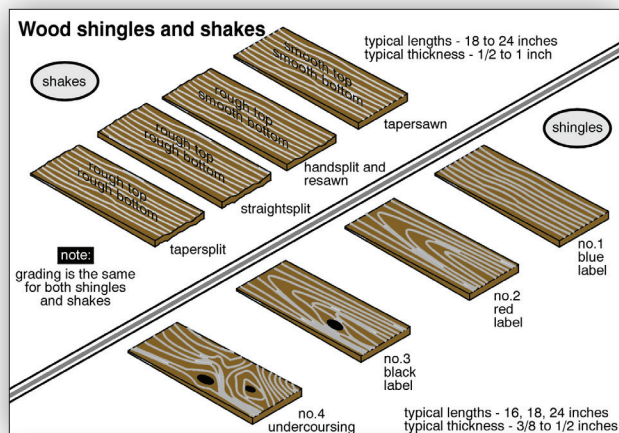
DESCRIPTION Wood shingles are machine cut. They are typically smaller, thinner and more uniform than wood shakes. Traditionally, wood shakes were hand split or mechanically split, although machine-sawn shakes are also available. Wood shakes are thicker and split shakes have a much more uneven surface. Most wood shingles are cedar; however, redwood and pine are also used.

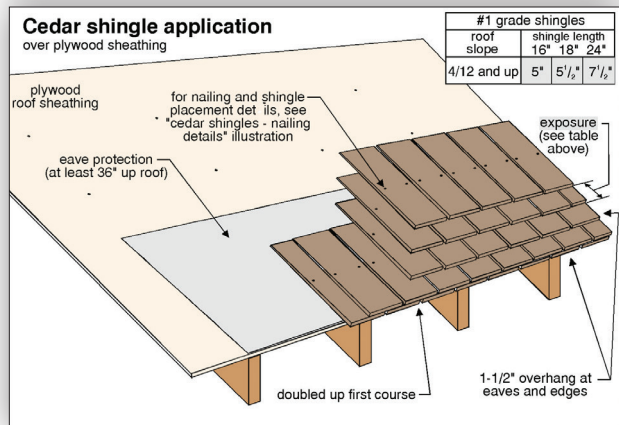
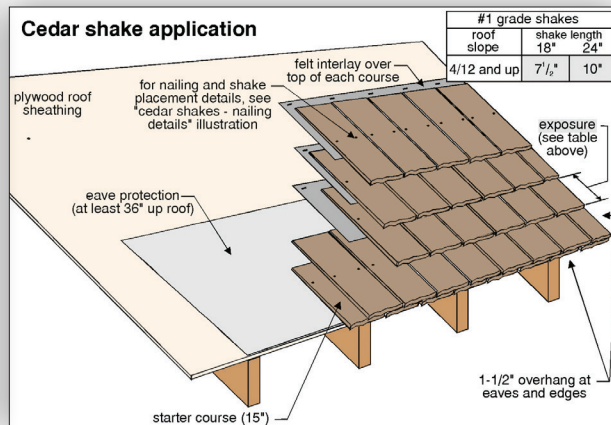
Shakes may be up to 24 inches long, with no more than half of the shingle exposed. Shakes typically have heavy building paper interwoven with the shakes to prevent wind driven rain and snow getting into the roof between the shakes.

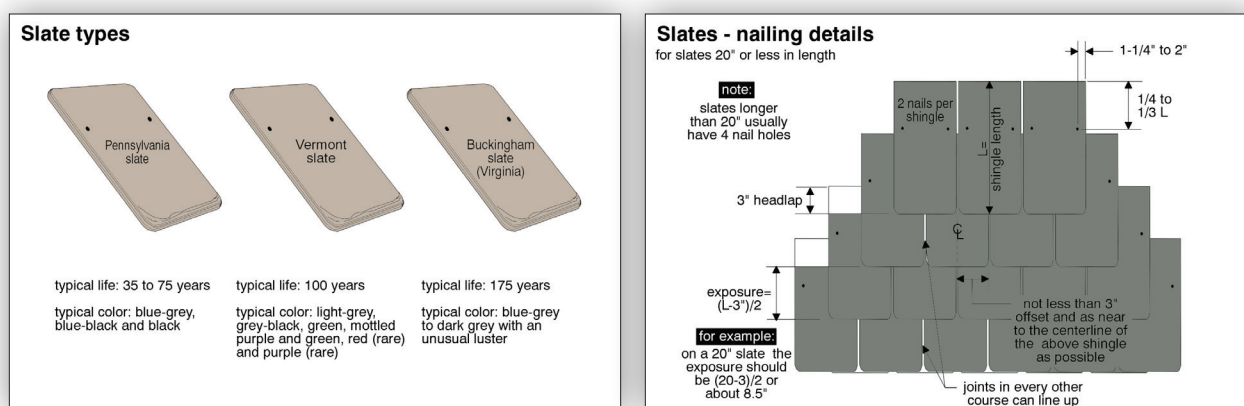
WEAR FACTORS While some slates are of low quality and tend to flake and shale, the biggest problem with slate roofs is often the nails holding the slates in place. With time, the nails rust and allow the slates to slide out of position. Copper and stainless steel nails last longer than galvanized nails. Once one slate has come loose, water rusts the nails holding nearby slates in place. Good maintenance is important on an older slate roof. While it is not common practice, slate roofs should be inspected and repaired at least annually. Slates that have slipped are re-secured, and slates that have cracked or split as a result of mechanical damage are replaced. As a general rule, roof replacement makes sense when more than 10% is in need of repair.

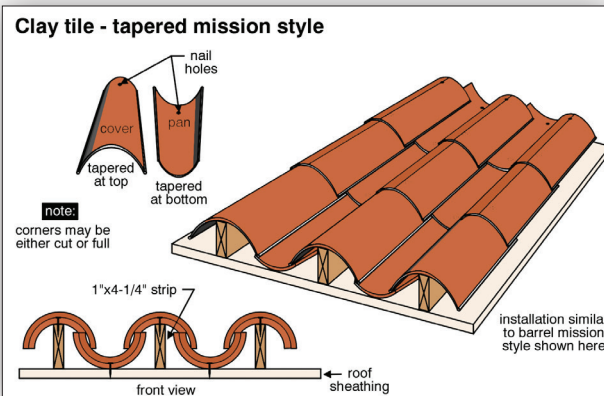
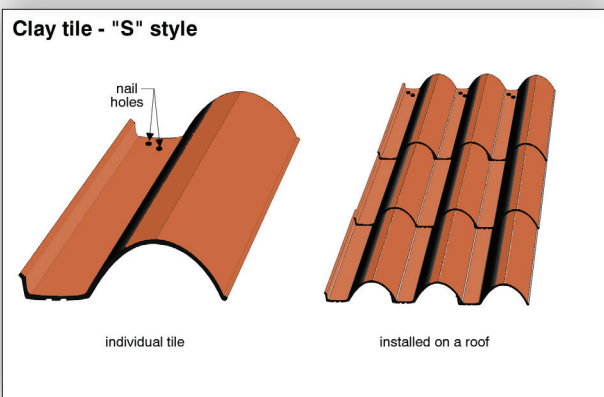
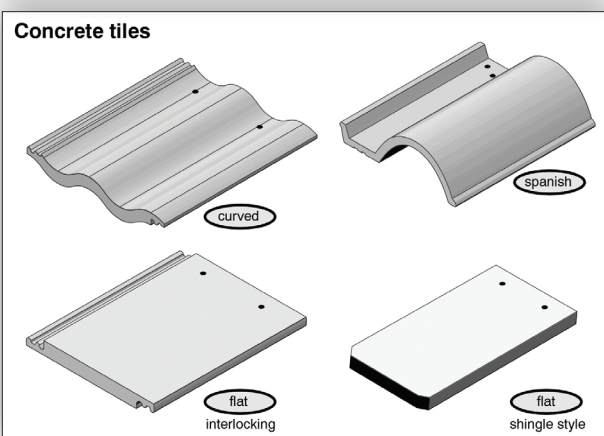
Concrete and clay tiles can be used on a slope as low as 4-in-12 but as with most roofing systems, steeper is better. Many current standards recommend 6-in-12 as a minimum. The amount of overlap (exposure of the tiles) varies depending on the roof system. Systems with a limited overlap are prone to leakage during wind-driven rains. Many loose-fitting concrete and clay tile roofs have a watertight membrane such as built-up roofing below, to act as a backup. The tiles provide protection against fire, ultraviolet light and mechanical damage.

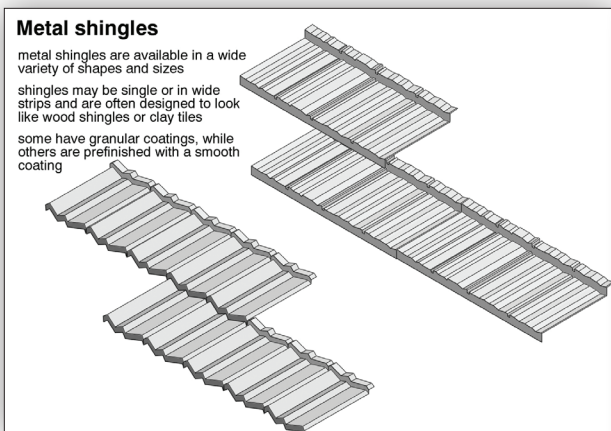
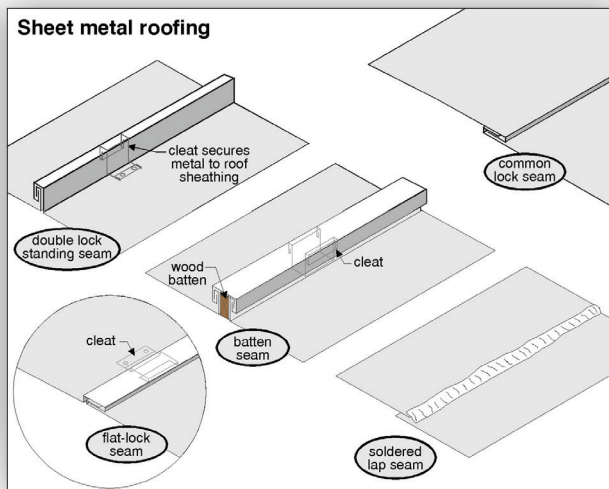
DESCRIPTION There are many types of metal roofs. Copper, galvanized steel, pre-painted or coated steel, terne and tin are common. Some metal roofs have a granular surface embedded in the finish. Most metal roofs (particularly copper) are expensive systems, but they last longer than asphalt shingles. They can be installed as sheets or shingles. Sheets and shingles can be used on sloped roofs; however, flat roofs are only covered in sheets. Sheet metal roofs can have different types of seams including soldered and crimped.

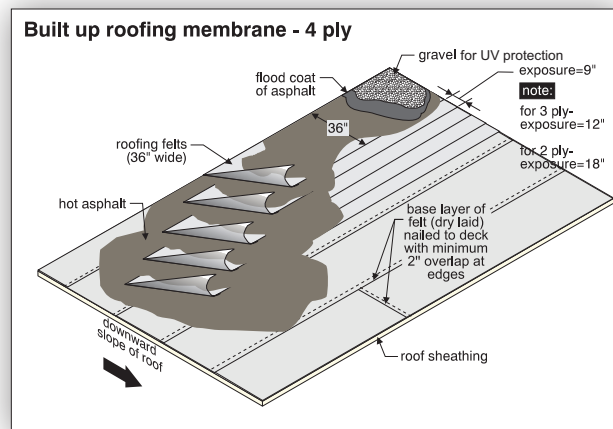
DESCRIPTION Built-up roofs are commonly called tar-and-gravel roofs, even though most modern systems use asphalt instead of tar. They are a multi-ply roofing system, consisting of two, three, four or even five plies of roofing felts with a mopping (coating) of asphalt between layers. A flood coat of asphalt is then applied over the top and covered with gravel to reflect ultraviolet light and protect the roof from mechanical damage. These roofs are still common commercially, but are being replaced residentially with newer systems that are faster and easier to install.

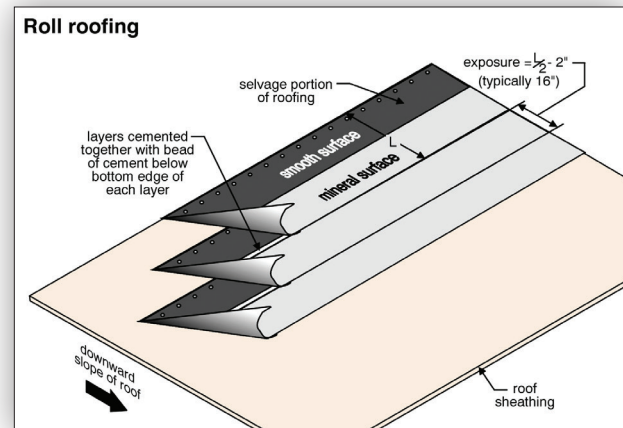
- DESCRIPTION** Roll roofing is sometimes known as selvage roofing. It typically comes in 18 or 36 inch wide rolls. It consists of the same material as asphalt shingles (asphalt impregnated felts covered with granules). The surface may be completely covered with granules or only 50% covered (designed for two-ply application). The material is most often installed as a single ply with very little overlap.
- LIFE EXPECTANCY** This low quality roof covering has a limited life expectancy of five to ten years. There is an exception to this rule. Sometimes, roll roofing is used to protect a built-up roof covering as an alternative to gravel. From a visual inspection it is impossible to tell. Modified bitumen roofing can be very similar to roll roofing in appearance. The home inspector may not be able to determine the roofing material.

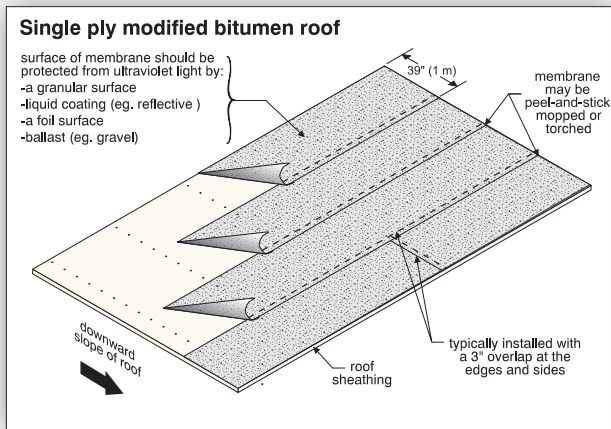
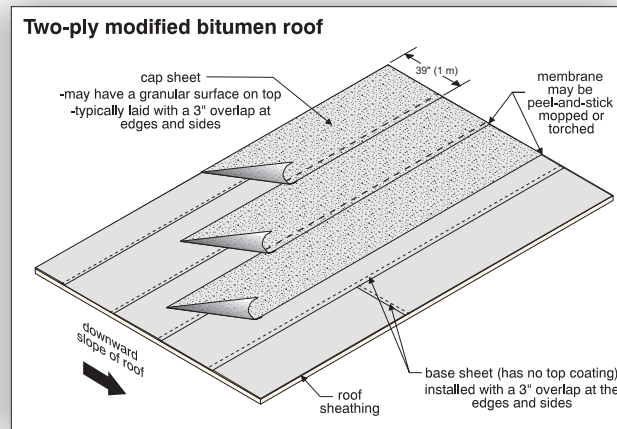
DESCRIPTION Modified bitumen membranes are an alternative to built-up roofs. Polymer-modified asphalt is bonded to fiberglass or polyester reinforcing to form sheets of roofing membrane. Rolls of this rubberized asphalt membrane are typically torched onto the roof, bonded (mopped in) to the roof with hot asphalt, or adhered to the roof using a peel-and-stick backing. The surface of the membrane may be protected from ultraviolet rays by a coating of granules, foil, or paint. The sheets are approximately 40 inches wide and usually overlap each other by four inches. Modified bitumen roofs may be installed as either a single or double layer system.

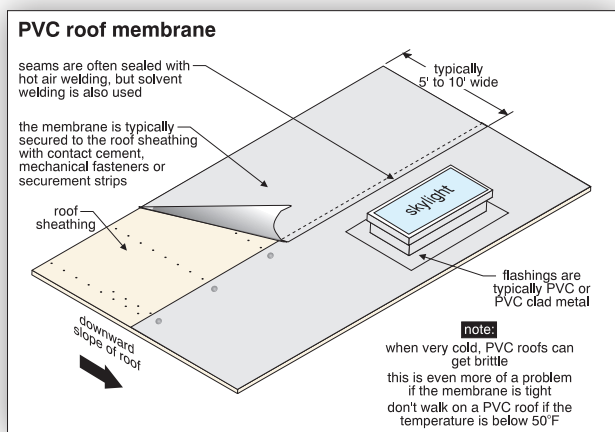
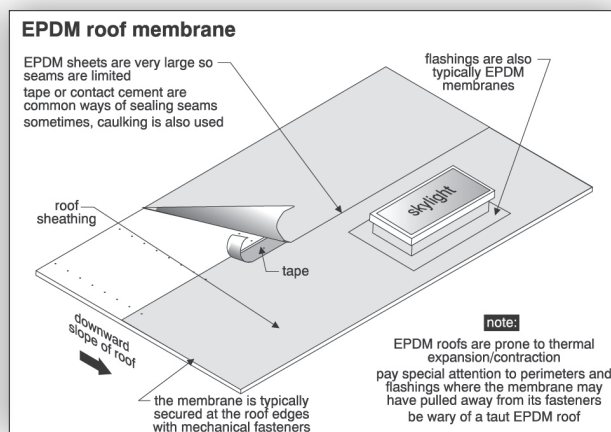
Plastic, or thermoplastic, membranes include polyvinyl chloride (PVC) and thermoplastic polyolefin (TPO). Rubber or thermoset membranes include ethylene propylene diene monomer (EPDM) and butyl rubber (polyisobutylene – PIB).

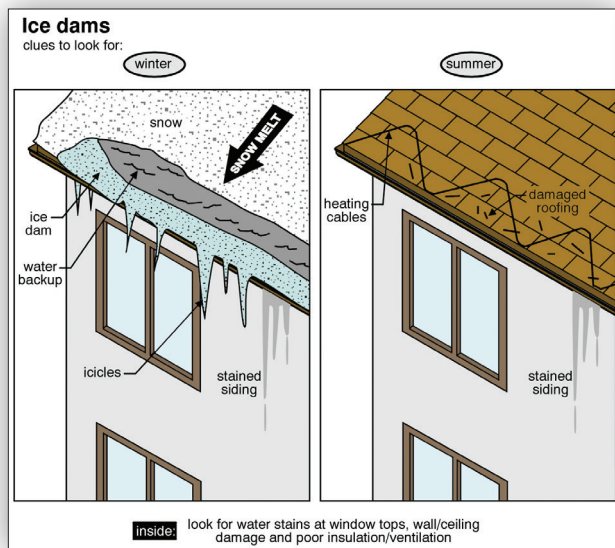
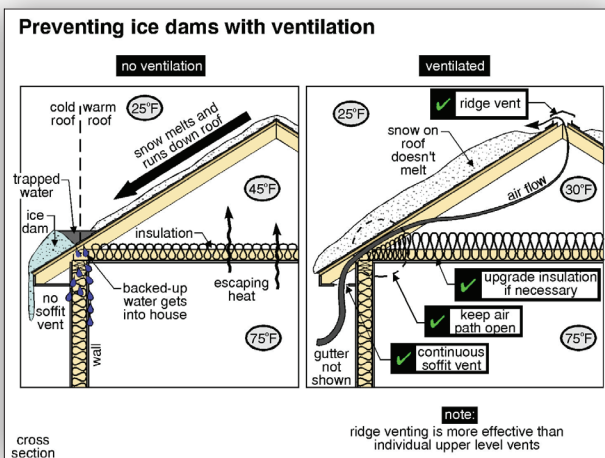
Ice damming occurs when snow and ice collect, often at the eaves. Melting snow on the upper portion of the roof, warmed by the attic, cannot drain properly as it is trapped behind the still-frozen dam at the cold eaves. If the dam is large enough, water will back up under the shingles and leak into the eaves, exterior walls or building interior.

SOLUTIONS Effective solutions to ice damming problems are increased attic insulation and ventilation. These two measures reduce the attic temperature so snow over the heated portions of the house does not melt so quickly.

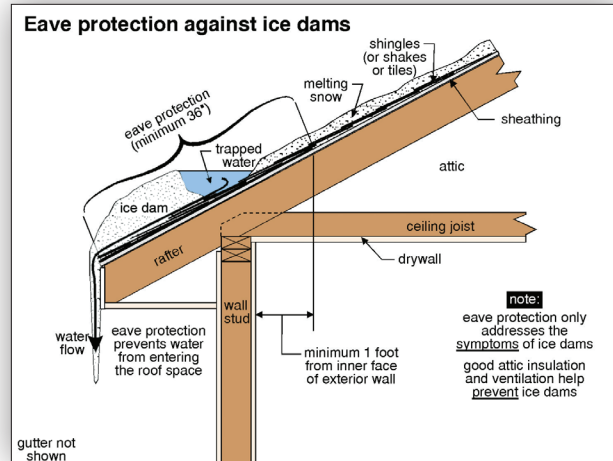
EAVE PROTECTION When re-roofing, eave protection should be provided along the lower part of the roof, from the edge up to roughly two feet beyond the exterior wall. Eave protection is often a waterproof rubberized asphalt membrane. In extreme climates, metal roofing is sometimes used on the lower part of the roof. The metal is watertight and allows snow and ice to slide off the roof. A metal or vinyl drip edge flashing will help protect the lower edge of the roof sheathing and direct water into the gutter.

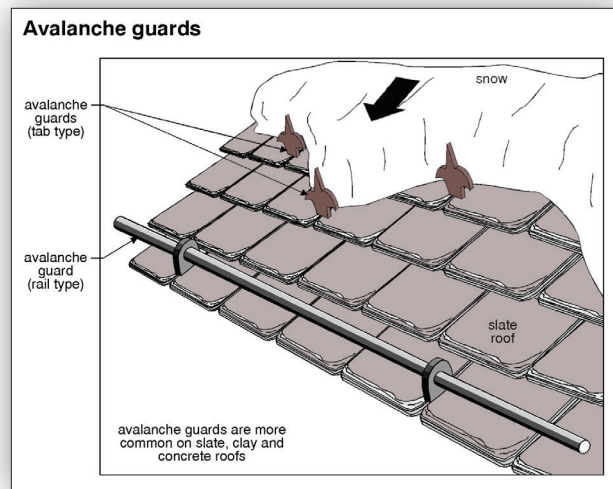
AVALANCHE GUARDS Small metal devices that protrude above roof surfaces (usually on the lower section of roof) are designed to hold snow on the roof and prevent avalanches. These are common on slate roofs and larger homes and commercial buildings. Some say these may worsen ice-damming conditions.

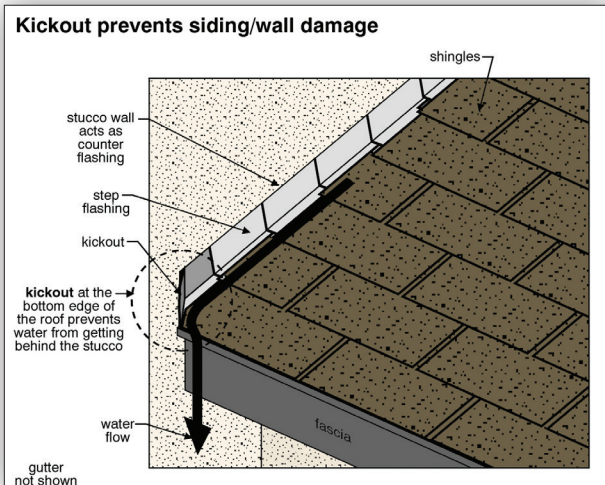
NO KICKOUT FLASHING This flashing should be provided at the bottom of the roof that is against the side wall. Where the flashing is omitted, water may get in behind the siding and cause damage to the wall around and below the bottom of the roof.

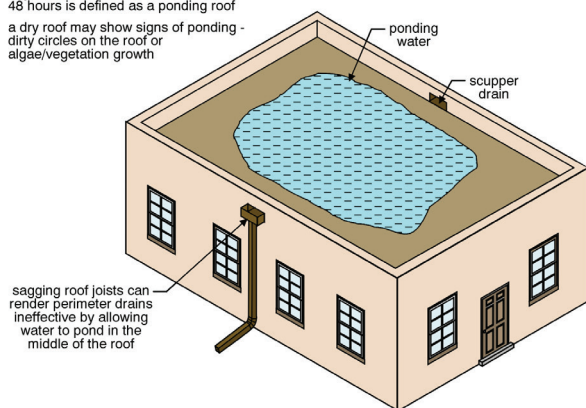
Ponding on flat roofs

any roof that still has water on it after 48 hours is defined as a ponding roof
a dry roof may show signs of ponding - dirty circles on the roof or algae/vegetation growth

PONDING ON FLAT ROOFS Ponding water on flat roofs reduces the life expectancy by as much as 50%. Flat roofs should not really be flat; they should have enough slope to drain water, usually described as 1 in 50 or 2%. We think that is cutting it pretty fine, and recommend more slope where possible.

While ponding is most often caused by inadequate roof slope, it may also be the result of missing or clogged roof drains. When leaks do occur, they do more damage if there is a large volume of water ponded on the roof.

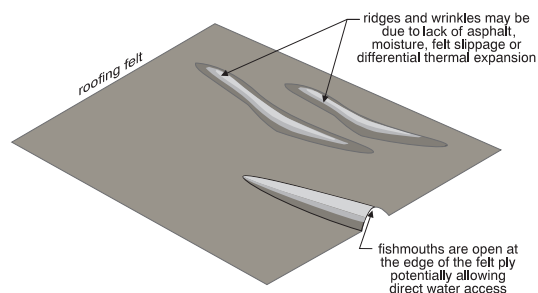
Ridging and fishmouths on flat roofs

BUCKLING, WRINKLING, OPEN SEAMS Buckling, wrinkling and open seams in membranes may be caused by poor installation, membrane slippage, thermal expansion or contraction, and moisture trapped in the roof. These conditions can lead to leaks as the membrane opens up or develops holes.

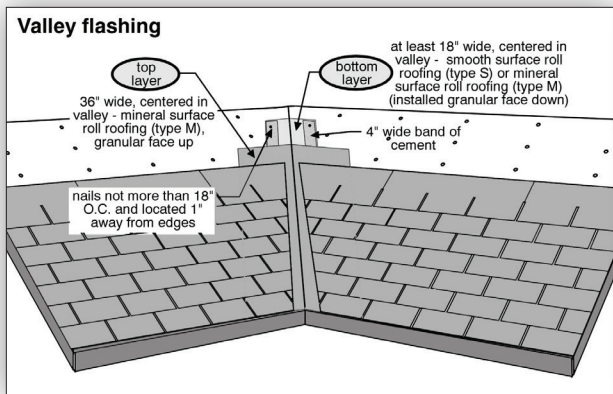
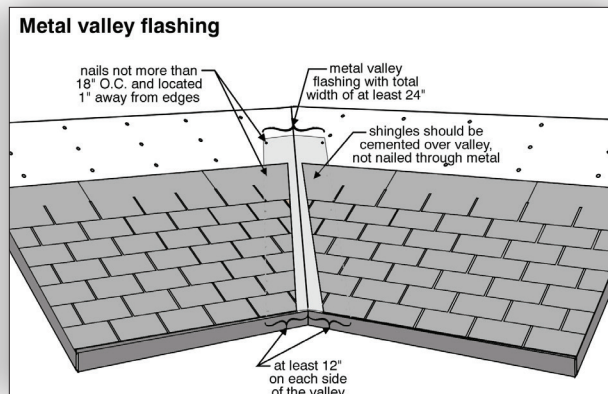
2.1 Valley Flashings

DESCRIPTION All valleys should have flashings. Metal valley flashings are better but more expensive than roll roofing. Where the flashing is visible, it is known as an open valley. Metal valley flashings are typically 24 inches wide; however, much of the material is hidden by the shingles. When roll roofing is used, two layers are installed; one being 18 inches wide, and the top one 36 inches wide.

VALLEY FLASHING ISSUES Valley flashings are often damaged by foot traffic or obstructed with leaves, twigs and pine needles, for example. Valleys may suffer ice dam problems in cold climates. Valleys that are too long at the bottom may allow water to overshoot the gutter. This allows water to collect against the foundation wall, and may lead to wet basements or crawlspaces.

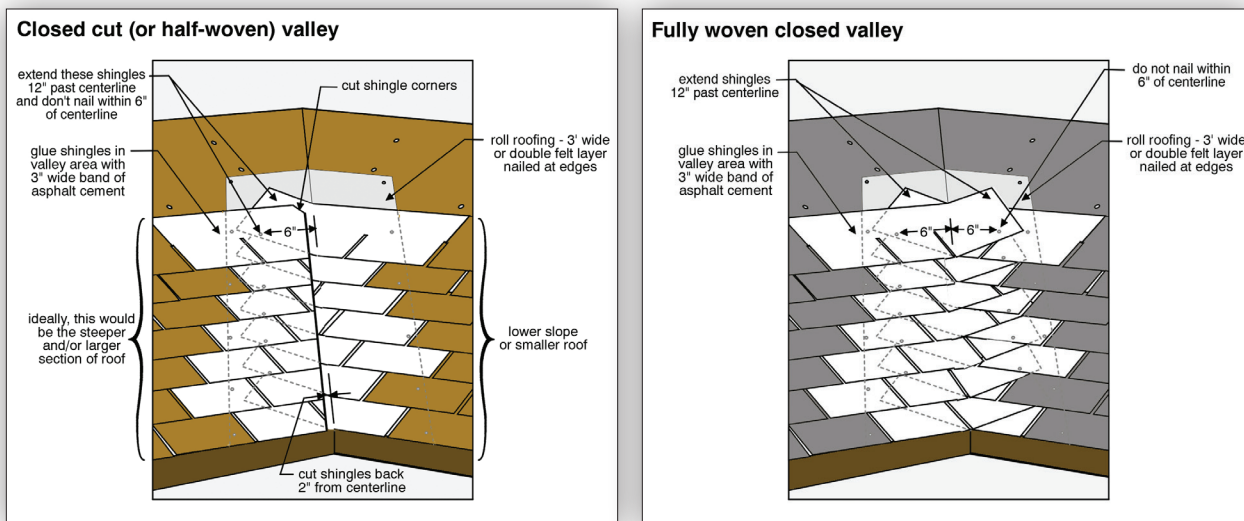
Sometimes a valley flashing is installed and then covered with shingles. This is called a closed valley. These may be closed cut or fully woven.

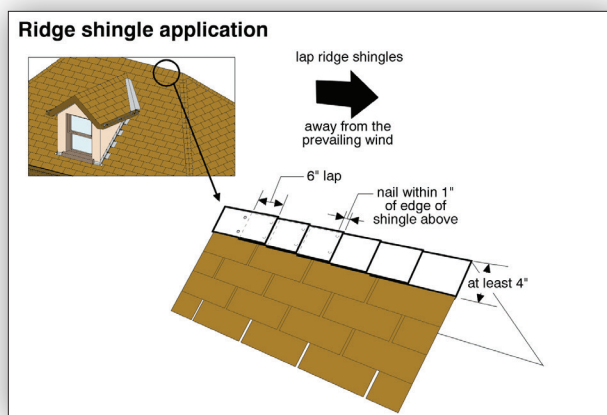
DESCRIPTION Flexible shingles (such as asphalt) are simply cut and bent over hips and ridges to make them watertight. Metal flashings are often used with brittle roofing materials (wood shingles, slate, and asbestos cement) at the ridges and hips. Flashings may also be made from the roofing material. On some roofs, the flashing is covered by a layer of shingles.

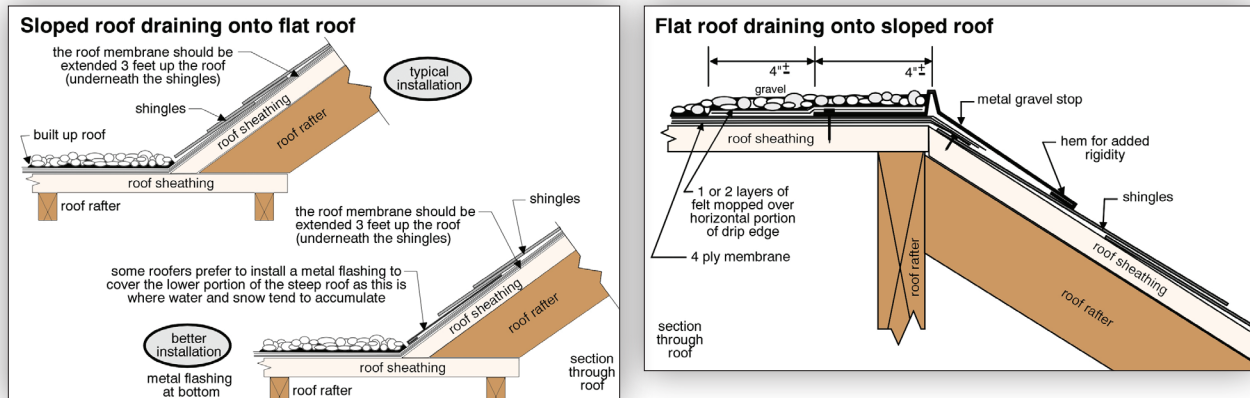
DESCRIPTION When the flat roof is below the sloped one, the flat roofing material is typically applied first and extended up the slope. The sloped roofing covers the flat membrane. There may be metal flashing used at the change in direction. When the flat roof is above the sloped roof, a metal flashing protects the top of the sloped roofing material. The metal flashing extends onto the flat roof and is covered by the flat roof membrane.

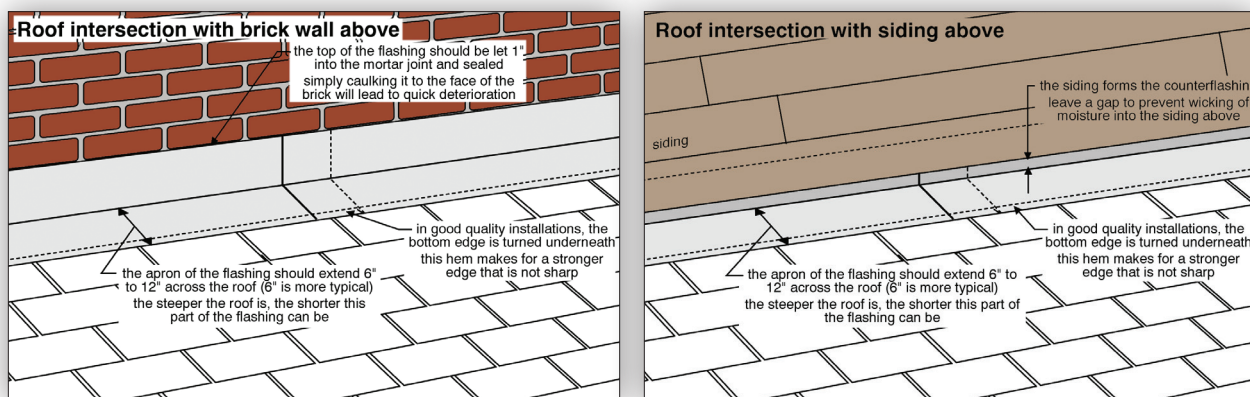
DESCRIPTION Special flashing is used when a roof intersects a wall. The flashing depends on the configuration and the roofing material. If the top of the roof meets a wall, a counter flashing can be installed over the roofing material. This metal skirt covers the top of the roofing material and extends up the wall behind the siding. On masonry walls, the metal flashing is let (embedded) into a mortar joint or sealed to the masonry surface with caulking (the less desirable approach).

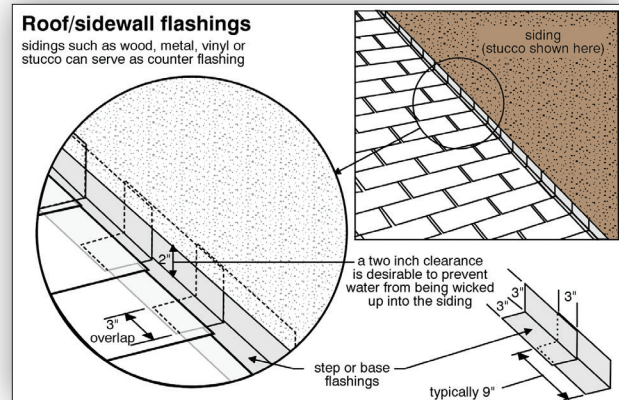
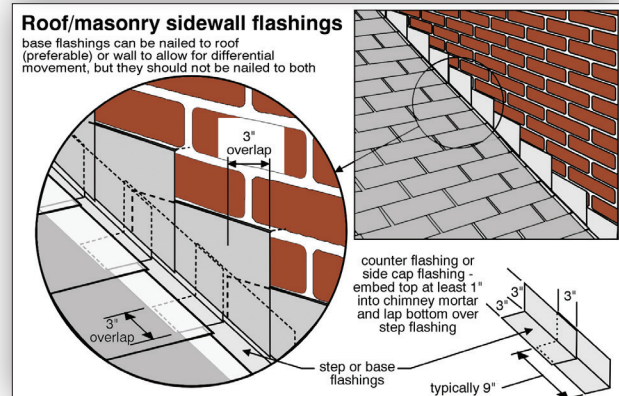
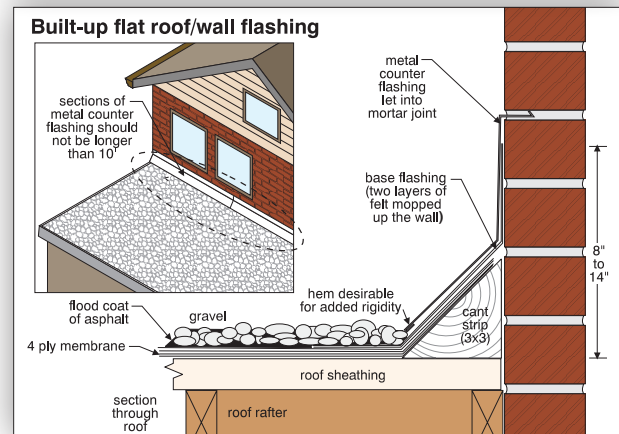
When the side of a roof ends at a wall, two sets of flashings are used. L-shaped step flashings are installed between each layer of shingles. The vertical part extends up the wall and is covered by siding or a metal counter flashing. Counter flashings are used on masonry walls, and the top may be let into mortar joints or sealed to the face of the masonry with caulking (a less permanent approach).

ROOF-TO-SIDEWALL FLASHINGS – INADEQUATE CLEARANCE Where wood siding is used as a counter flashing, it should stop roughly two inches above the roof surface so that the wood is not constantly wet. Wood close to the roof surface is prone to rot.

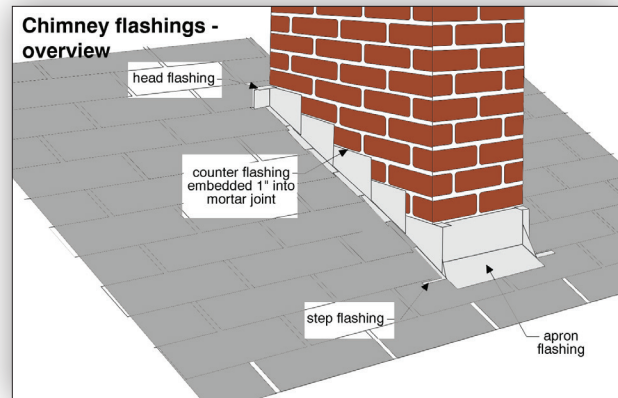
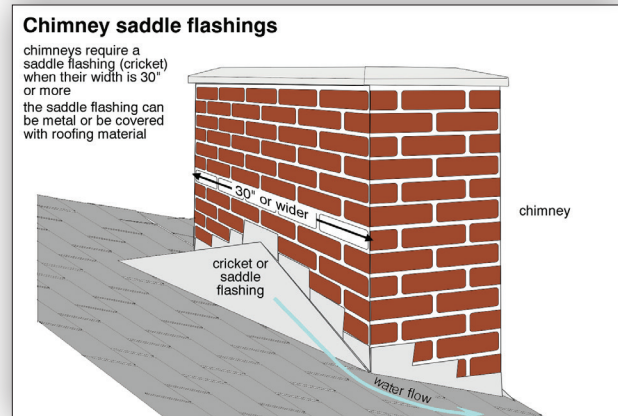
2.5 Chimney Flashings

DESCRIPTION The flashings used on the sides and downhill portion of the chimney are similar to the wall flashings described above. The weakest part of a chimney flashing is the high side, facing up the roof. Water running down the roof must be diverted around the chimney. The flashings on the high side typically extend up at least six inches or one-sixth of the width of the chimney, whichever is greater. The flashing should continue up under the roofing to an equal height.

When a chimney is more than 30 inches wide, a saddle (or cricket) should be used to divert water around the chimney. This is a small peaked roof that directs water around the chimney.

LOCATION The location of a chimney affects how prone it is to flashing leaks. A chimney near the peak of a roof is better than a chimney at the bottom of a roof, which is better than chimney in a valley.

SADDLE MISSING Saddles (or crickets) should be provided for chimneys wider than 30 inches to divert water around the chimney. A missing saddle may result in roof leaks at the chimney.

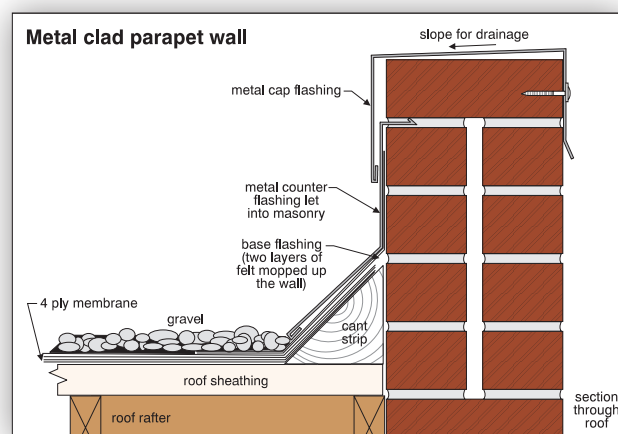
2.6 Parapet Wall Flashings

DESCRIPTION The exterior house wall may protrude above the roofline, forming a parapet wall. Where the roof meets the wall, typical wall/roof flashings are used. A cap flashing should also be provided over the top of the wall to prevent water penetration into the wall system.

PARAPET FLASHINGS – PONDING Parapet flashings should drain water quickly. When water accumulates on the top surface, premature rusting and leakage may occur.

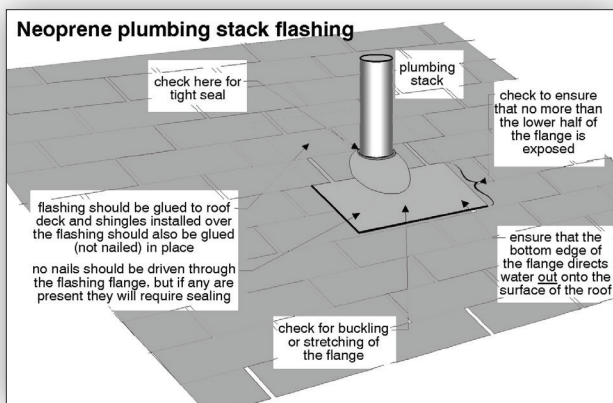
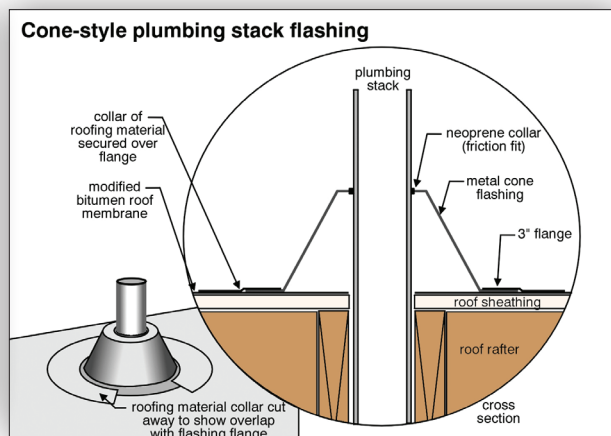
2.7 Plumbing Stack/Electrical Mast/Exhaust Flue Flashings

DESCRIPTION A metal or rubber flashing is provided where anything penetrates the roof.

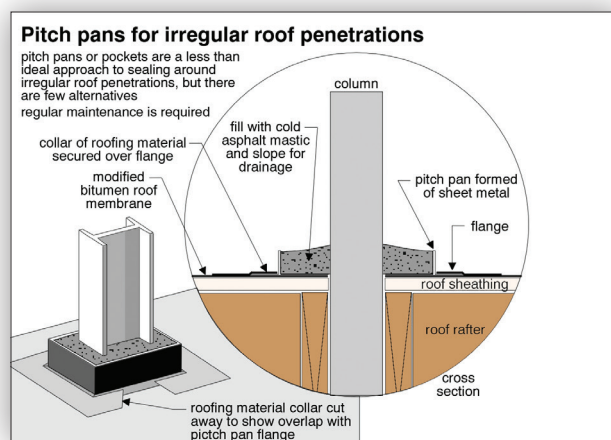
PITCH PANS (PITCH POCKETS) On flat asphalt roofs, pitch pans are sometimes used. A sheet metal pan around the stack or mast is filled with pitch or tar to a depth of one or two inches. Some experts consider this a poor flashing.

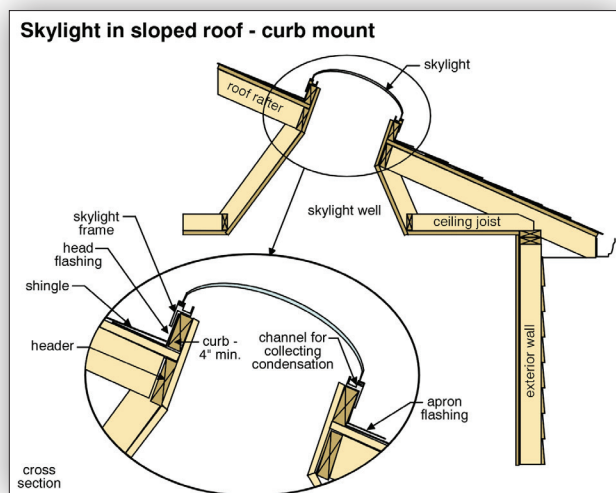
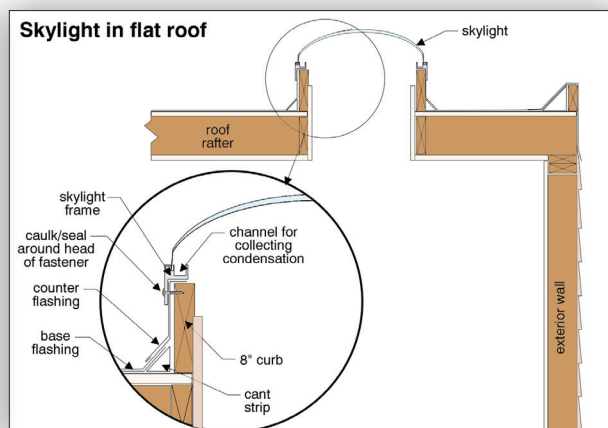
2.8 Skylight Flashings

DESCRIPTION Skylights should be flashed much like chimneys. A skylight should be installed on a curb or box that protrudes above the roof surface (unless the skylight comes with a pre-manufactured flashing assembly). This allows for the installation of proper flashings and limits snow accumulation on the skylight in cold climates.

SKYLIGHT FLASHINGS Leaks are common where there are no curbs or very short curbs. Other common problems include incomplete or improper flashing details around the skylight.

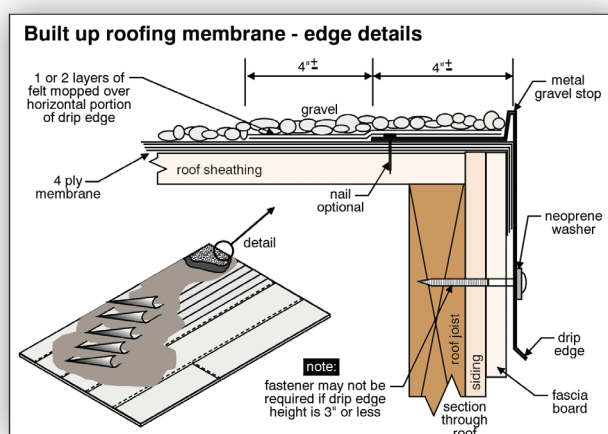
2.10 Gravel Stop Flashings

DESCRIPTION On most built-up flat roofs, a gravel stop flashing made of metal is used at the perimeters. This metal flashing typically has a low profile and performs several functions, including securing and protecting the roof membrane at the edge of the roof, preventing the gravel from sliding off the roof, and forming a drip edge to keep water run-off from damaging the wood fascia.

GRAVEL STOP FLASHINGS Gravel stop flashings are sometimes loose, rusted or missing altogether. It is common to find the roof membrane pulling away from the gravel stop. This can lead to leaks at the roof edge.

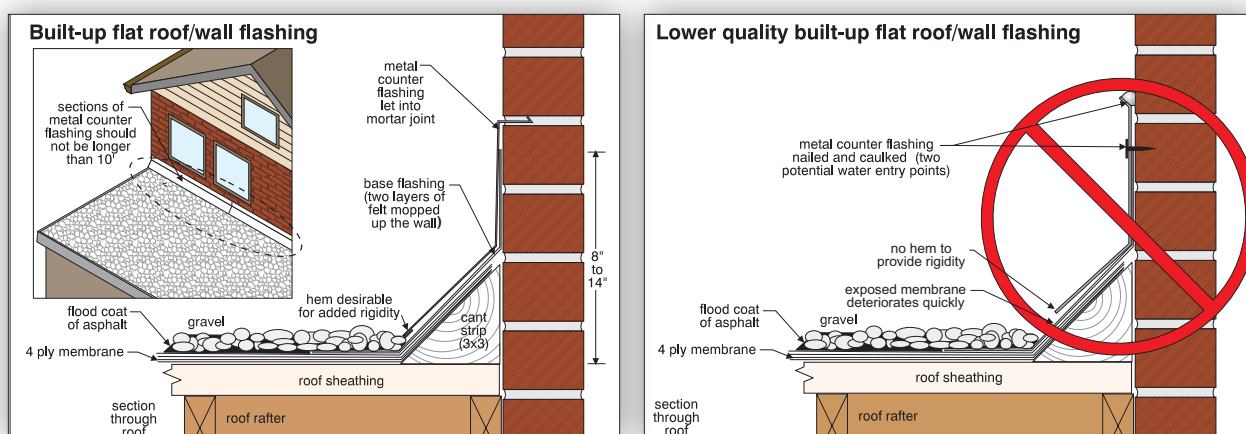
MISSING, POORLY INSTALLED The most common problems with flashings are that they are missing or not properly installed. Poor installation includes loose or missing components, poor fastening, inadequate height or length and poor sealing at the top. The illustrations below show a good way and an inferior way to attach a flashing to a brick wall.

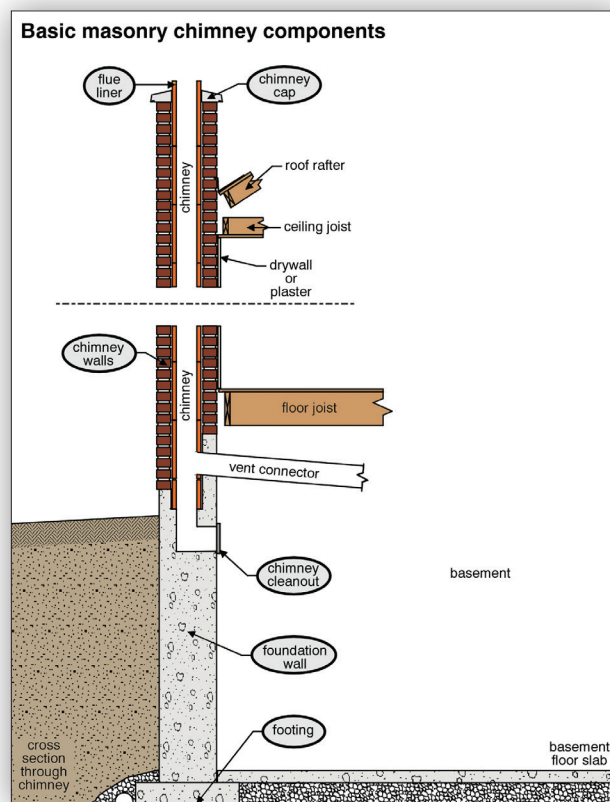
FLUES Chimneys often have more than one flue. Each flue is a separate channel for the smoke. Each appliance has a separate flue, with a few exceptions. Two gas furnaces on the same floor within a house can share a common flue, as can a gas furnace and a gas hot water heater on the same level.

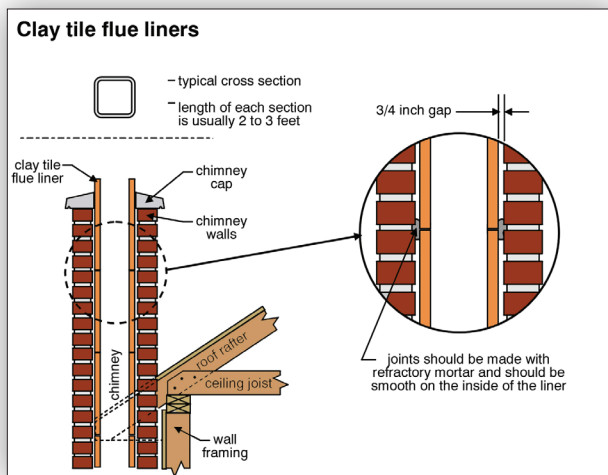
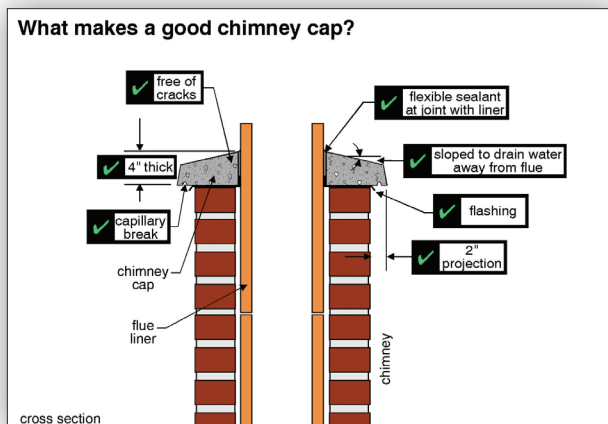
METAL

CHIMNEY CAP – Caps on metal chimneys are designed to keep rain out and help promote good draw by preventing downdrafts. Caps for wood burning appliances often include a screen to prevent sparks and embers escaping from the chimney top.

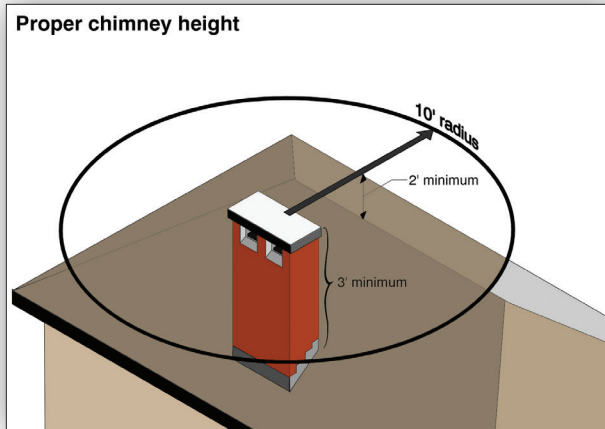
HEIGHT Chimneys should be a minimum of three feet above the point of penetration through the roof and two feet higher than anything within ten feet of them to help ensure good draft. Minor liberties can be taken with this rule when considering single flue metal chimneys for furnaces. A common solution for fireplaces that draw poorly is to extend the chimney or divert down drafts.

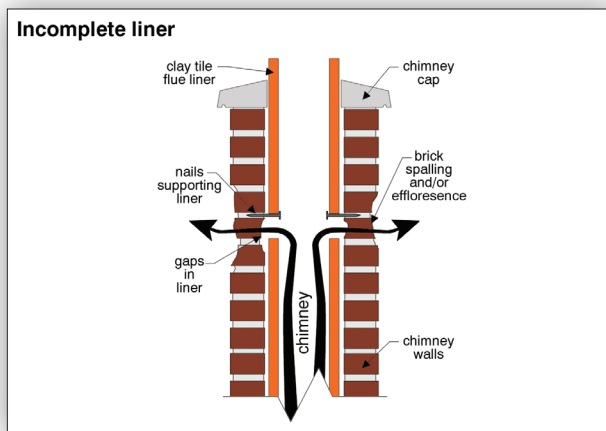
GAP IN LINER Some masonry chimneys lined with clay tile have a gap in the liner. The top flue tile should protrude two to four inches beyond the top of the chimney. If the top section of clay tile was too short to protrude (two-foot lengths are common), some masons simply raised the top tile, leaving a gap between the top two tiles. A ring of deterioration may show up on the exterior of the chimney, corresponding to the gap in the clay tile liner.
